ECC Casualty Reduction Site Investigation 2012-13

Safety Scheme: 20

Mount Road j/w Banks Lane

District: Epping Forest

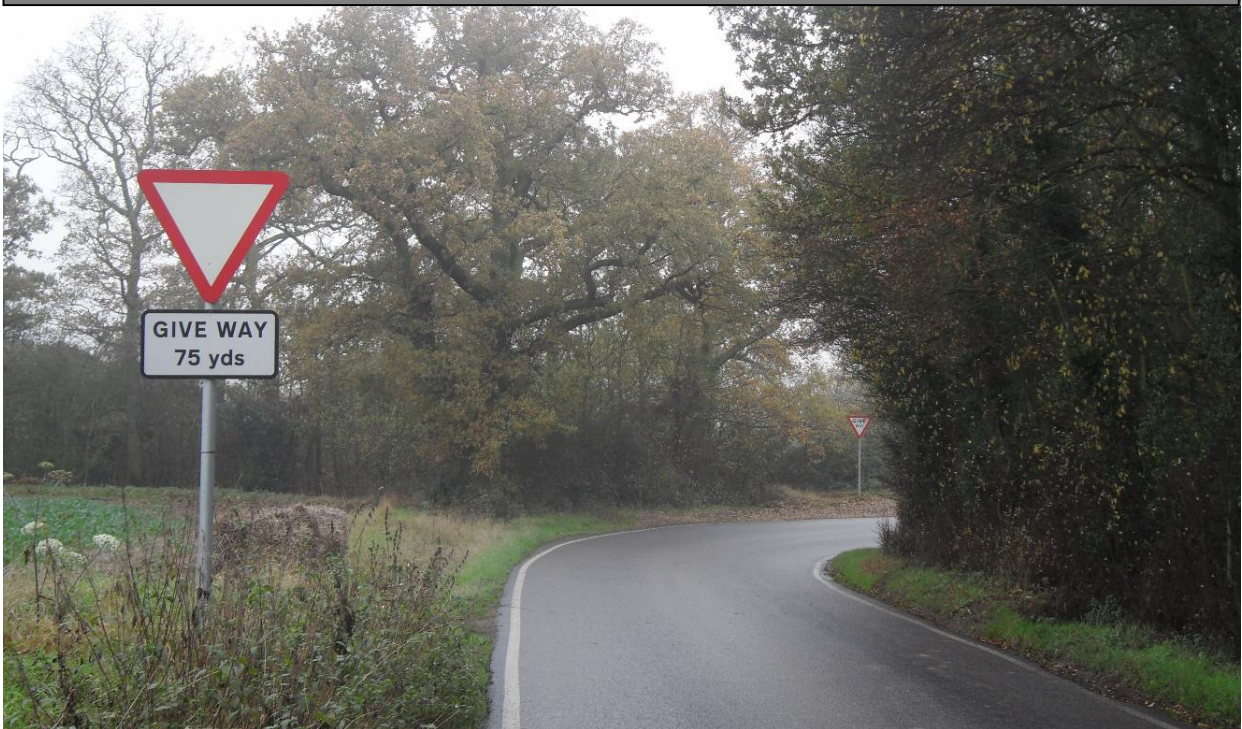
Photograph 1. On Banks Lane approaching the junction with Mount Road

Because of the right hand bend on Banks Lane, when waiting to enter Mount Road, visibility to the left is restricted. This view is also further restricted by vegetation on Mount Road.

There is evidence of vehicles over running the verge on the outside of the bend on Banks Lane. This over running, most probably by vehicles turning left into Mount Road and occasionally right into Banks Lane, will spread gravel and mud onto the mouth of Banks Lane.

- Straightening the Banks Lane approach to Mount Road.

This will require the diagram 602 GIVE WAY sign and the finger post direction sign to be relocated.

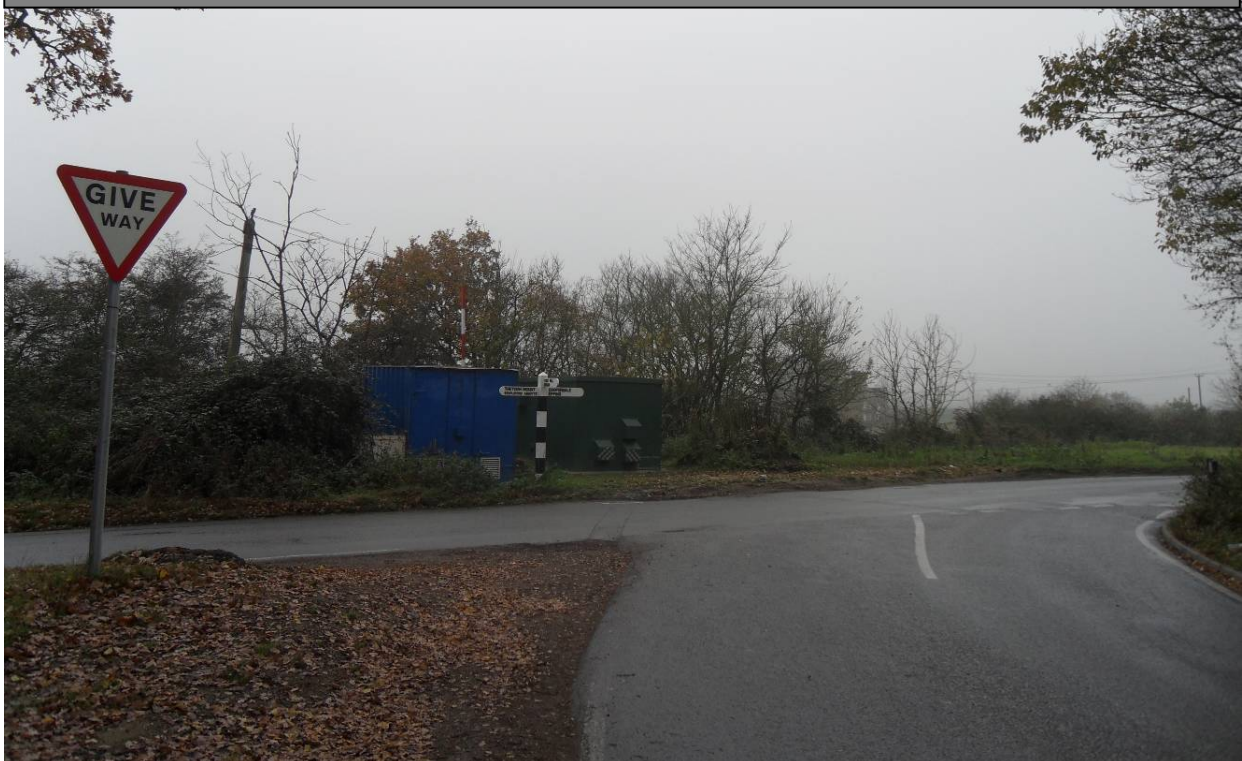
Photograph 2. On Banks Lane at the junction with Mount Road

The road markings at the junction and the SLOW markings on the Mount Road approaches to the junction were faded and indistinct.

- Refreshing the road markings at the junction and the SLOW road markings on the Mount Road approaches to the junction.
- Installing Diagram 506.1 Side Road ahead on both Mount Road approaches to the junction.

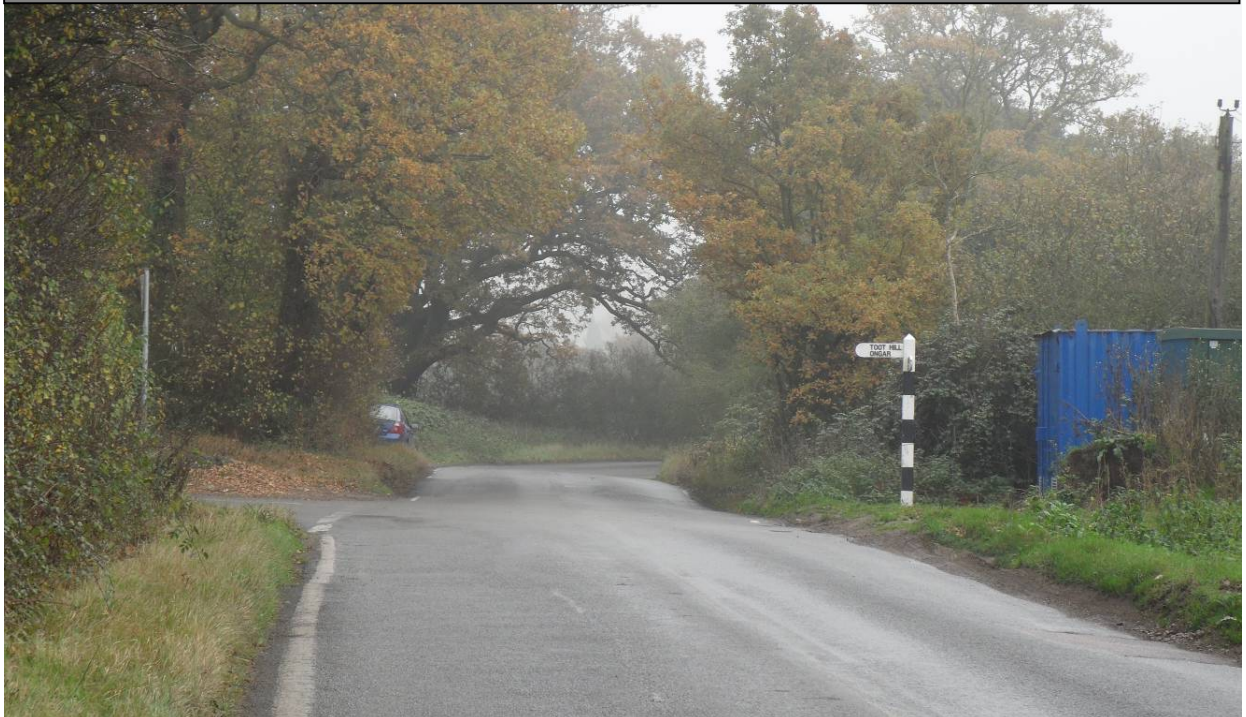
Photograph 6. Eastbound on Mount Road at the junction

On Mount Road there were some holes along the carriageway edges and areas of worn road surface.

It is also recommended that an examination of the road surface be carried out at this location by the Maintenance Activity to determine if any repairs/resurfacing are required.

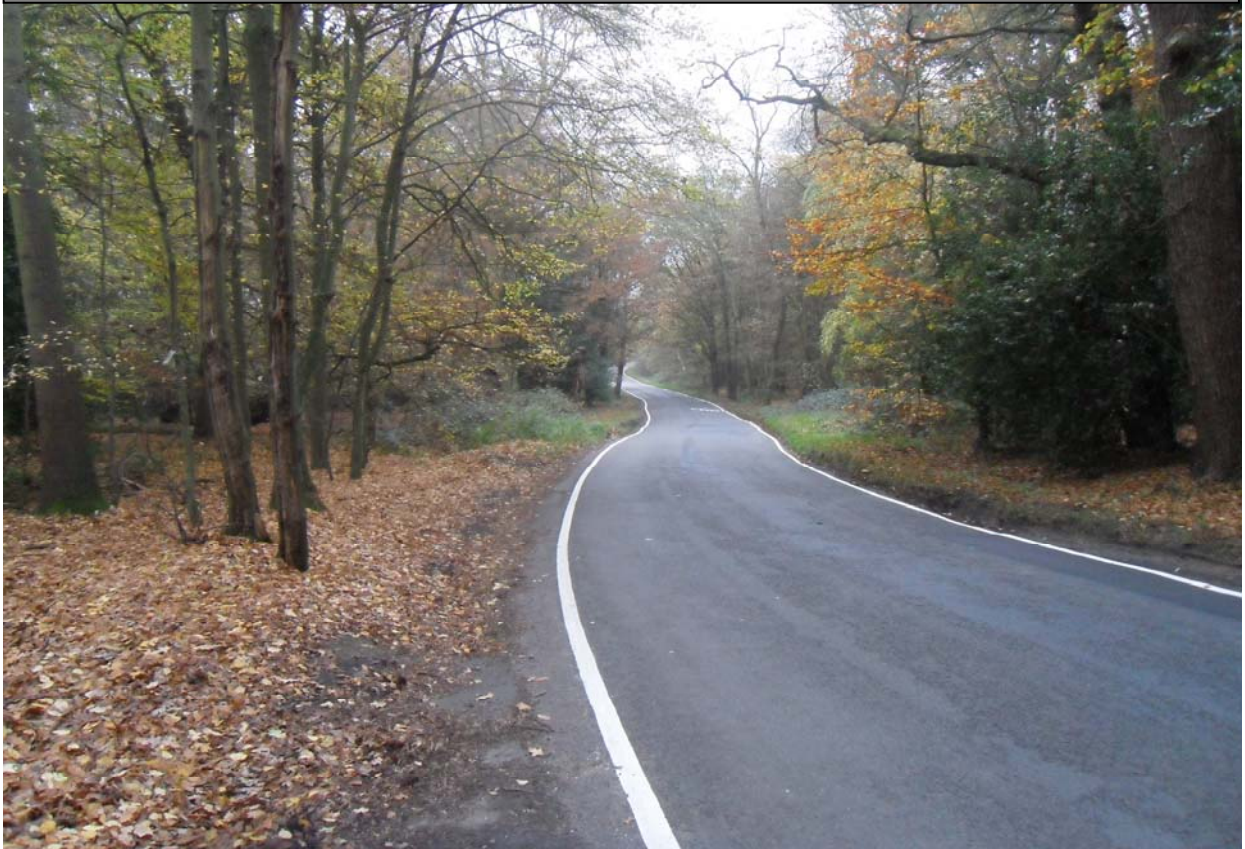
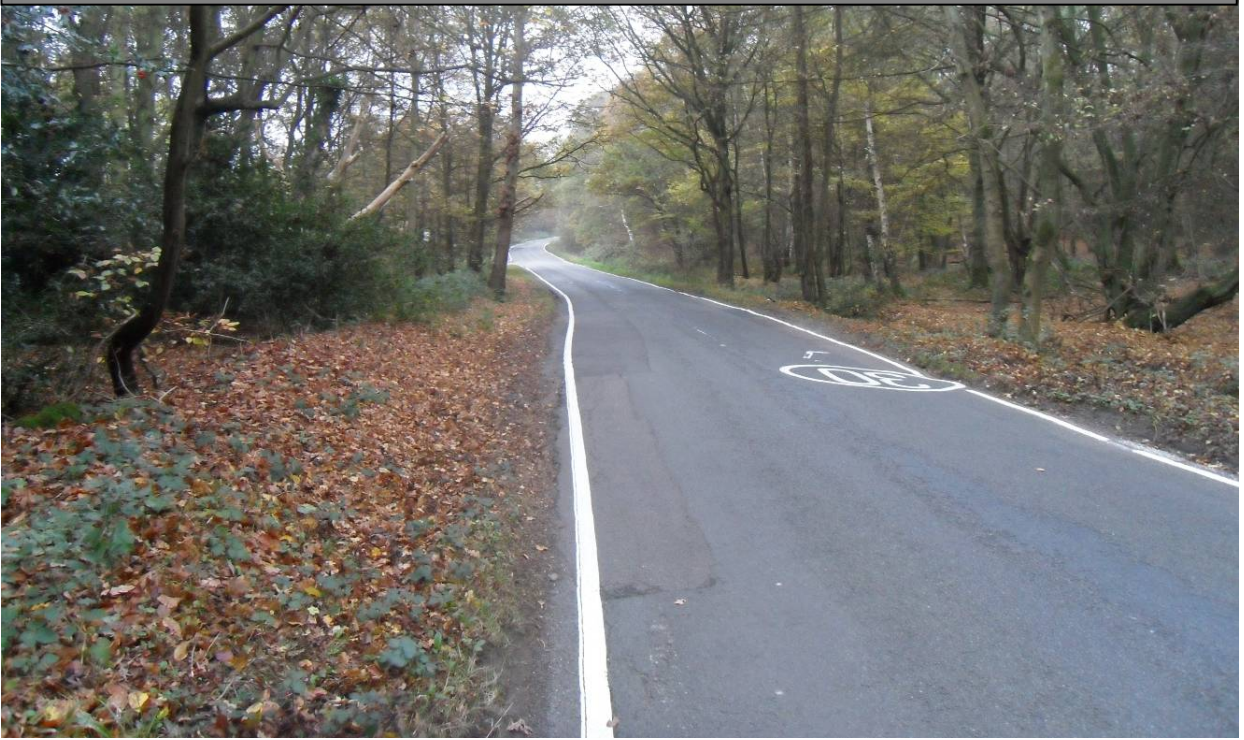
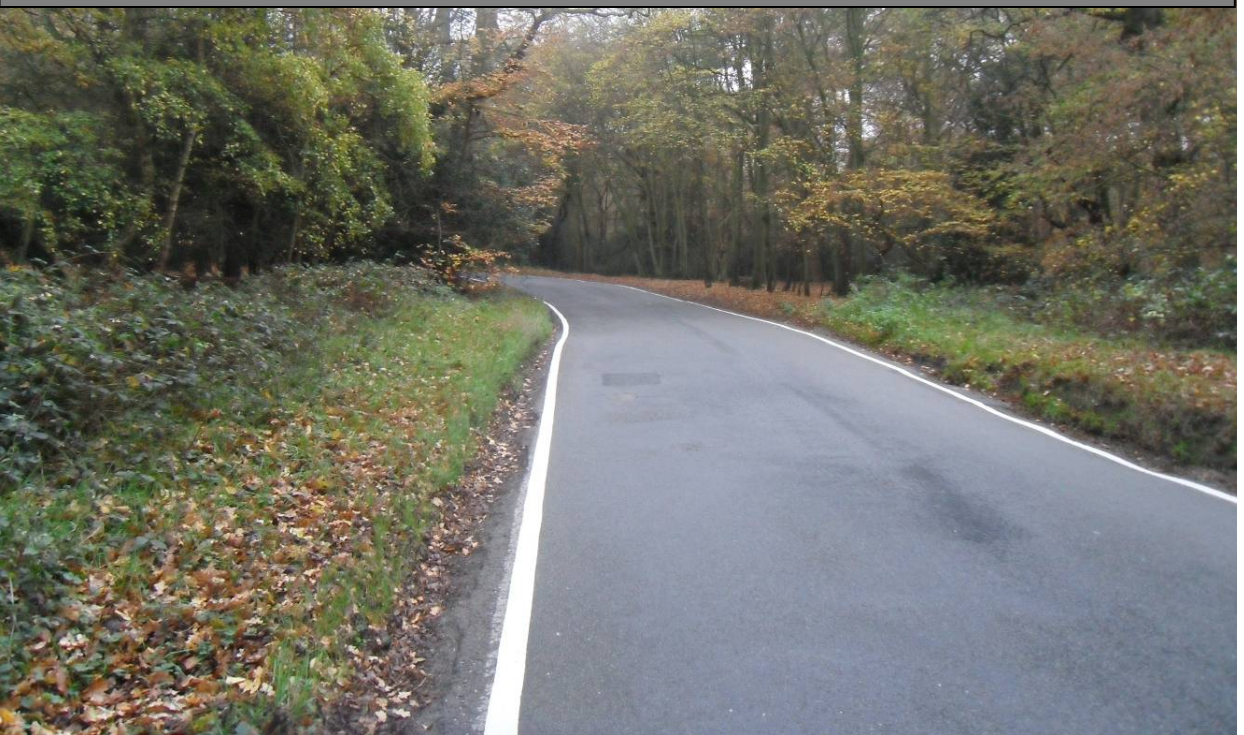
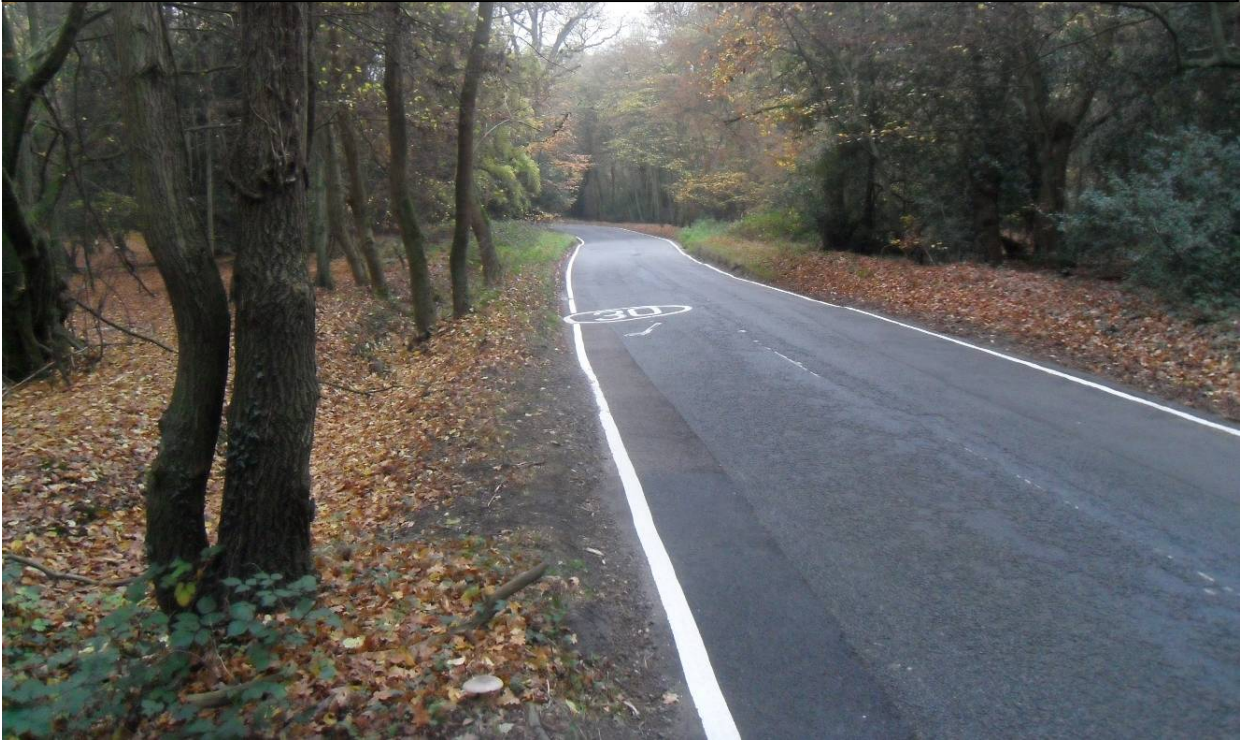
The road surface of the subject length of Claypit Hill appears to be in serviceable condition and the edges of the carriageway are clearly marked. Although the road is sinuous, the start and severity of each bend is clear enough not to require warning signs or delineation by Chevrons or verge markers.

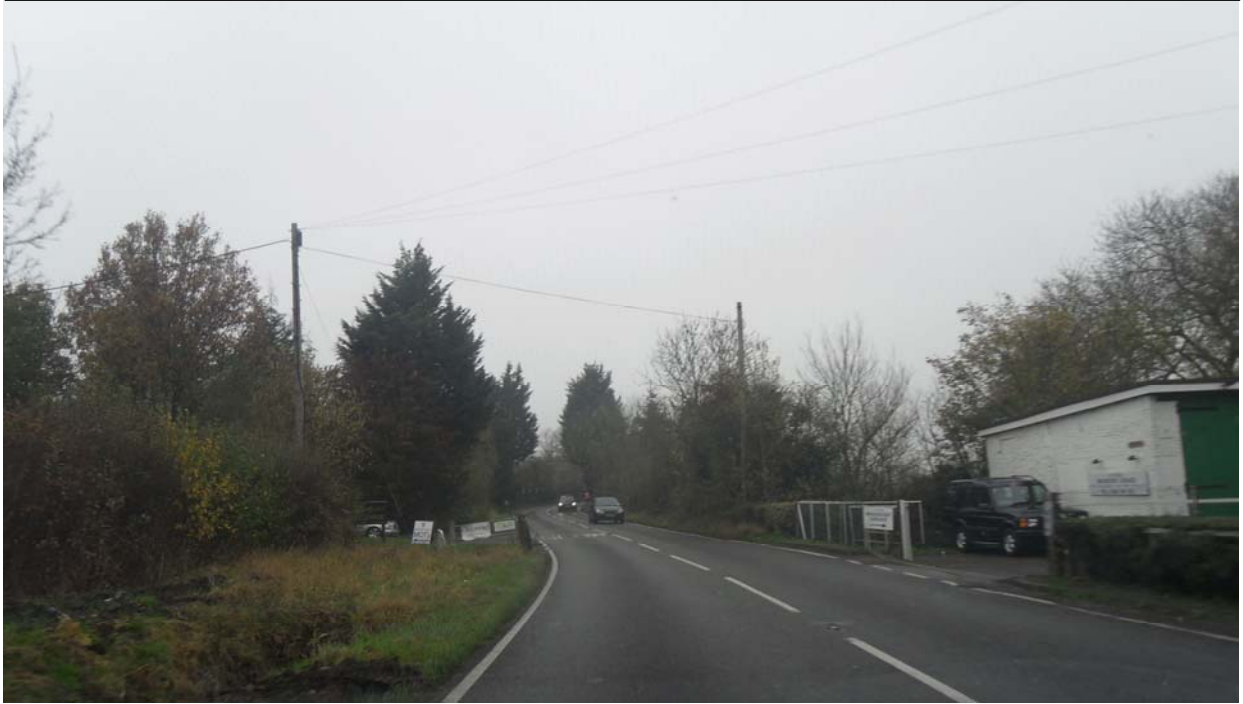
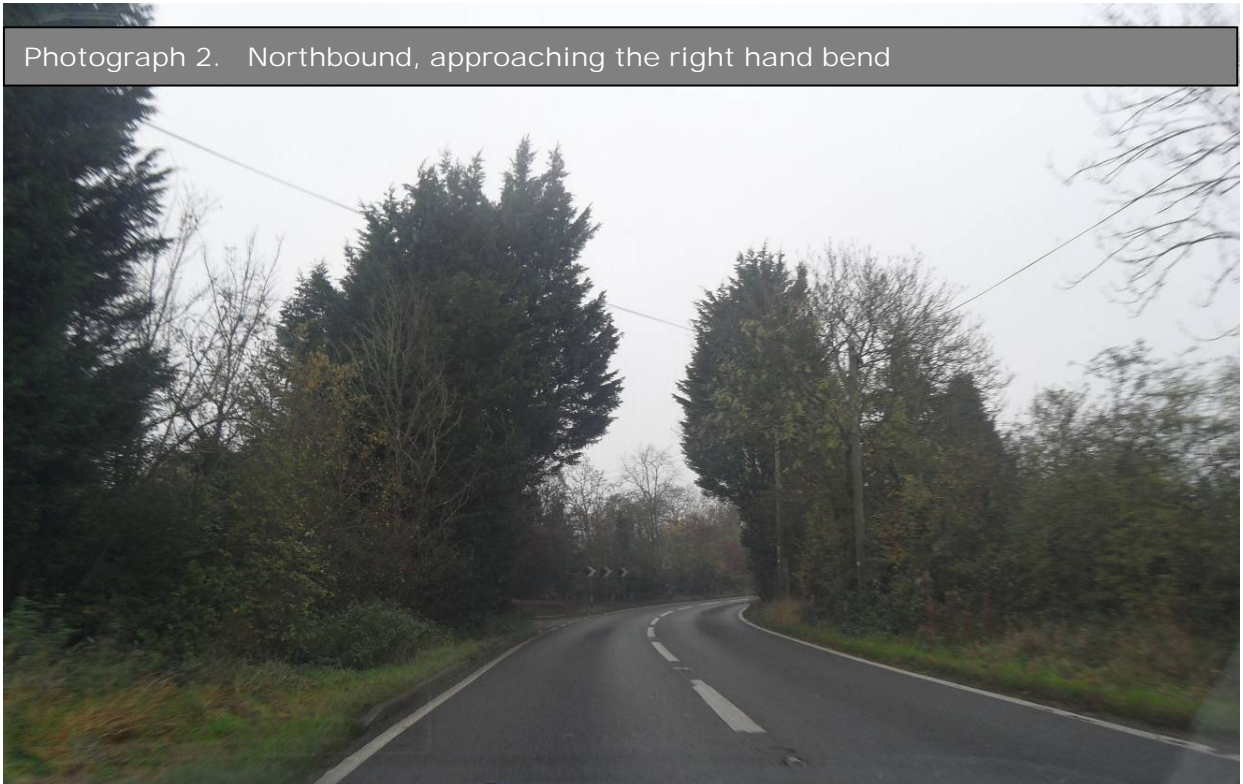
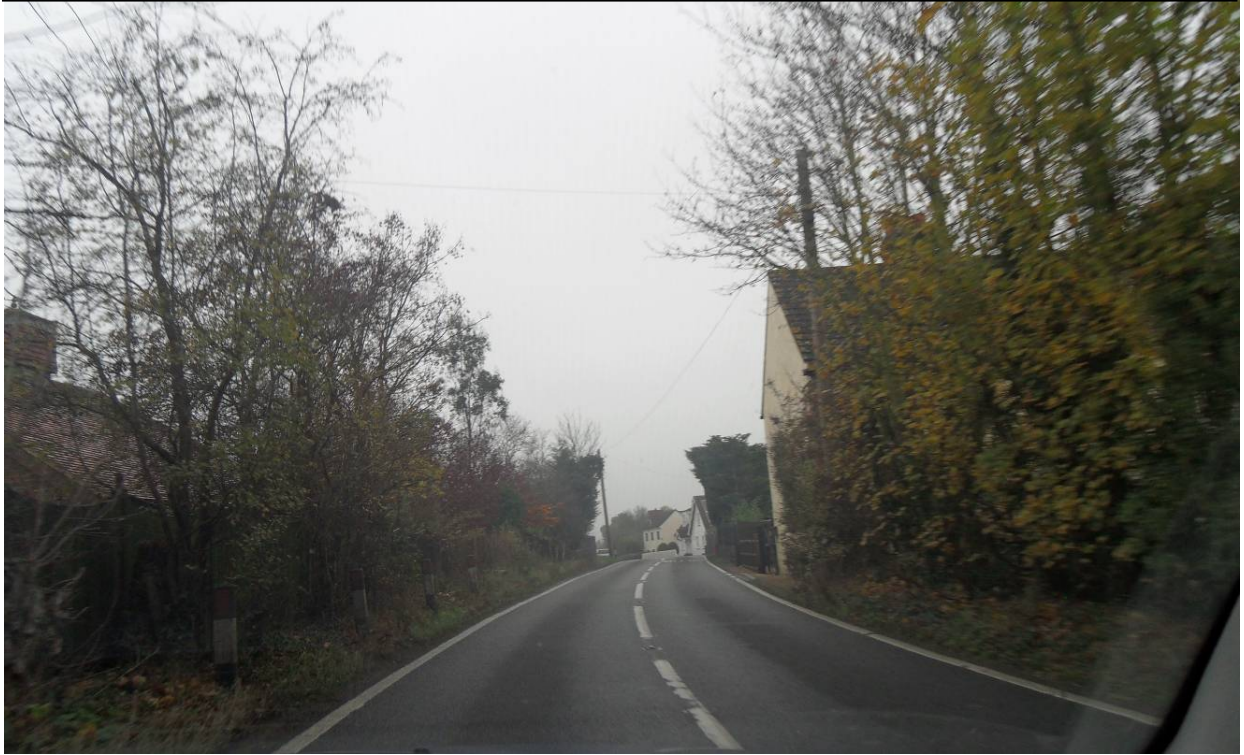
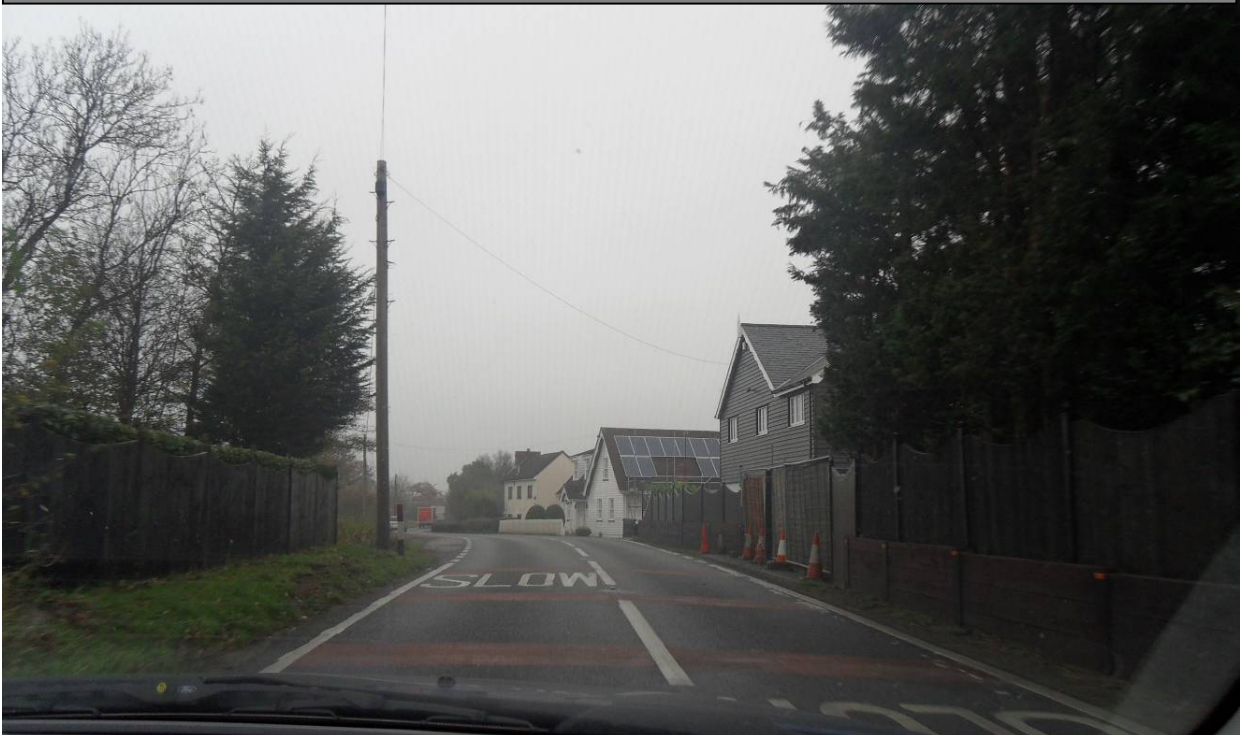
Three of the 5 collisions have involved northbound vehicles losing control. This pattern is confirmed by the residents who have witnessed a number of damage only collisions on this bend.

Work funded from localism sources is in progress to replace the black and white chevrons at this location with more conspicuous yellow backed chevrons.

The pattern of collisions and the evidence from residents suggests road users are negotiating the right hand bend on the northbound approach at inappropriate speeds. The Grip Test also indicates that the road surface on this approach should be investigated.

- The Maintenance Activity should check the road surface to determine if any repairs/resurfacing are necessary.

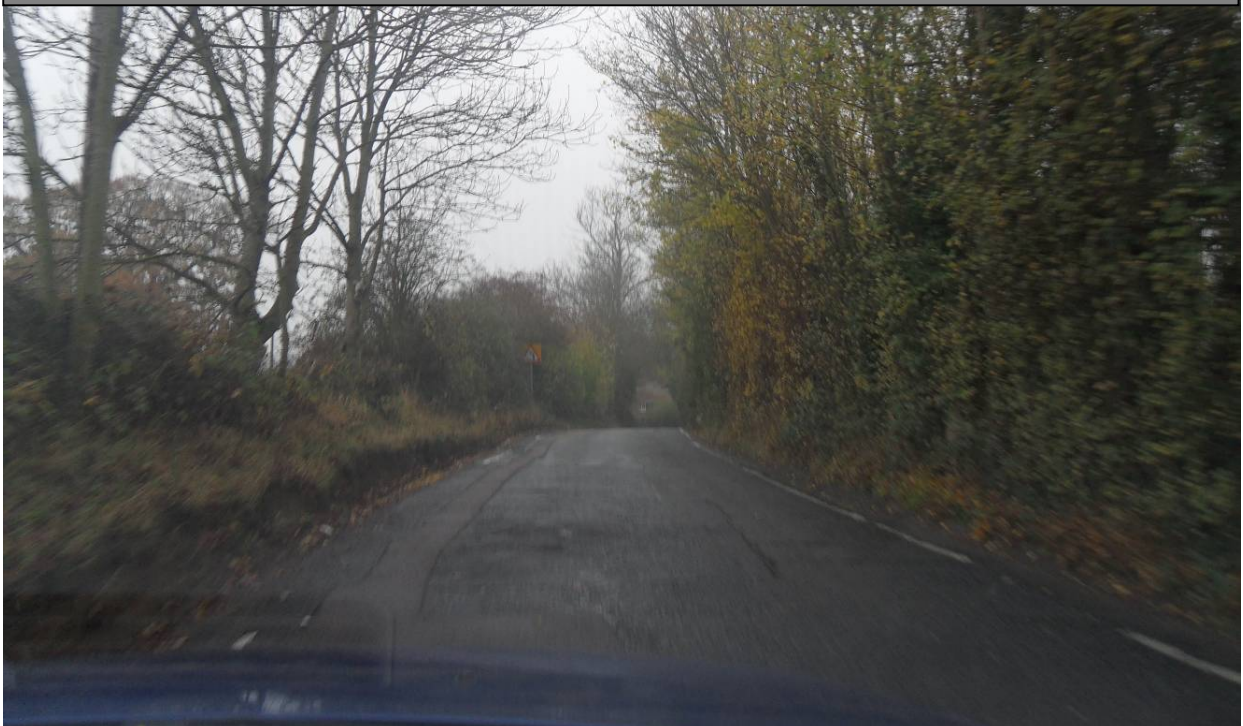
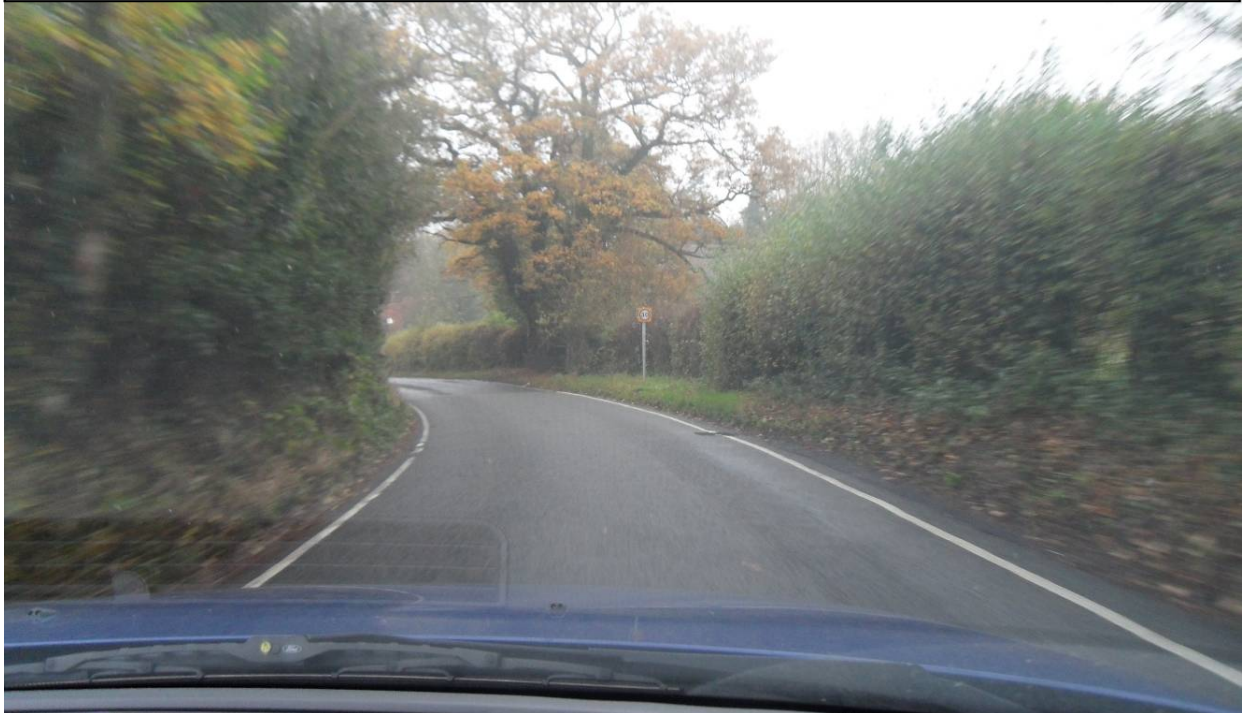
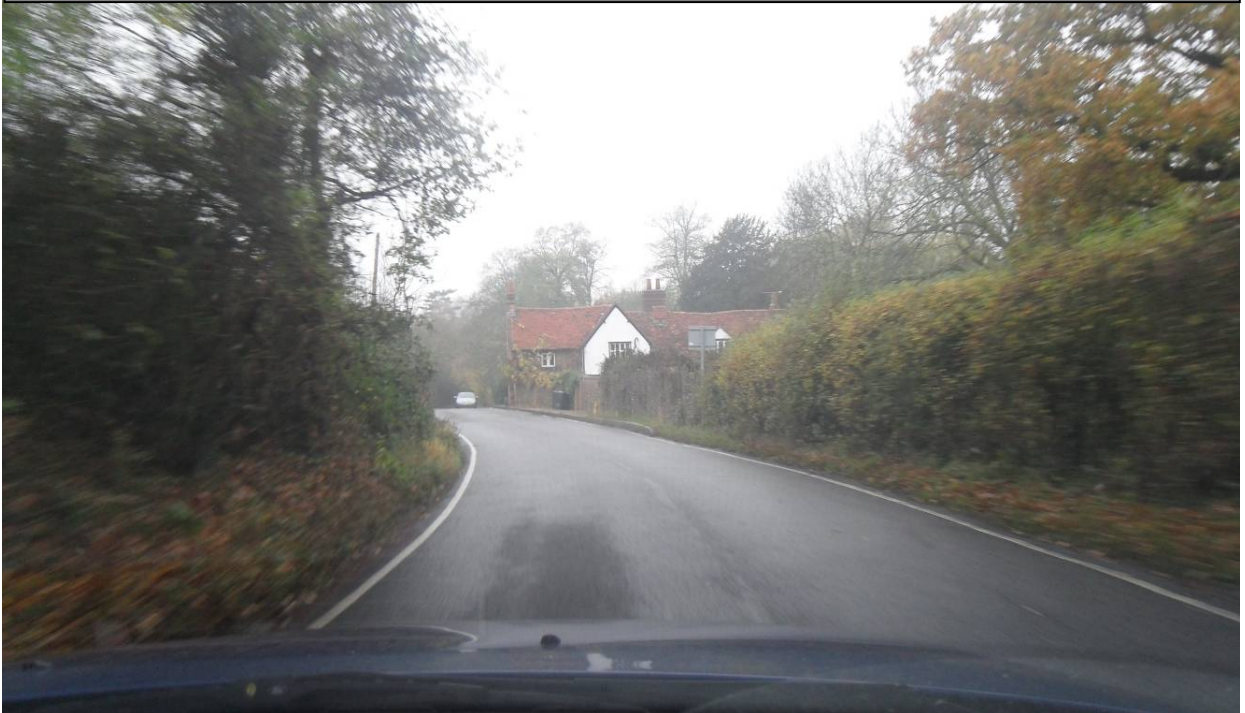
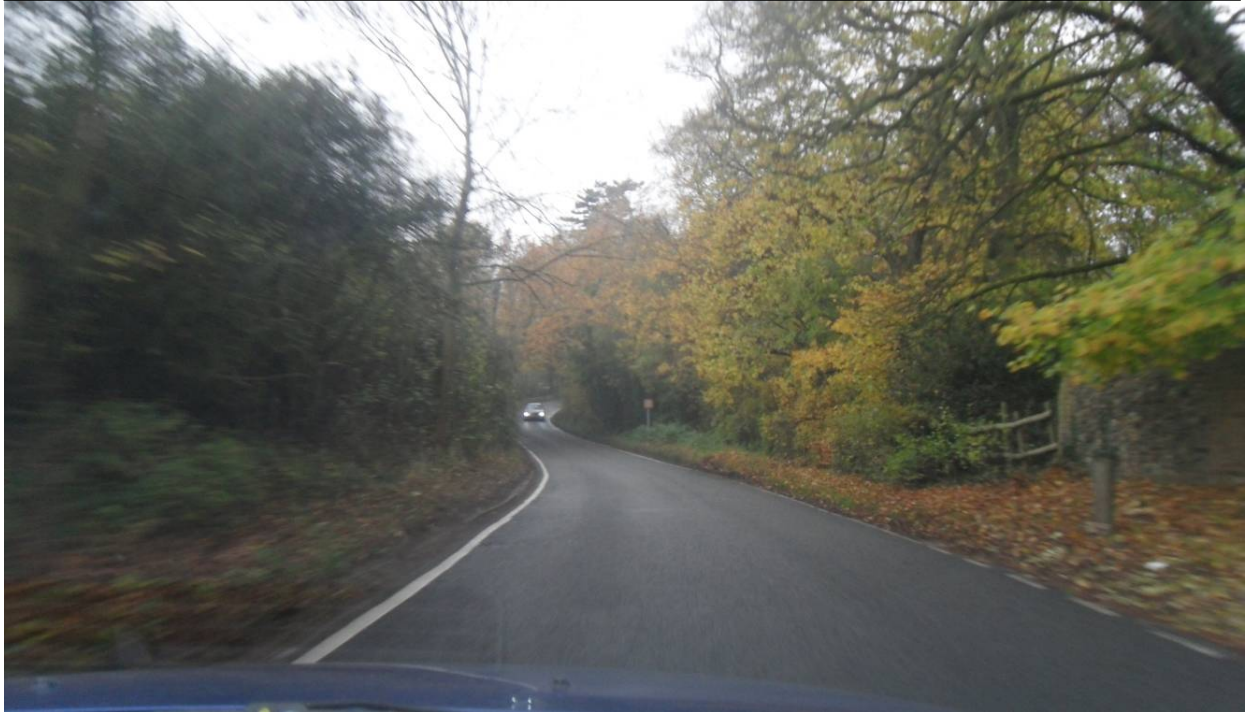
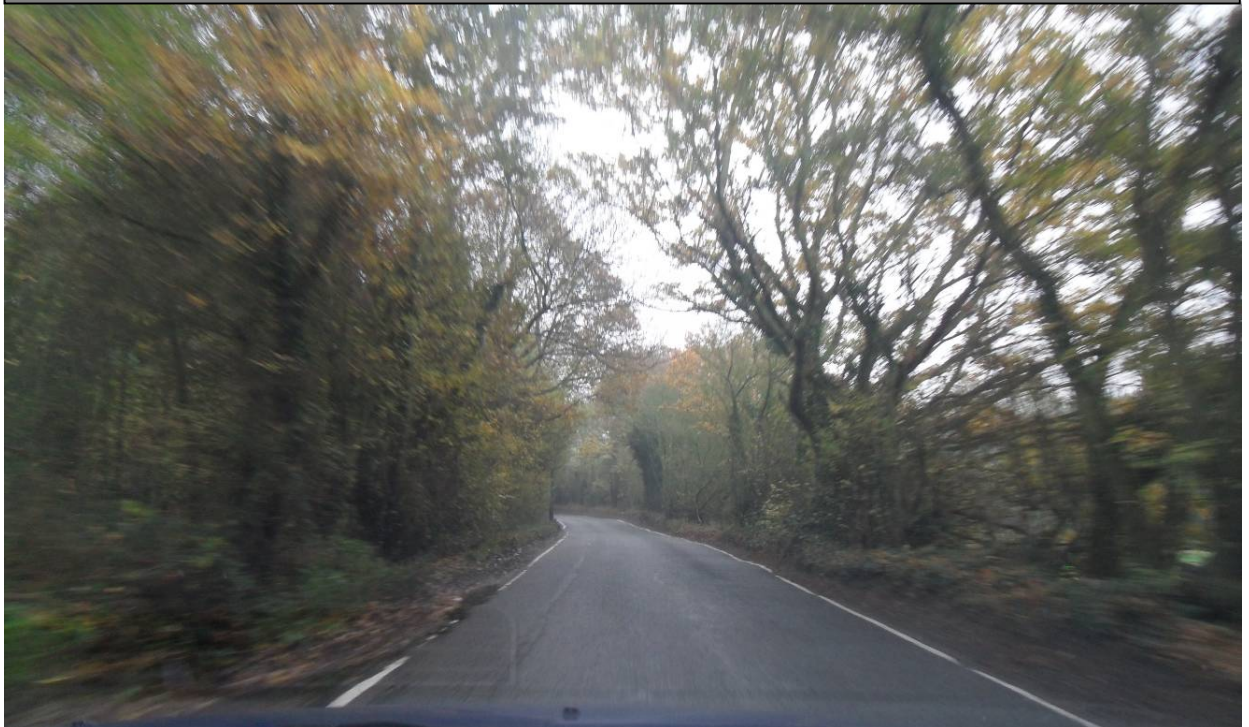
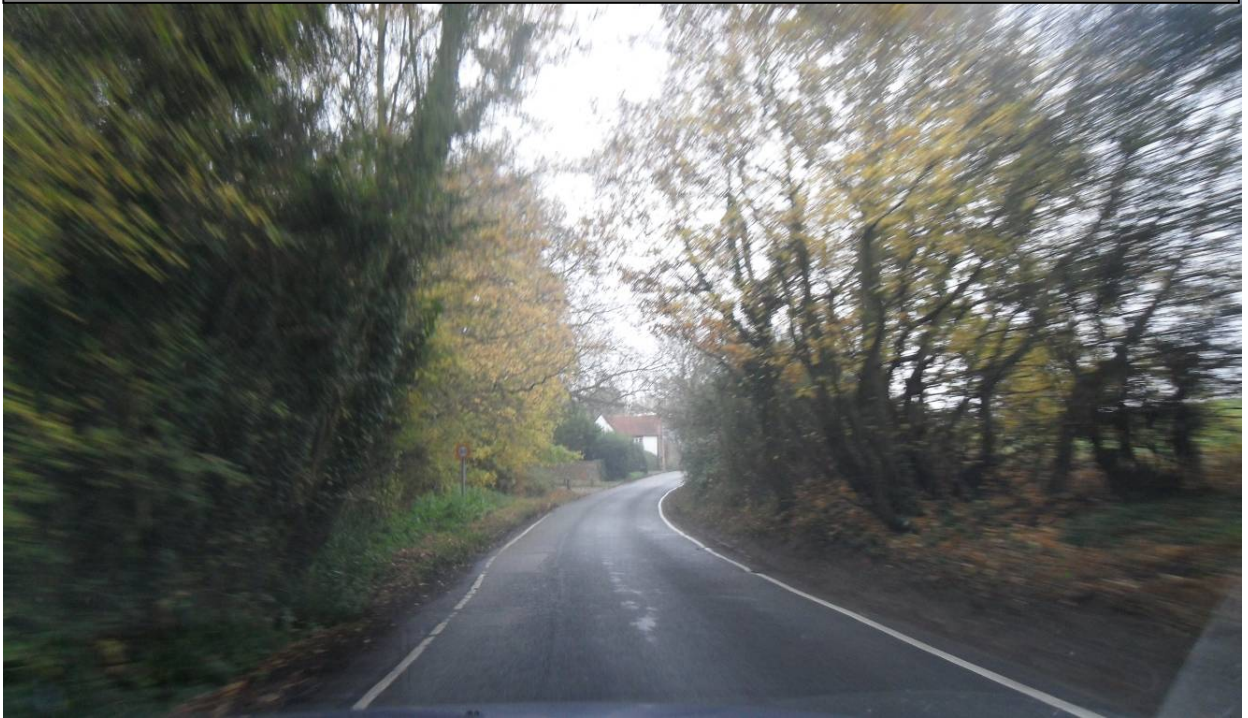
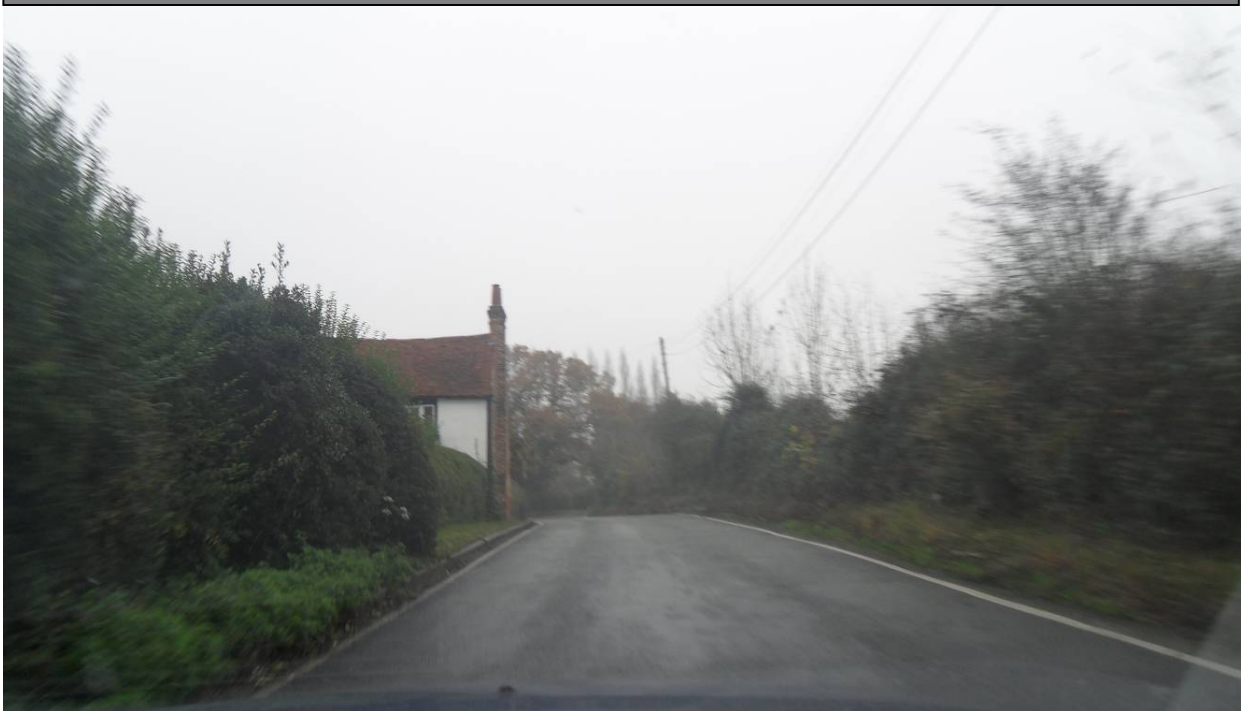
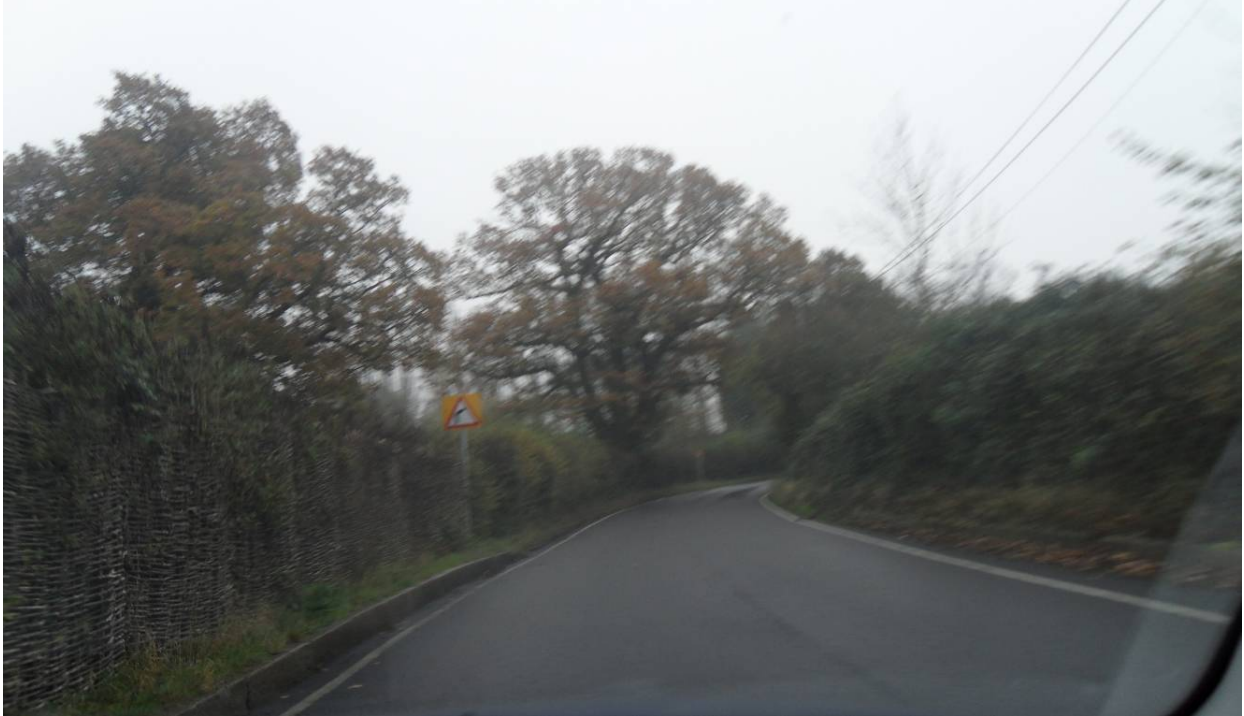
Northbound, the subject section of Pudding Lane is narrow, downhill and sinuous. In places, the roadside verges slope towards the carriageway such that rainwater together with mud and gravel will flow into the carriageway. There are no drainage gullies, grips or ditches to carry water away from the carriageway. Parts of the carriageway edges are undercut and broken – possibly due to water flowing down the edges of the carriageway.

- Where possible, drainage should be improved.
- Pudding Lane (with a daily vehicle flow of around 1,700 each way) is included in the winter gritting programme
- That the carriageway be inspected by the Maintenance activity to determine if repairs/resurfacing is necessary.

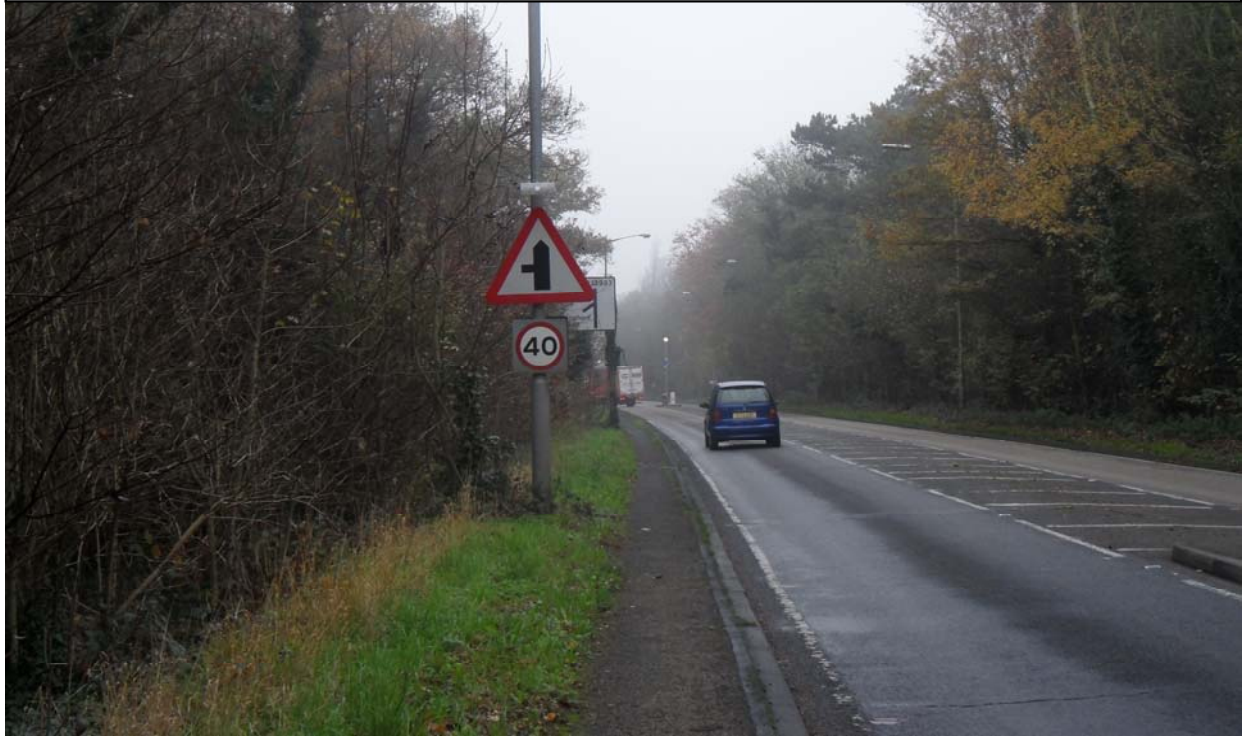
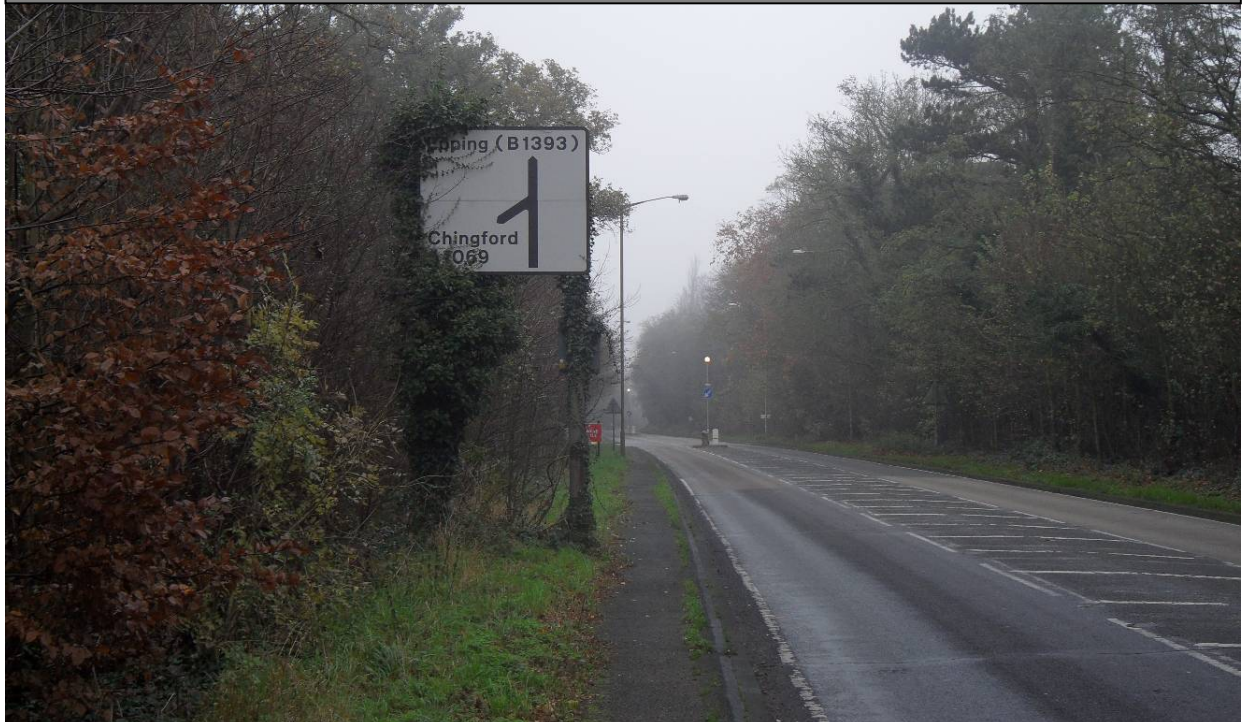
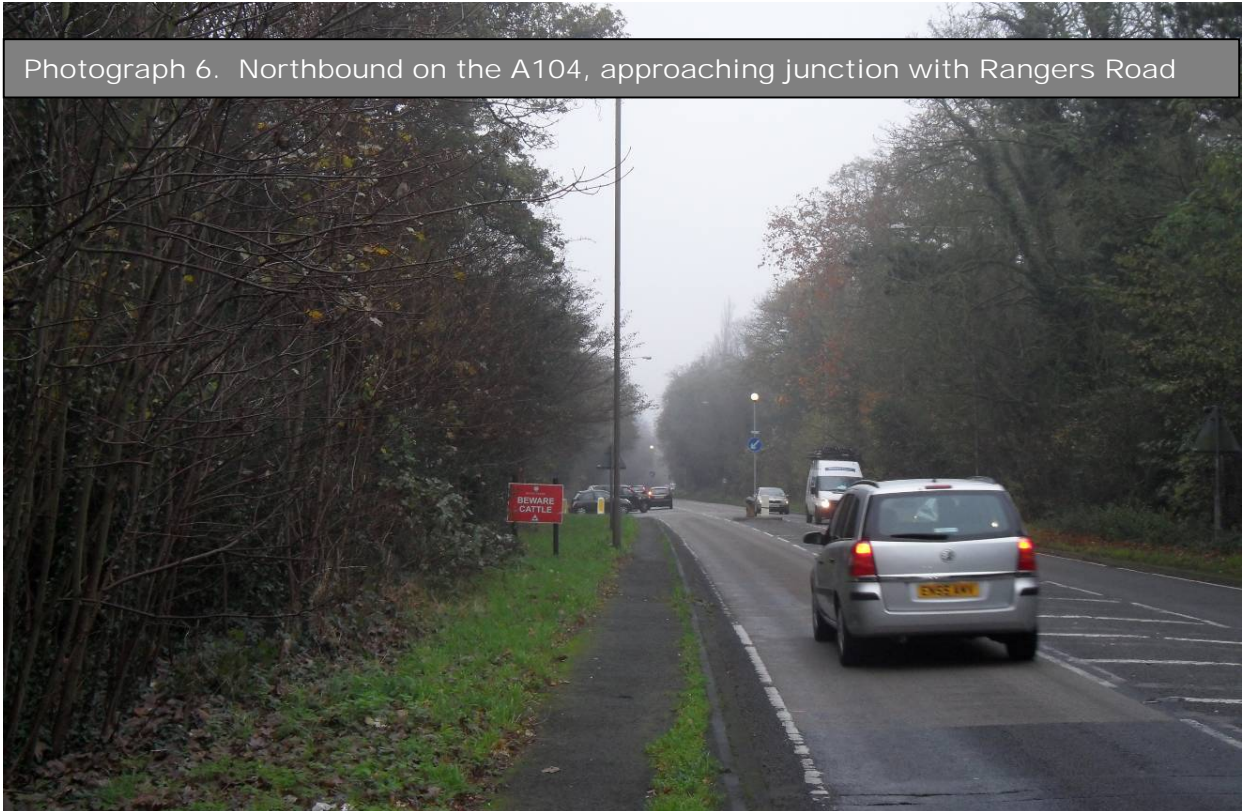
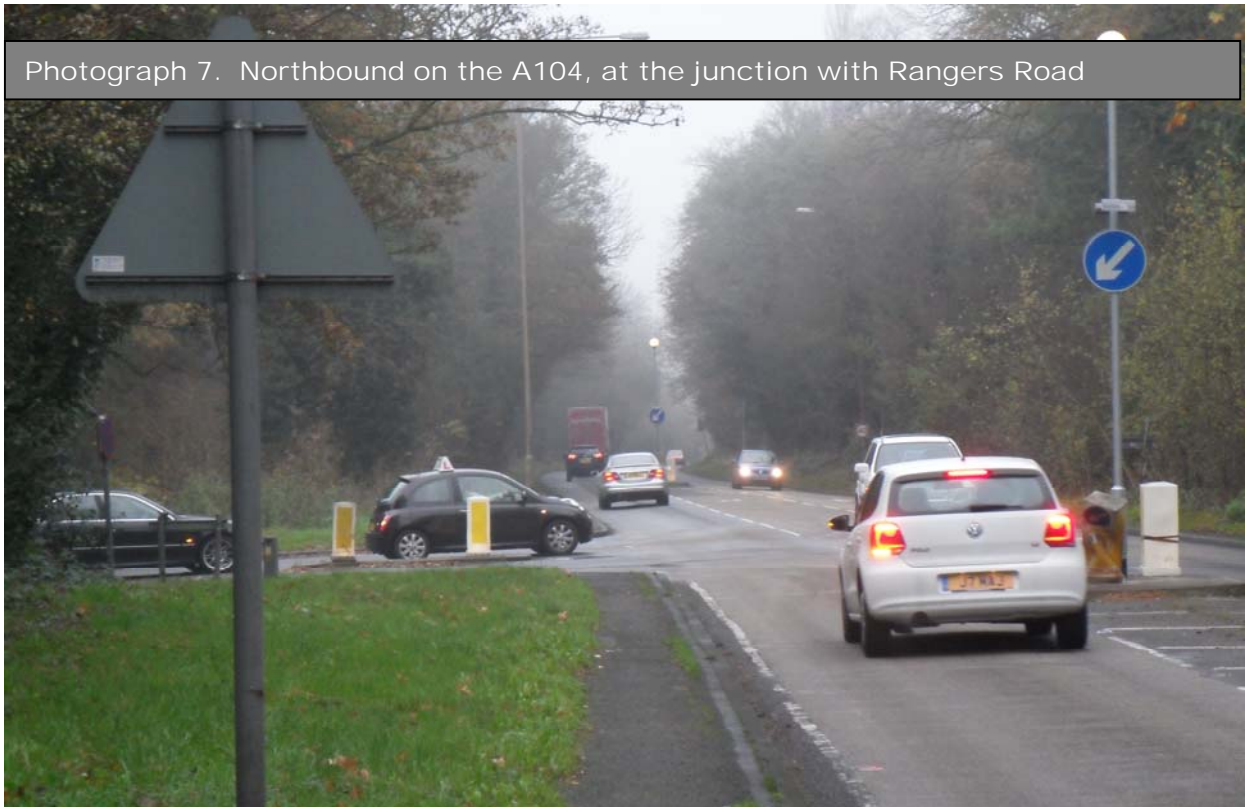
The buff anti-skid surfacing on the A104 at the junction is very worn.

The Keep left bollard on the northbound approach is damaged.

- Clearing the vegetation away from the map-type direction signs on both approaches.
- Realigning the diagram 506.1 Side road ahead sign on the southbound approach.
- Refreshing the road markings at the junction.
- Realigning the brown direction sign opposite Rangers Road.
- Adding prominent north and southbound direction signs opposite Rangers Road.
- Replacing the damaged Keep Left bollard on the northbound approach to the junction.

Replace damaged keep left bollard

Replace worn anti skid surfacing
