ECC Casualty Reduction Site Investigation 2012-13

Safety Scheme: 20

Mount Road j/w Banks Lane

District: Epping Forest

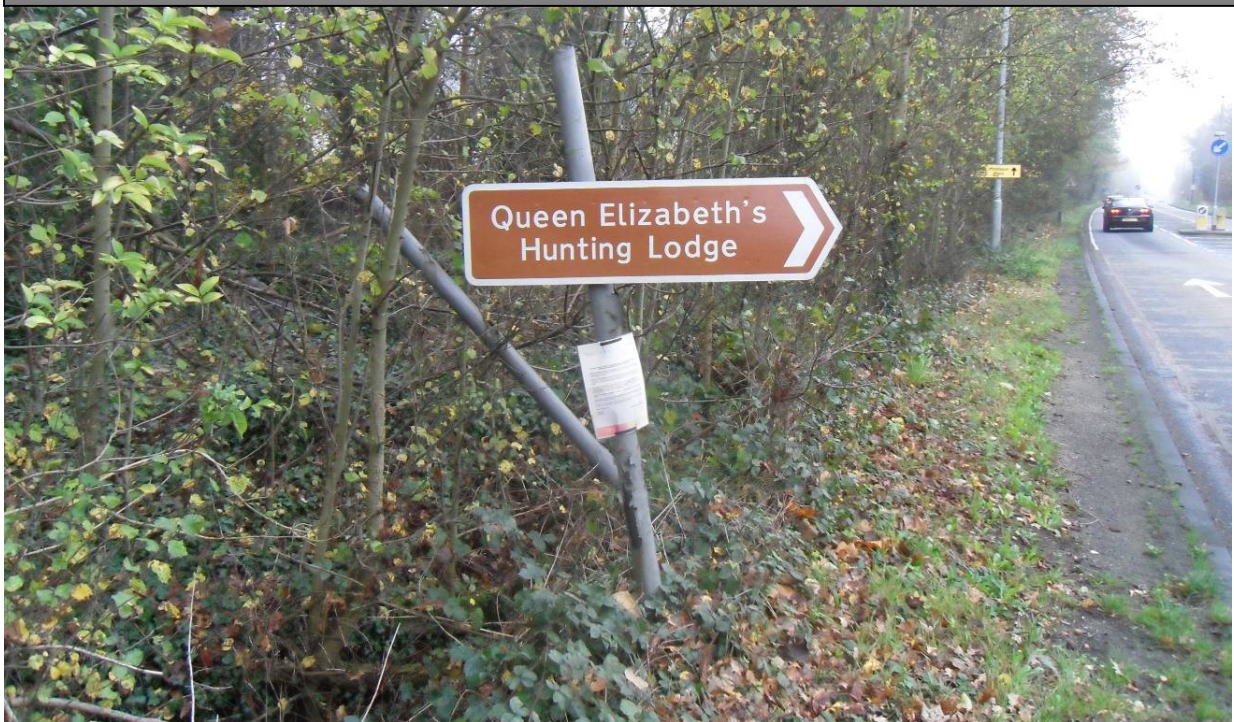
Photograph 11. Sign opposite Rangers Road

The brown direction sign opposite Rangers Road is leaning and misaligned and other sign/s may be missing from this location.

- Clearing the vegetation away from the map-type direction signs on both approaches.
- Realigning the diagram 506.1 Side road ahead sign on the southbound approach.
- Refreshing the road markings at the junction.
- Realigning the brown direction sign opposite Rangers Road.
- Adding prominent north and southbound direction signs opposite Rangers Road.
- Replacing the damaged Keep Left bollard on the northbound approach to the junction.
