## **Appendix 1:**

### **Epping Forest Casualty Reduction Sites 2015/16**

Site Report Essex Highways  
Casualty Reduction Site Report

Location: A104 Epping New Road j/w A1069 Rangers Road, Loughton / Buckhurst Hill

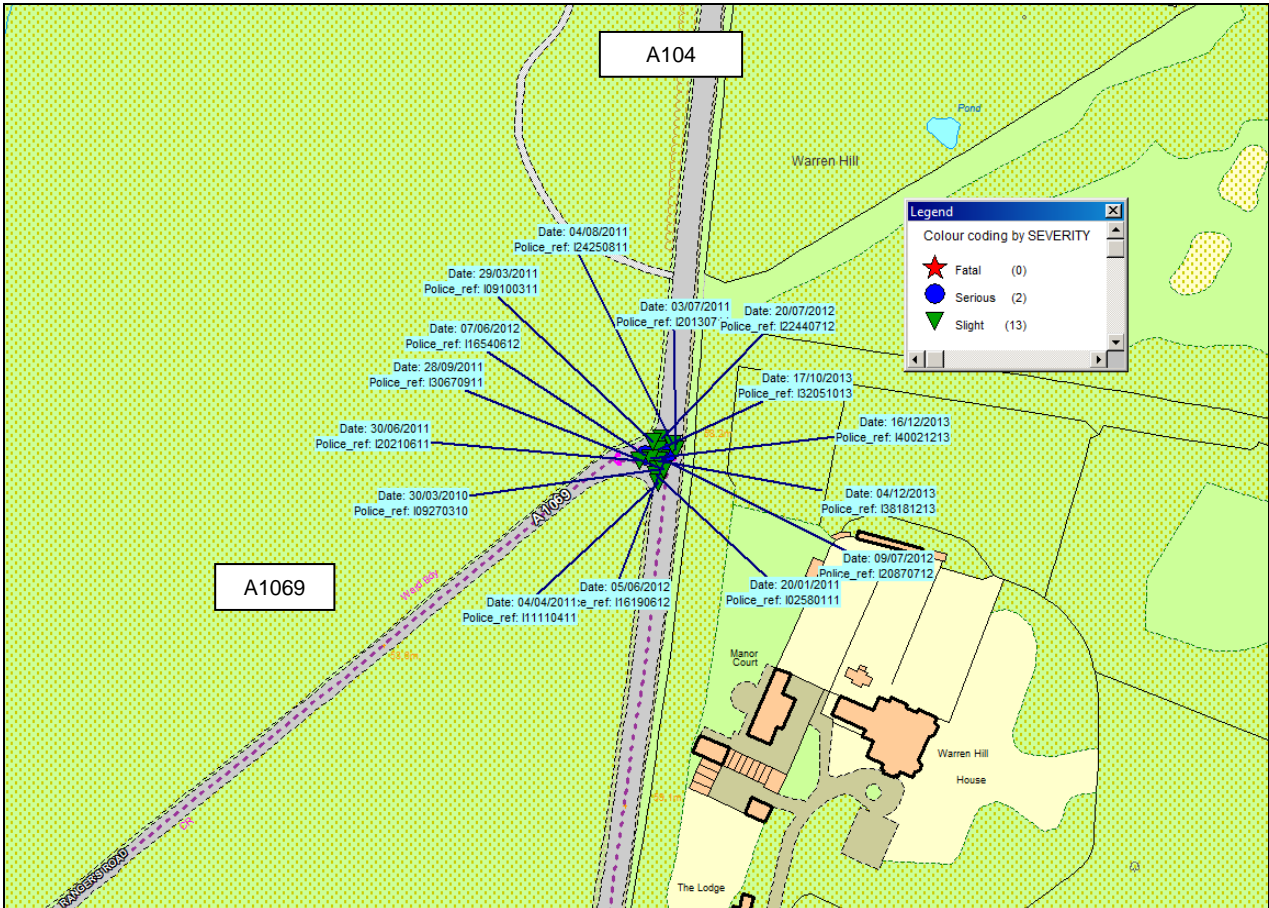
1.0 Site Plan with Collision Plot

<b>Identified Collision Pattern(s)</b>	<b>No of Collisions</b>
Collisions involving vehicles emerging from Rangers Road - 5 involving a northbound vehicle on Epping New Road being struck and 3 collisions where a southbound vehicle has been struck.	8 (53%)
Collisions involving vehicles turning right from Epping New Road into Rangers Road striking oncoming northbound traffic on Epping New Road.	4 (27%)

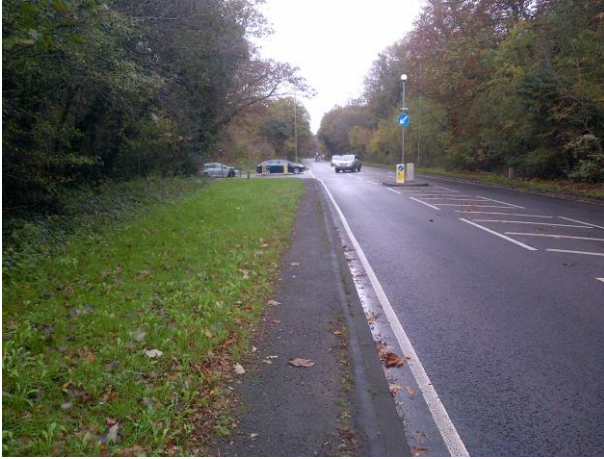
<b>Road Surface</b>	The road surface along Epping New Road appeared to be in very good condition owing to recent resurfacing works.
<b>Signing</b>	The road in the vicinity of the junction is covered by a 40mph speed limit. There are junction warning signs and ADS signs on both approaches on Epping New Road (see Images 1 and 4 below). Rangers Road has a yellow backed advanced give-way 80 yds sign (see Image 2 below). However, there is no give way sign present on Rangers Road at the junction (see Image 3 below).
<b>Road Markings</b>	There are edge of carriageway and central hatching with road studs along Epping New Road that incorporate the traffic islands for the right turn lane. There is give way lining at the Rangers Road junction. They are all in a good condition.
<b>Visibility</b>	Whilst Epping New Road is straight, visibility of the signing and junction is partially restricted due to the adjacent heavily wooded area of Epping Forest. The visibility of the junction ahead on Rangers Road is partly restricted due to the road alignment which curves to the right at the junction. Visibility to the left and right from the give way line in Rangers Road was good at the time of the site inspection (13/11/14).

Image 1 – View travelling northbound on Epping New Road approaching the Rangers Road junction on the left (taken 13/11/14)

- 1) Install new Vehicle Activated junction warning signs on both Epping New Road approaches to the Rangers Road junction. The signs are to be connected to detector loops in the carriageway so that they only activate when a vehicle is waiting to exit Rangers Road. The VAS for northbound vehicles will also activate when a vehicle is in the right turn lane waiting to turn right into Rangers Road.
- 2) Install new SLOW markings on the carriageway adjacent to the new VAS signs.

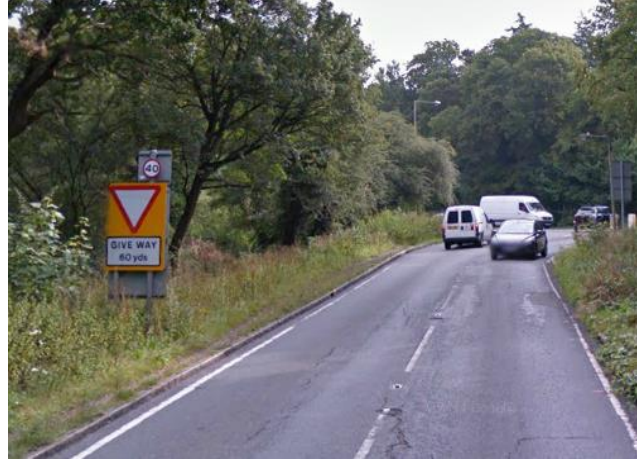
Image 2 – View travelling north eastbound on Rangers Road towards the junction with Epping New Road (taken from Streetview)

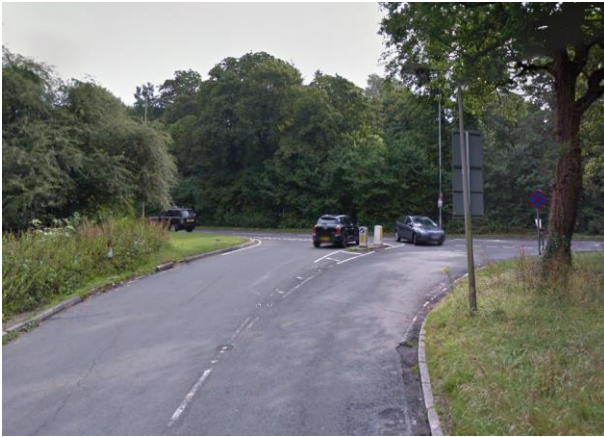
Image 3 – View on Rangers Road of junction ahead with Epping New Road (taken from Streetview)

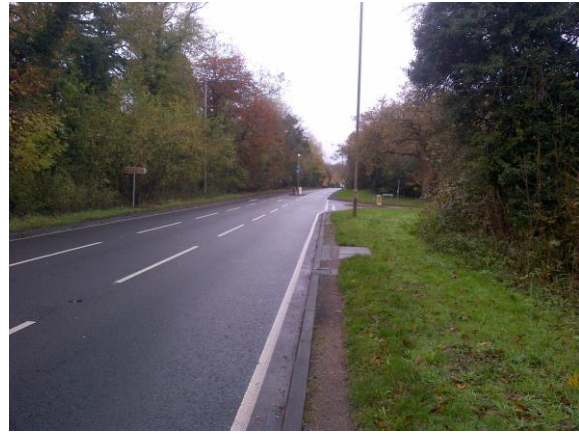
Image 4 – View travelling southbound on Epping New Road with Rangers Road junction on the right (taken 13/11/14)

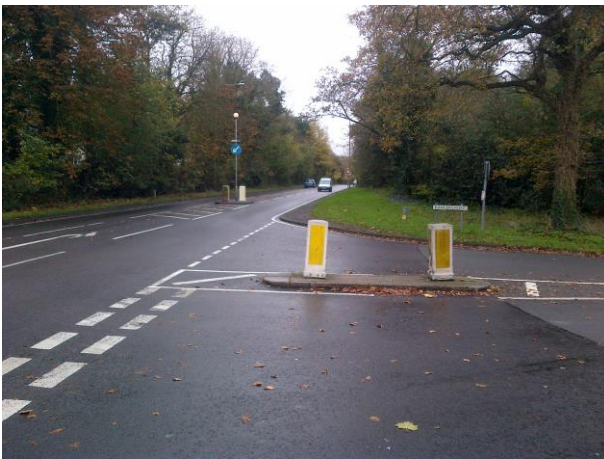
Image 5 – View to the right from Rangers Road (taken on 13/11/14)

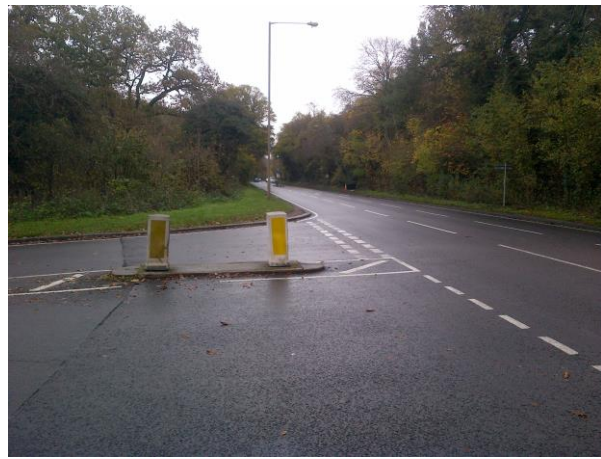
Image 6 – View to the left from Rangers Road (taken 13/11/14)

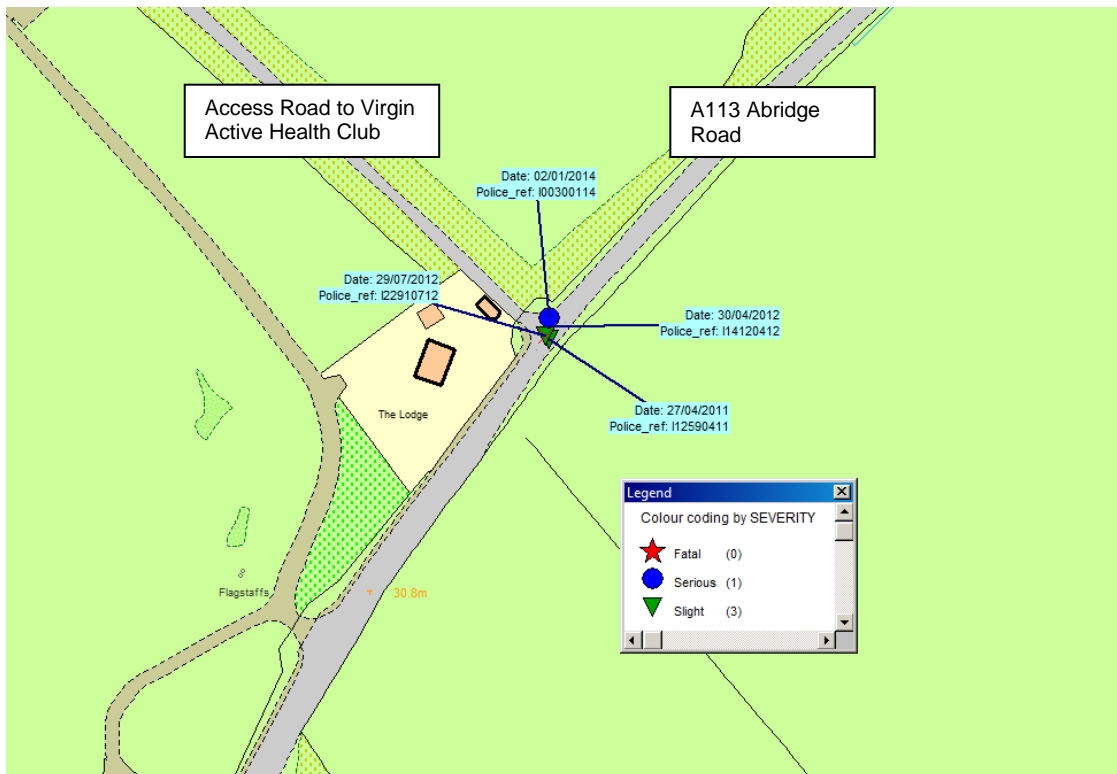
## 1.0 Site Plan with Collision Plot

Identified Collision Pattern(s)	No of Collisions
Failure to give way collisions caused by motorists pulling out of Health Club access and hitting northbound traffic on Abridge Road.	3 (75%)

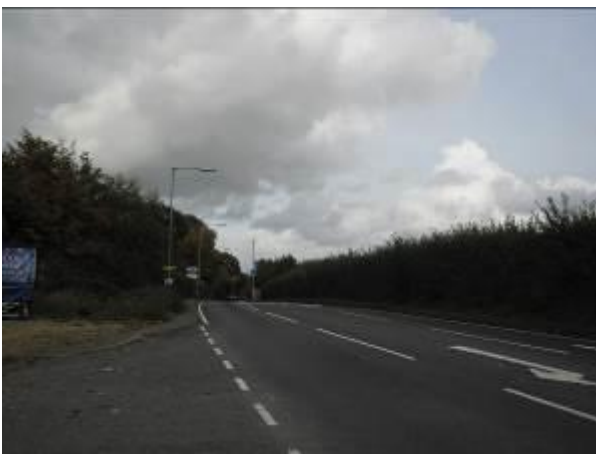
Details	Description/Observations
Road Name (s)	A113 Abridge Road j/w access to Virgin Active Health Club
Speed Limit	60mph
Street Lit	Yes
Carriageway type	Single carriageway
Gradient	The northbound Abridge Road approach to the junction goes up a slight incline (see Image 1) and then levels out prior to the junction.
Traffic Management	The access in/out of the Virgin Active Health Club/Golf Range is a standard T junction (see Image 2). There is a ghost island right turn lane further south on Abridge Road to assist vehicles turning right into the Woolston Manor Golf & Country Club access.
Road Surface	The road surface along the site appeared to be worn and the scrim data shows that on the Abridge Road northbound approach to the junction the skid resistance is below the recommended level. The Maintenance team do not have any plans at present to undertake resurfacing works here.
Signing	There are no warning signs for the junction. There is a brown tourist sign

Image 1 – View travelling northbound along Abridge Road before Health Club access

- 6) Resurface the northbound Abridge Road approach to the junction to ensure the skid resistance is improved.

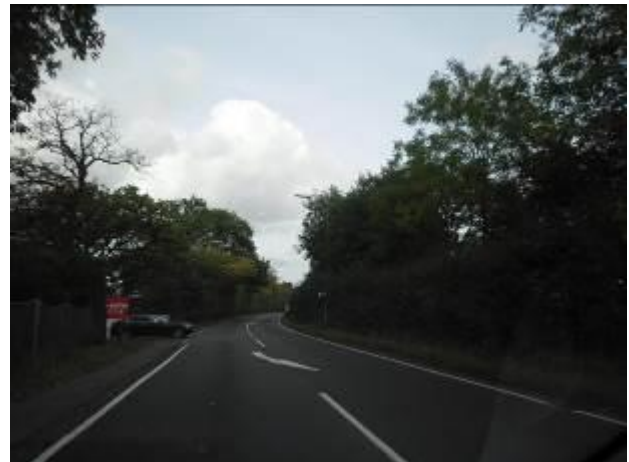
Image 2 – View travelling northbound on Abridge Road just prior to health Club access on nearside

- 1) Install new yellow backed 'junction on left ahead' warning sign on Abridge Road for northbound traffic. Sign to be lit.
- 2) Install new SLOW road marking next to above sign.

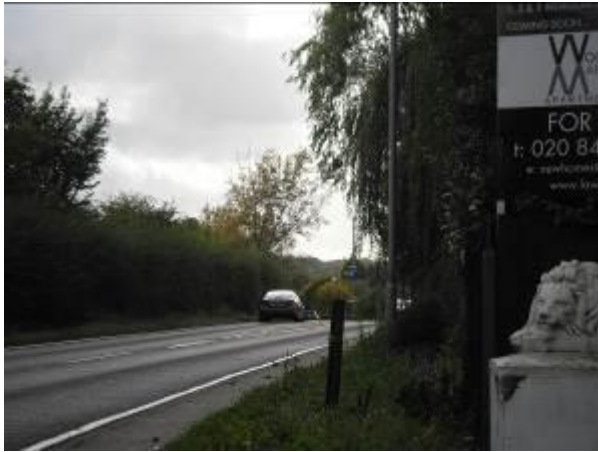
(double backed) located on the lamp column opposite the access for Virgin Active Health Club, however it does not appear to be an official Highways sign (this would need to be checked).
<b>Road Markings</b>	There is edge of carriageway and centre lining along Abridge Road. The lining along this stretch of road has recently been renewed.
<b>Visibility</b>	Visibility to the right when exiting the access is reduced due to the road gradient falling away and the adjacent overgrown vegetation (see Image 3).
<b>Vegetation</b>	See above – the verge requires cutting but there is also a mature willow tree which requires cutting back to improve the sight line.
<b>Other</b>

Image 3 – View to the right when exiting the Health Club access

The overgrown vegetation/willow tree on the south west side of the access has been reported to maintenance to arrange for it to be cut back.

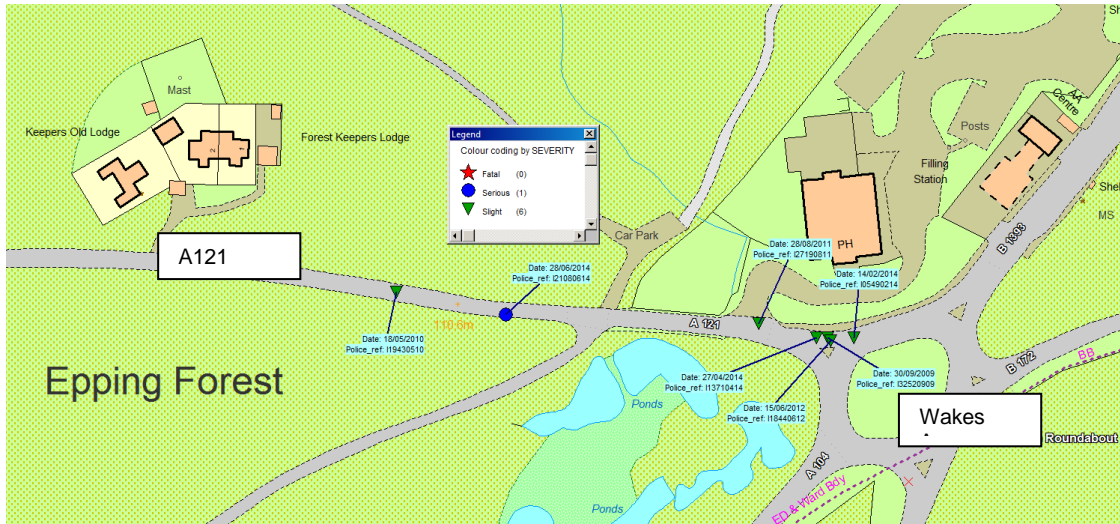
### 1.0 Site Plan with Collision Plot

Identified Collision Pattern(s)	No of Collisions
Nose to tail collisions on the approach to the roundabout.	35 (71%)

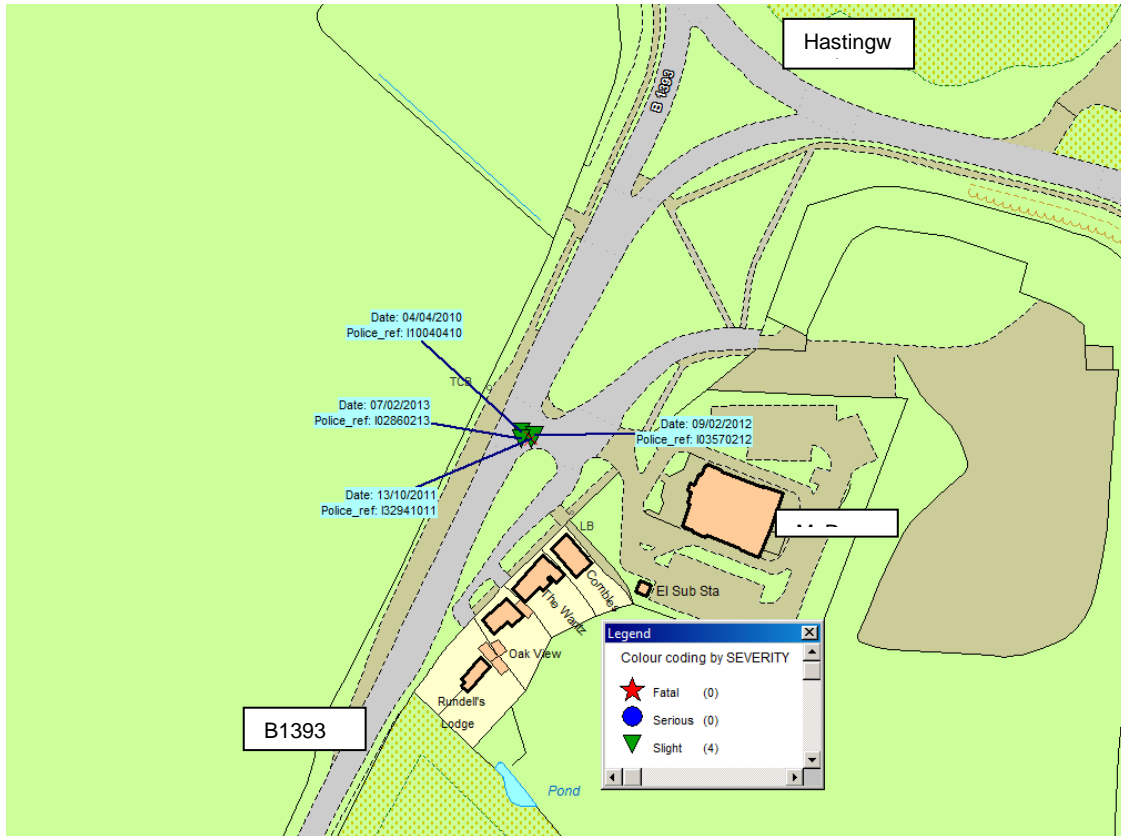
### 1.0 Site Plan with Collision Plot

Identified Collision Pattern(s)	No of Collisions
Failure to give way collisions caused by motorists turning right out of McDonalds access and hitting southbound traffic on London Road.	4 (100%)

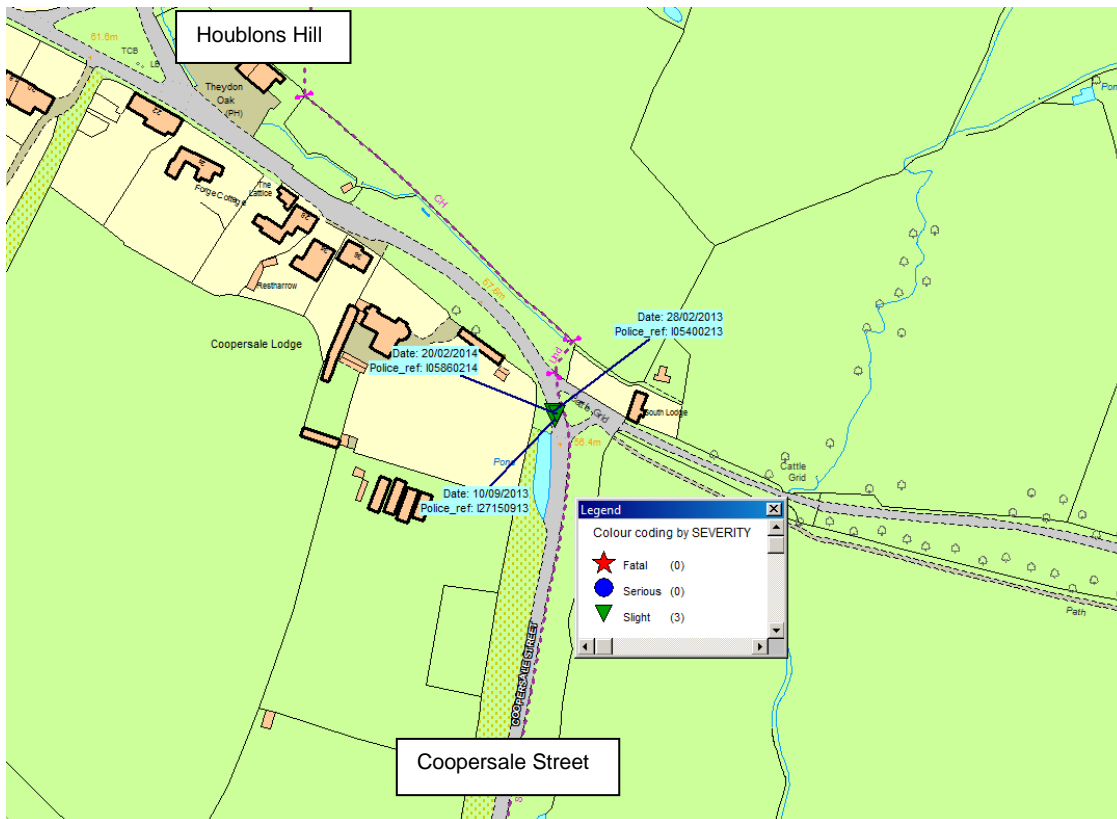
1.0 Site Plan with Collision Plot

Identified Collision Pattern(s)	No of Collisions
Loss of control collisions on bend near South Lodge (one single vehicle, 2 head on).	3 (100%)

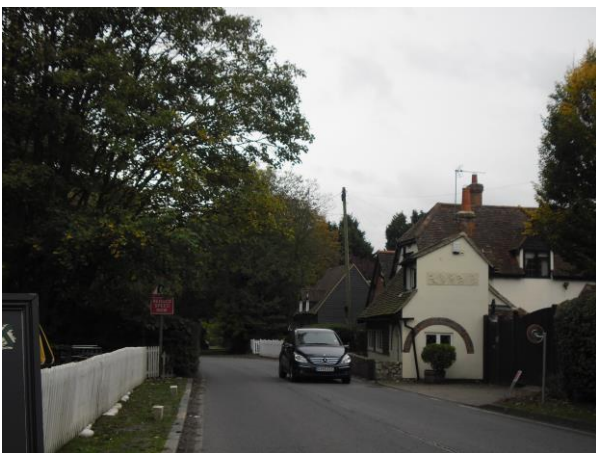
Details	Description/Observations
Road Name (s)	Coopersale Street, bend 200m south east of Houblons Hill
Speed Limit	40mph
Street Lit	No
Carriageway type	Single carriageway
Gradient	Level
Traffic Management	None, carriageway forms a 90 degree bend near access to South Lodge
Road Surface	The road surface along the site appeared to be very worn, particularly around the bend. There is no scrim data available for this road. The Maintenance team do not have any plans at present to undertake resurfacing works here.
Signing	There are 'bend ahead' warning signs with 'reduce speed now' sub-plates on both approaches to the bend. There are both overgrown and the northbound sign is in a very poor condition (see Images 1 & 3). There are

Image 1 – View travelling eastbound along Coopersale Street, bend sign obscured (adjacent to Theydon Oak PH)

The overgrown bend warning signs on both approaches have been reported to the Maintenance team to arrange for them to be cut back.

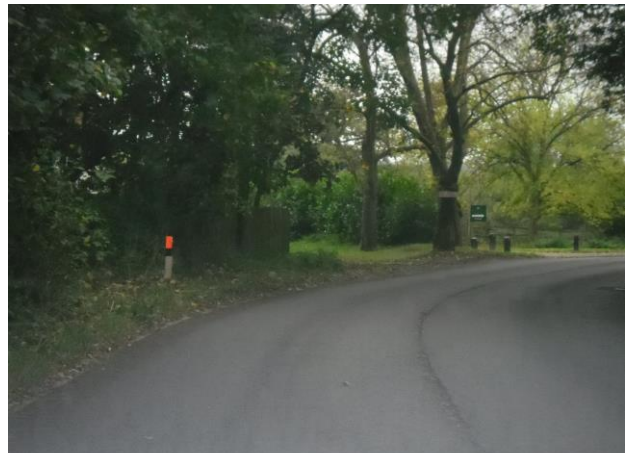
a couple of reflector posts on the northern verge near the bend which indicates there were previously more (see Image 2). There are no chevron signs to highlight the bend to motorists.
Road Markings	There are edge of carriageway and centre lining along Coopersale Street however they are extremely faded around the bend.
Visibility	Visibility of the bend ahead is partially reduced by road alignment and adjacent vegetation.
Vegetation	See above – the bend warning signs require cutting back so that they are fully visible.
Other

Image 2 – View travelling south eastbound on Coopersale Street at bend near South Lodge

- 1) Renew the existing northbound 'bend ahead' with 'reduce speed now' sub-plate signs.
- 2) Install new chevron signs for both directions at the bend.
- 3) Renew remaining reflector posts and install further ones around the sweeping bend to highlight it to motorists. Cut verge back to ensure the reflector posts are visible.
- 4) Carry out resurfacing of the carriageway around the bend and the approaches to it.
- 5) Remark the centre and edge of carriageway lining throughout the bend.

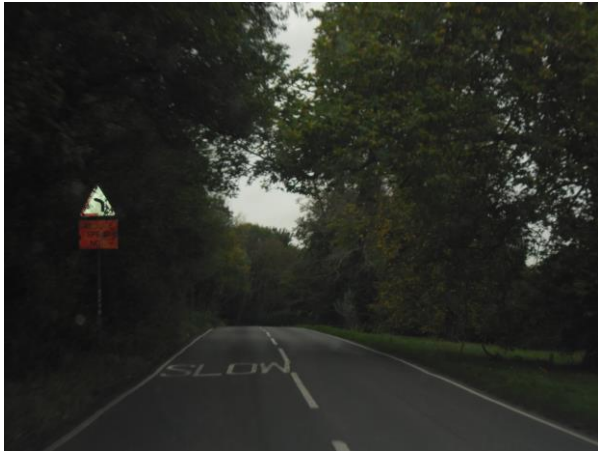
Image 3 – View travelling northbound on Coopersale Street before bend. Bend warning sign is in poor condition.
