ECC/Epping Forest District Local Highways Panel

Feasibility Studies and Designs – April 2014

FEASIBILITY REPORT – DC1692

Station Way, Buckhurst Hill Pedestrian Crossing Facilities Feasibility Study

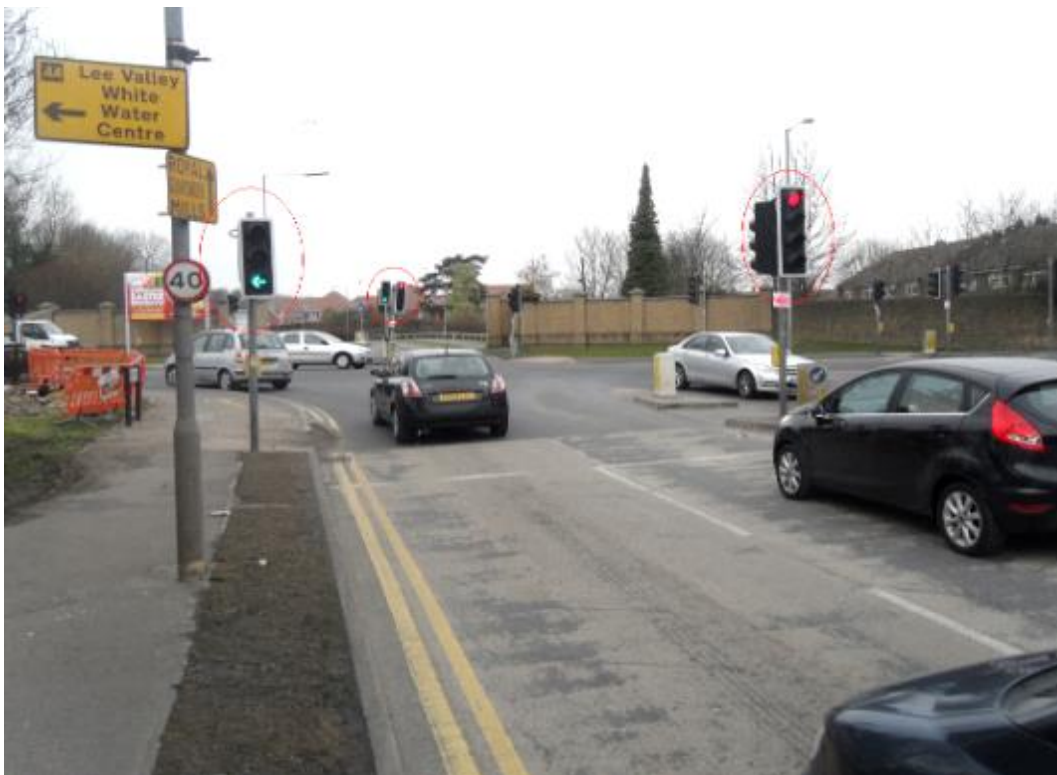
A related possibility is that drivers are incorrectly selecting the left turn lane to go ahead to Beaulieu Drive. The junction layout is such that the left turn lane on Meridian Way is in line with the exit to Beaulieu Drive and this could contribute to drivers thinking this is the correct lane for this ahead movement. When the left turn lane is first at green in the cycle the adjacent ahead/right turn lane is still at red. Drivers attempting to go ahead to Beaulieu Drive from the left turn lane would be in conflict with vehicles proceeding from Station Road who have right of way during this stage (see Figure 2).

Figure 2: Meridian Way left turn traffic is at green at the same time as Station Way traffic. Note that signal for the ahead/right turn lane is still at red and drivers wishing to proceed ahead to Beaulieu Drive must wait for the green signal.

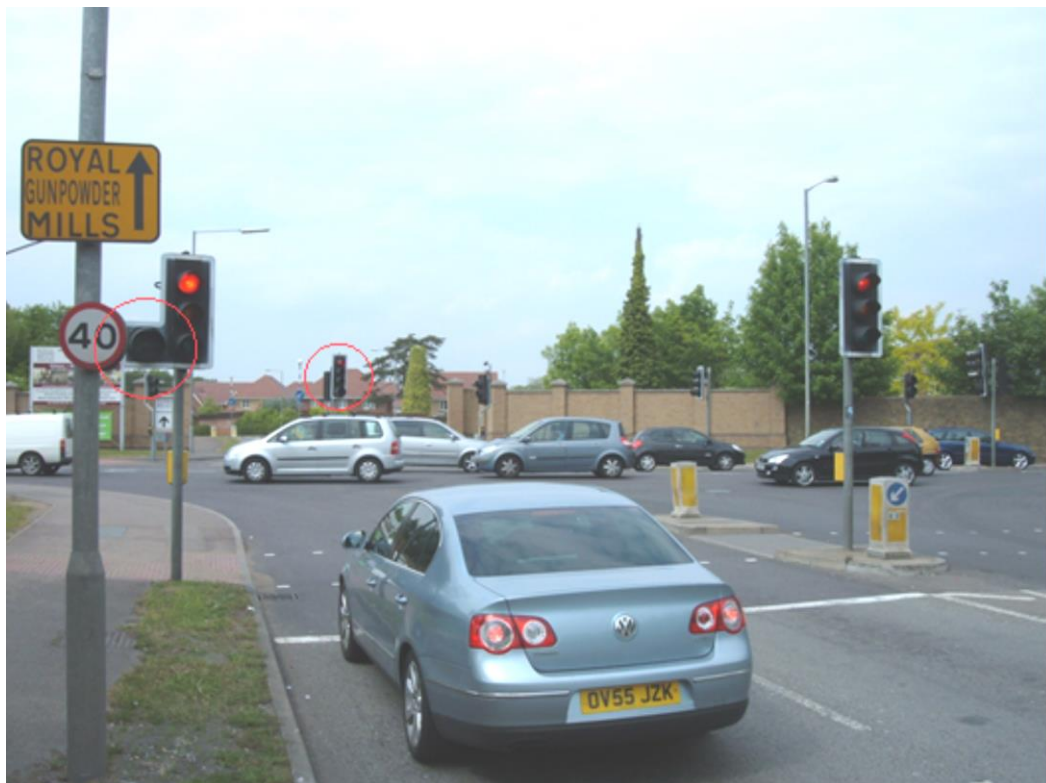
Figure 3: Meridian Way approach showing left turn filter green arrows (circled in red) before 2009 improvements

When the filter signals were previously installed (prior to the 2009 improvement) there were no recorded personal injury collisions following the pattern of those recorded in the period 01/04/2009 to 31/03/13. It is considered that returning to

The use of a filter signal arrangement would permit vehicles to turn left from Meridian Way to Station Road whilst the ahead/right turn lane is held at red. Station Road traffic would continue to run with the left turn movement as at present.

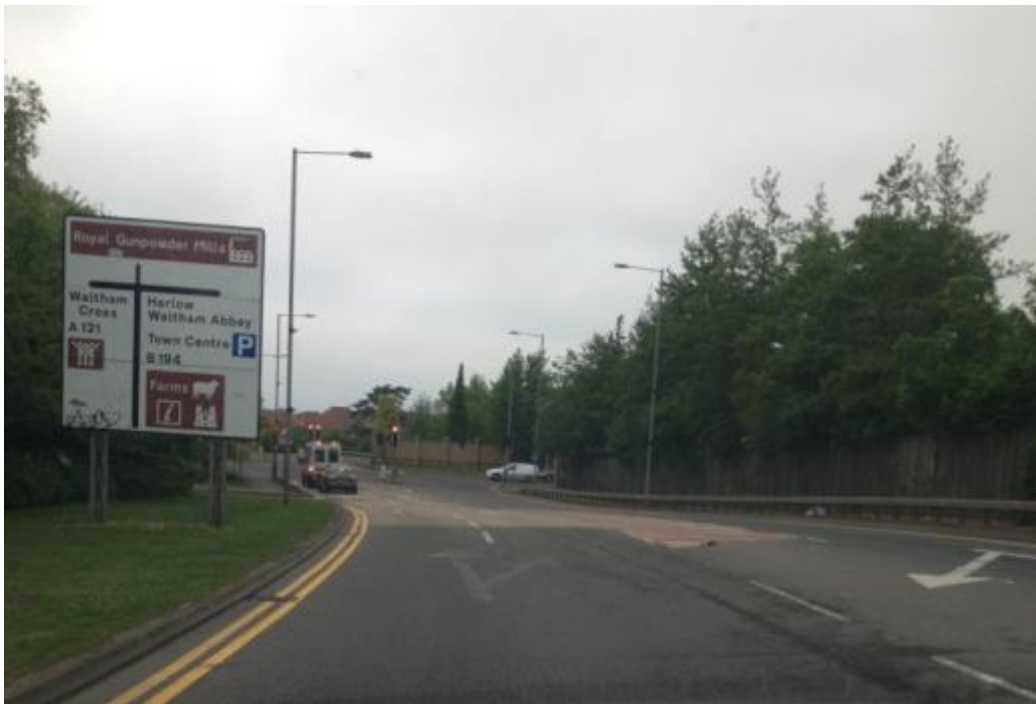
Figure 5: Meridian Way approach showing bifurcation arrow at start of lanes. Arrow to be reversed to indicate 'ahead' direction is via right hand lane

- 6.7 Subject to the signal phases and layout being altered, replace the existing misleading bifurcation arrow with one that better reflects the junction layout (I.e. Bifurcation to the left).
- 6.8 Refresh all other worn road markings throughout the junction and on approaches.

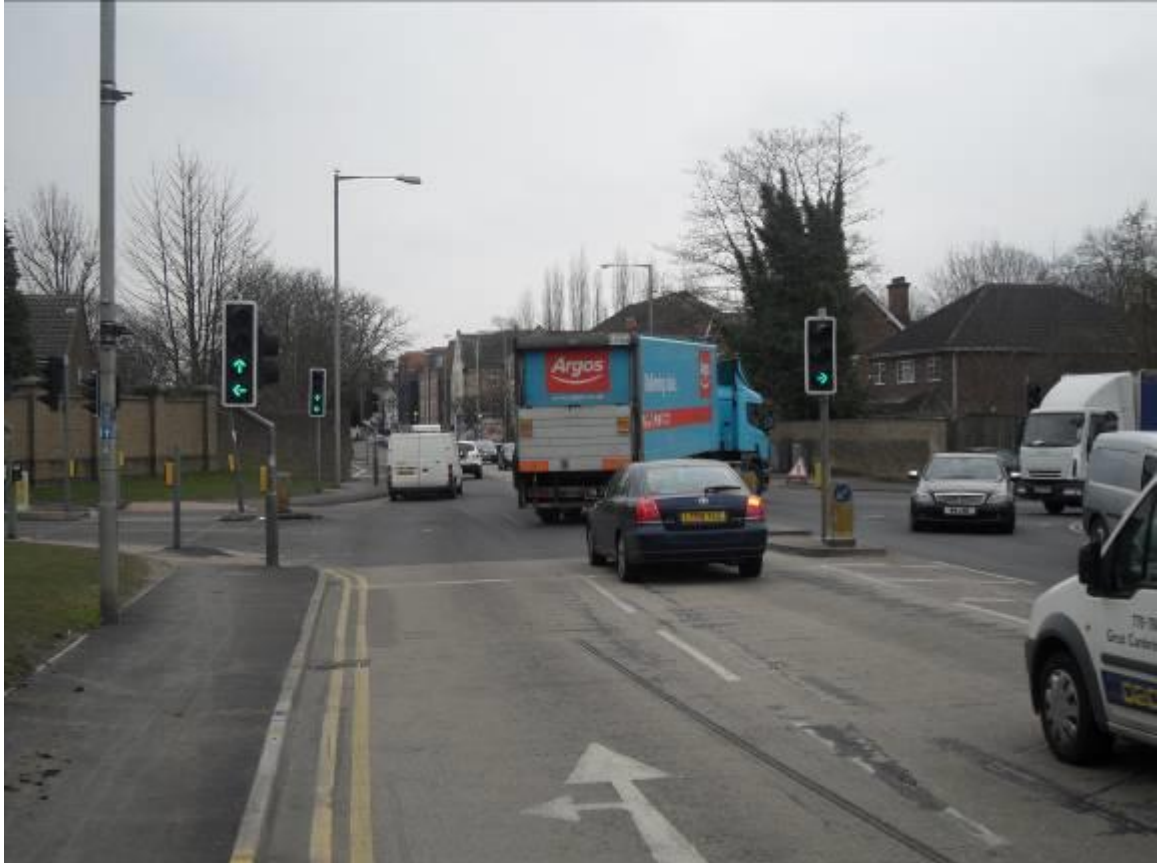
- 5.1 During numerous site visits and numerous drives through the site travelling in all directions it was observed that the junction gets congested throughout the day. Numerous larger vehicles such as HGVs, LGVs, buses and coaches were observed to be travelling through the junction throughout the day.

Photo 1 – Junction can get congested throughout the day.

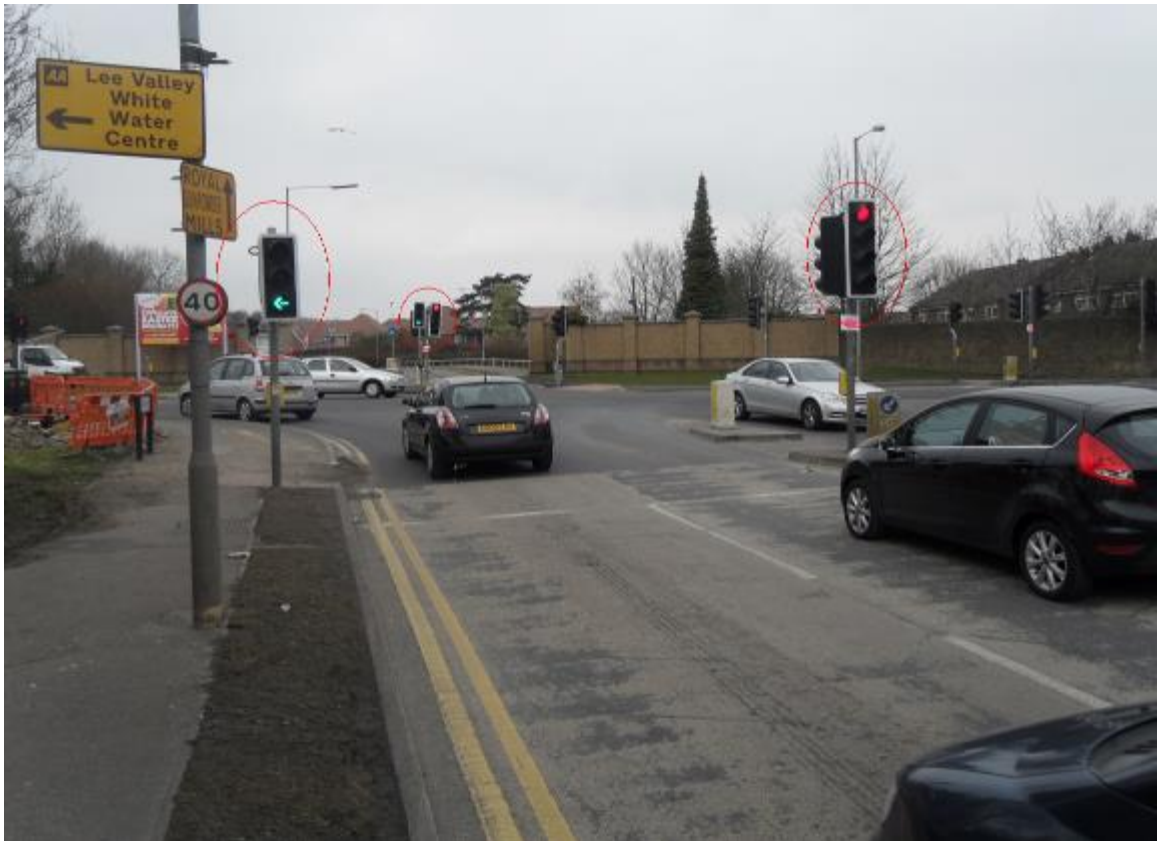
- 5.4 It was observed that the junction has an unusual layout. On the A121 Meridian Way northbound approach to the junction the nearside traffic lane that is directly in-line with the opposing Beaulieu Drive is assigned as a 'left turn only' lane and is subject to its own left turn filter traffic light phase. The offside traffic lane that does not line up with the opposing Beaulieu Drive is assigned as an 'ahead or right turn' lane and is controlled by a full green and accompanying right turn arrow light. It is believed that this unusual arrangement may be leading to confusion for northbound motorists resulting in them travelling straight ahead from either the nearside or offside traffic lane when the traffic signals indicate a green 'left turn only' filter arrow.

Photo 2 – Different traffic signals relate to the nearside and offside traffic lanes.

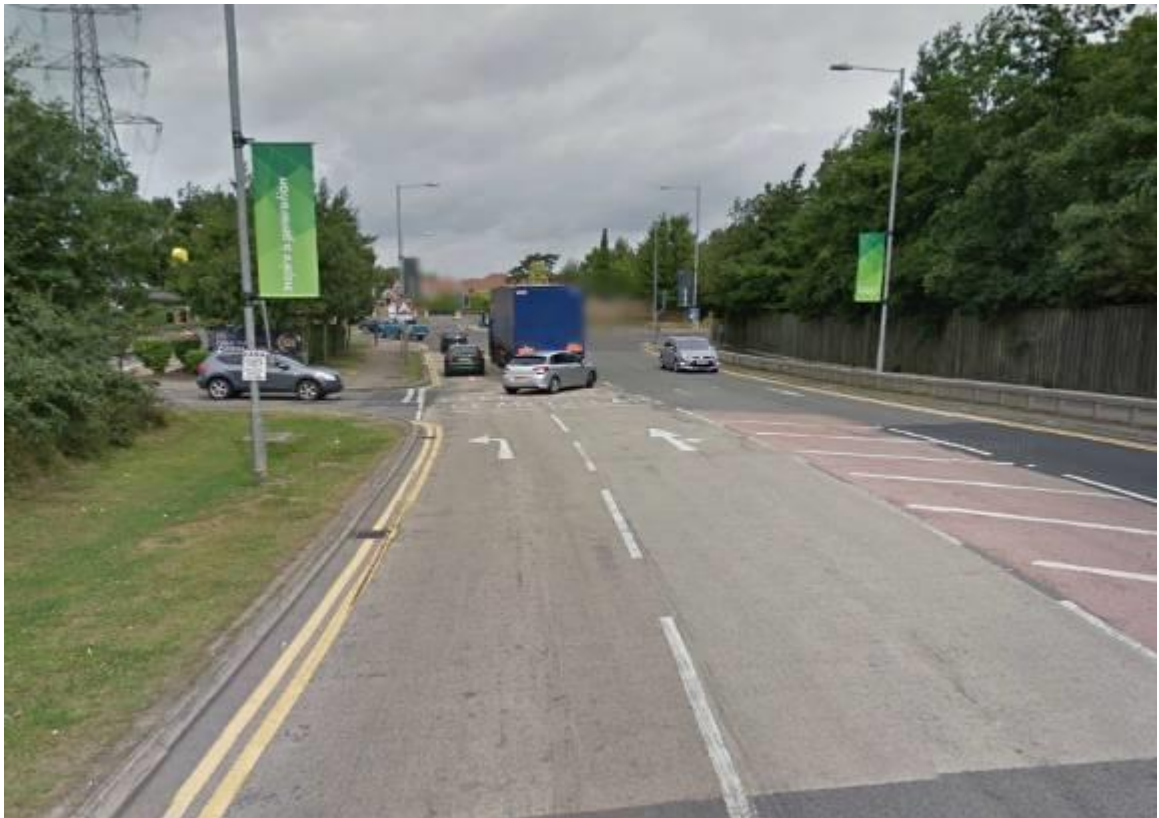
- 5.5 It was observed that it may not be completely clear to motorists which lane they should be in to travel in each direction as they approach the traffic signals on the A121 Meridian Way northbound approach. The presence of the vehicle access to the small retail park area and a fast food restaurant located to the left hand side just prior to the junction.

Photo 3 – Left turn arrow markings just prior to the vehicle access to the small retail park area and a fast food restaurant may mislead motorists into using the wrong traffic lane at the junction.

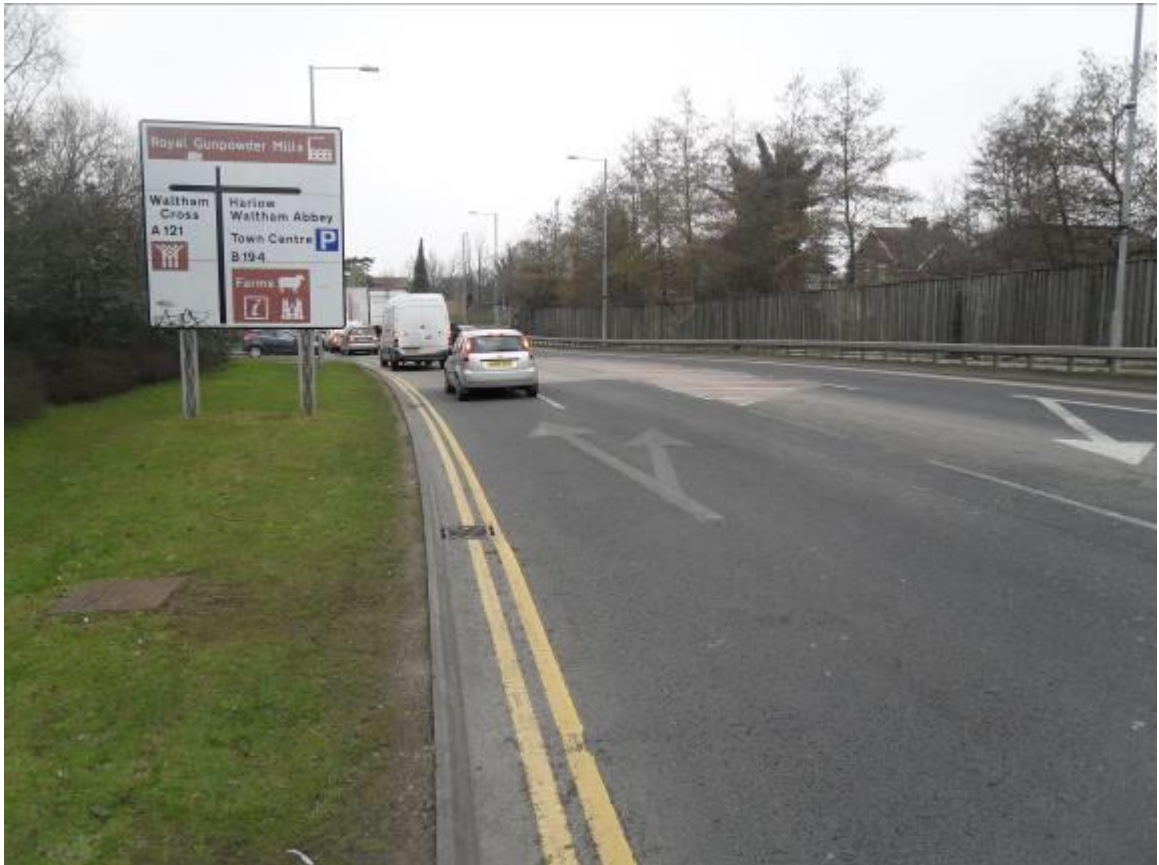
- 5.6 There is a large advanced directional sign present on the A121 Meridian Way northbound approach but it does not indicate the presence of the retail park.
- 5.7 The arrangement of the existing bifurcation arrow may also mislead motorists into thinking that they should be in the nearside traffic lane to go straight ahead.
- 5.8 It was observed that some of the stop lines, directional arrow markings and other road markings throughout the junction are partially worn.

Photo 4 – Advanced directional sign on A121 Meridian Way northbound approach. Also shows worn directional arrow markings.

- 6.5 Provide a traffic lanes directional sign to TSRGD dia.877 on the A121 Meridian Way northbound approach to junction to reflect the road layout (Design dependant on signal phases and layout). Ensure that the sign is located just north of the vehicle access to the retail park to avoid any confusion. Signs will need to be mounted at least 2.3m above the footway and sign posts located to impair visibility splays for motorists exiting the retail park.
