ECC Casualty Reduction Site Investigation 2012-13

Safety Scheme: 20

Mount Road j/w Banks Lane

District: Epping Forest

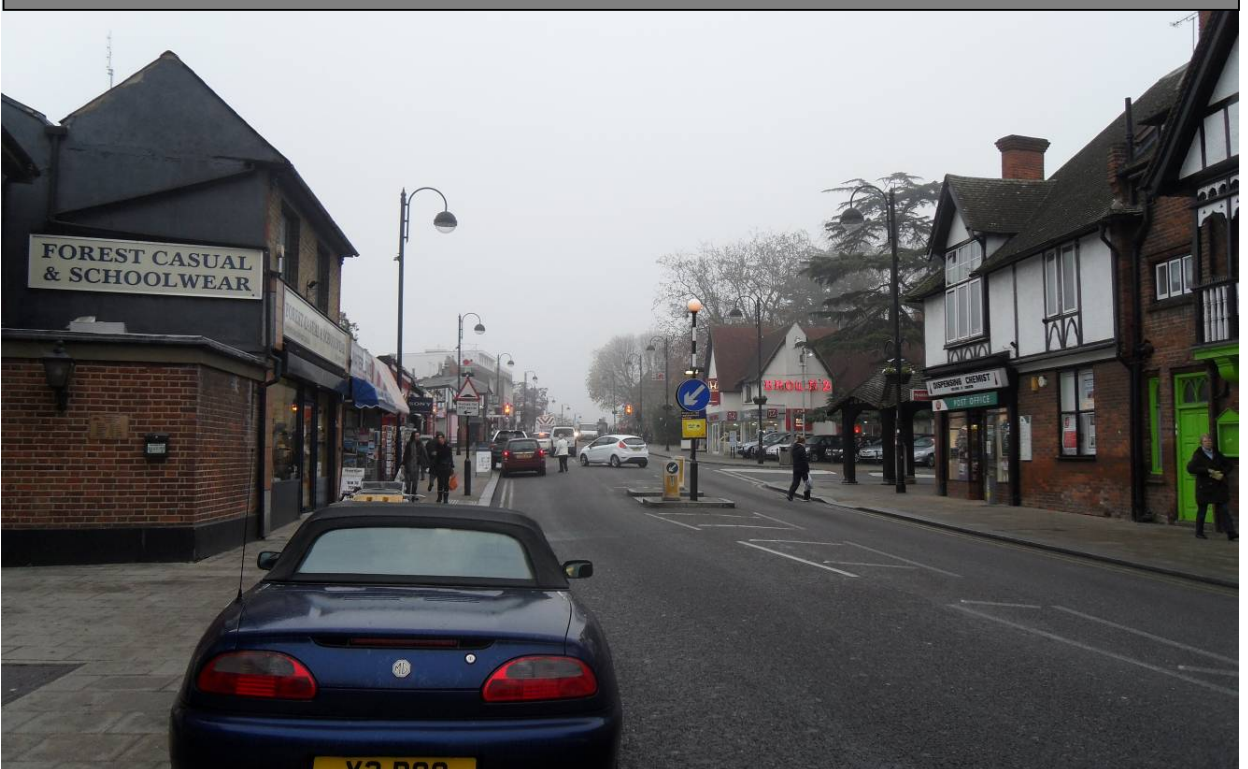
Photograph 4. Crossing point on High Road south of junction

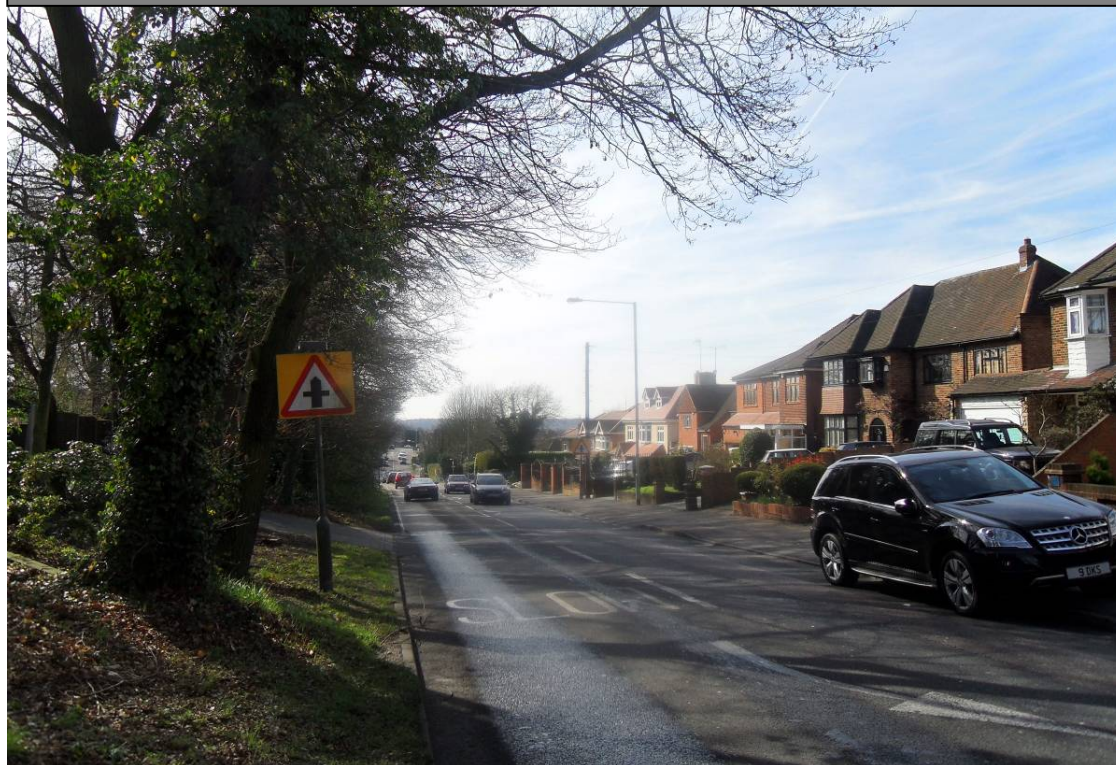
Photograph 3. Southwest bound on Manor Road, approaching the junction

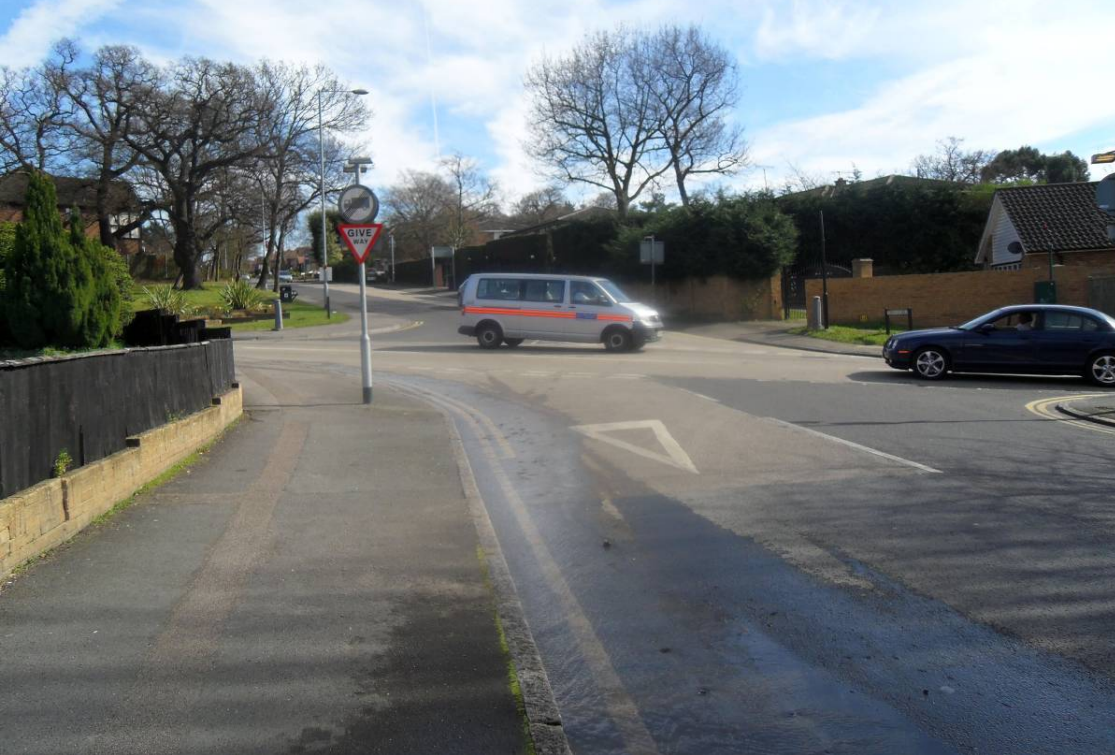
Photograph 8. On Turpins Lane, approaching the junction

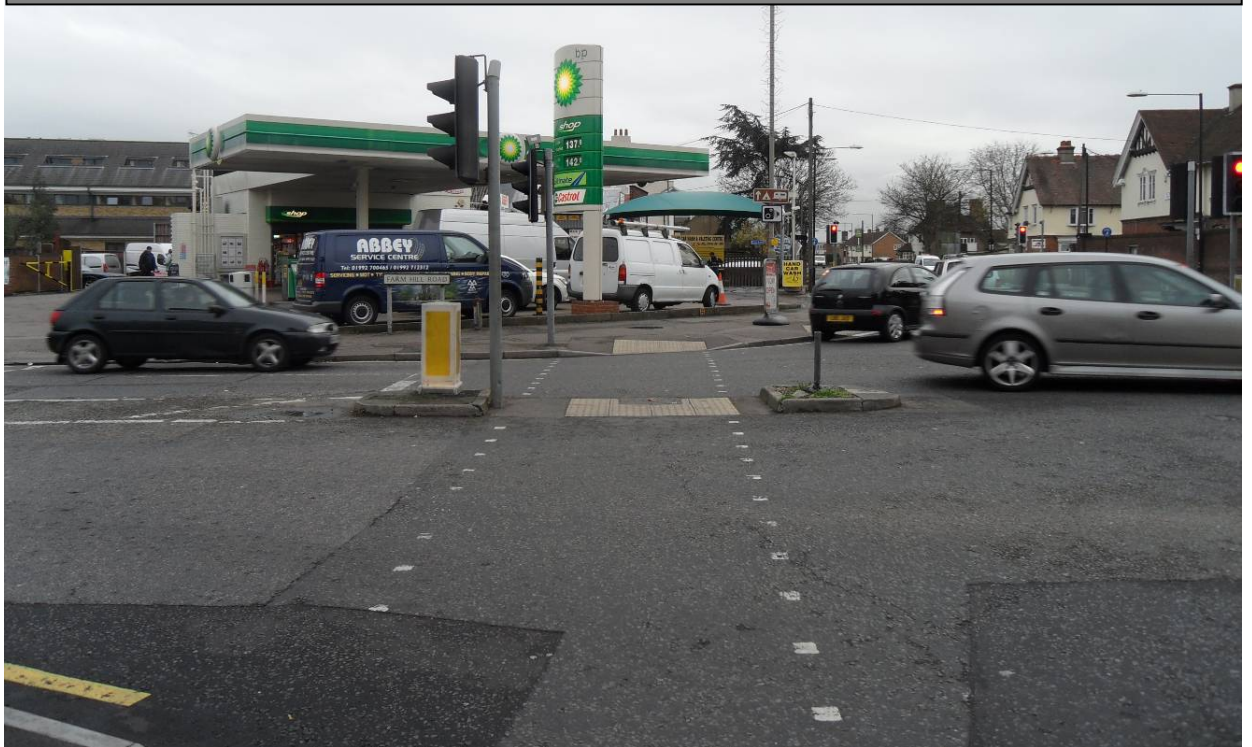
Photograph 3. Pedestrian crossing at Farm Hill Rd signals east of junction

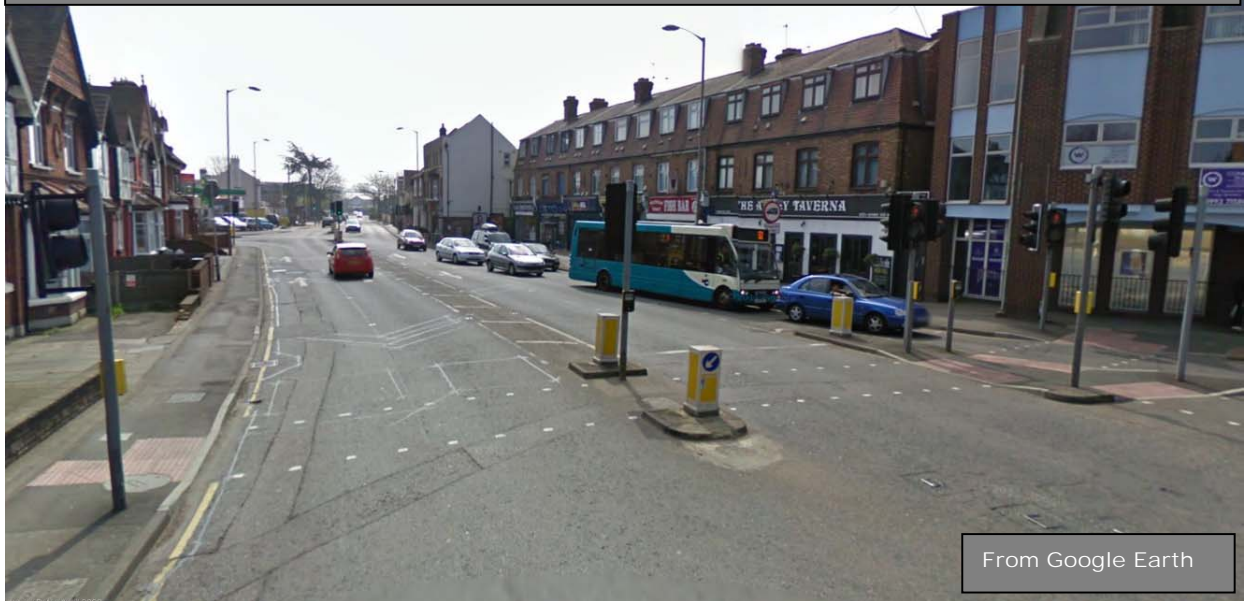
Photograph 5. Pedestrian controlled crossing on Sewardstone Rd north of junction

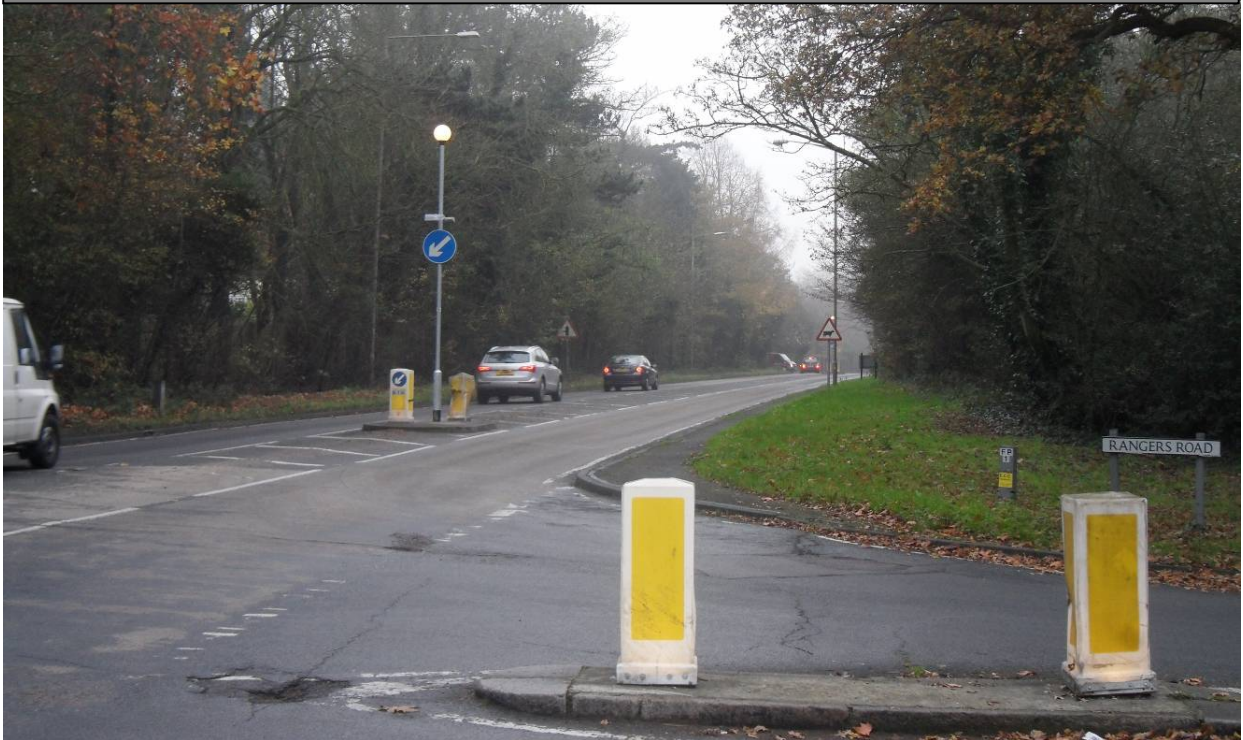
Photograph 3. On Rangers Road at the junction with the A104, looking to the left

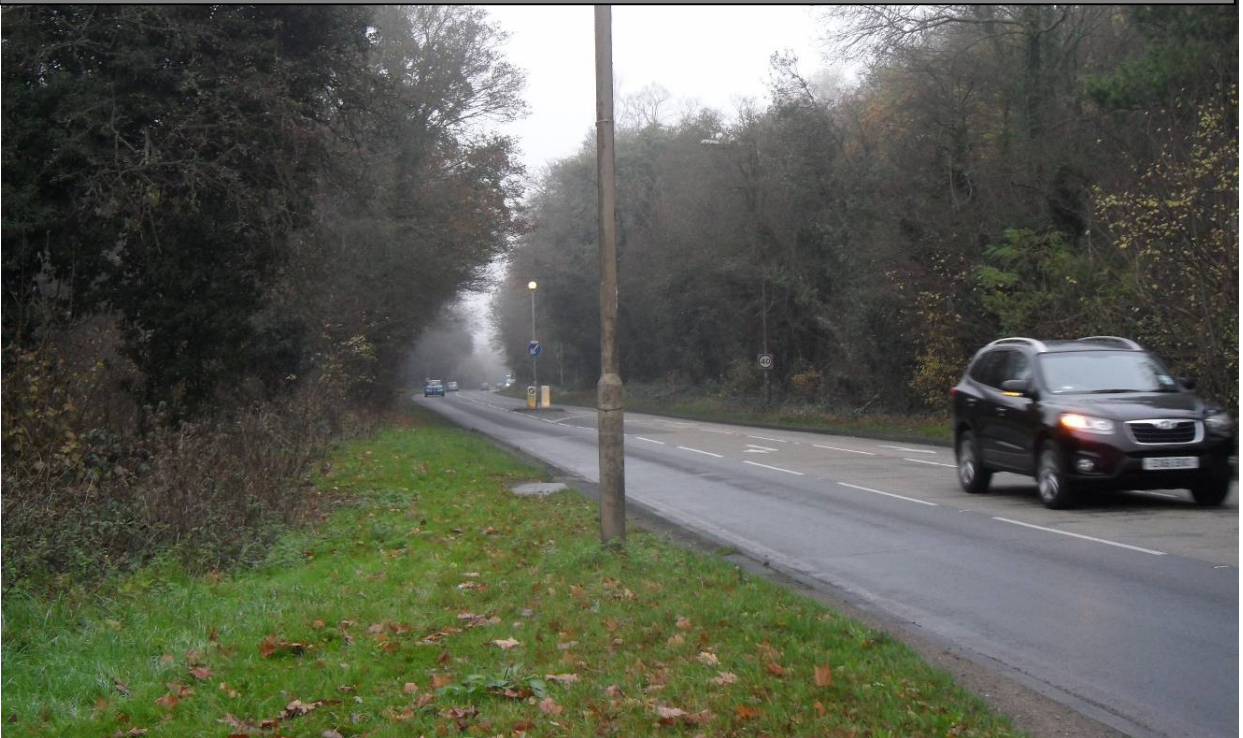
Photograph 4. Northbound on the A104, approaching junction with Rangers Road
