ECC/Epping Forest District Local Highways Panel

Feasibility Studies and Designs – April 2014

FEASIBILITY REPORT – DC1692

Station Way, Buckhurst Hill Pedestrian Crossing Facilities Feasibility Study

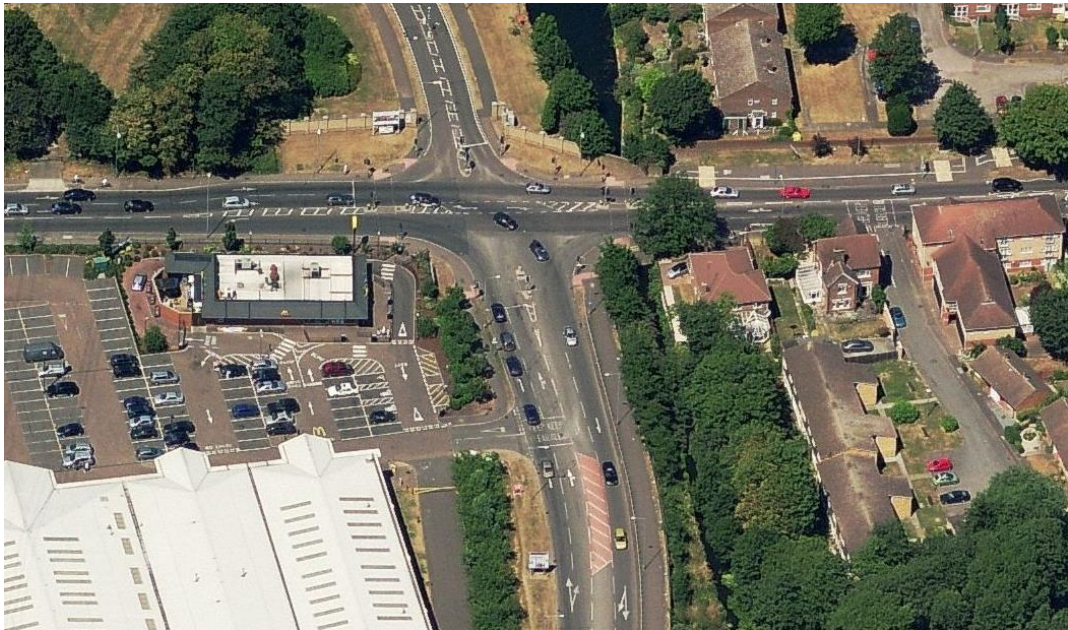
Figure 1: Aerial photograph of the junction. A121 Meridian Way approach is in the foreground

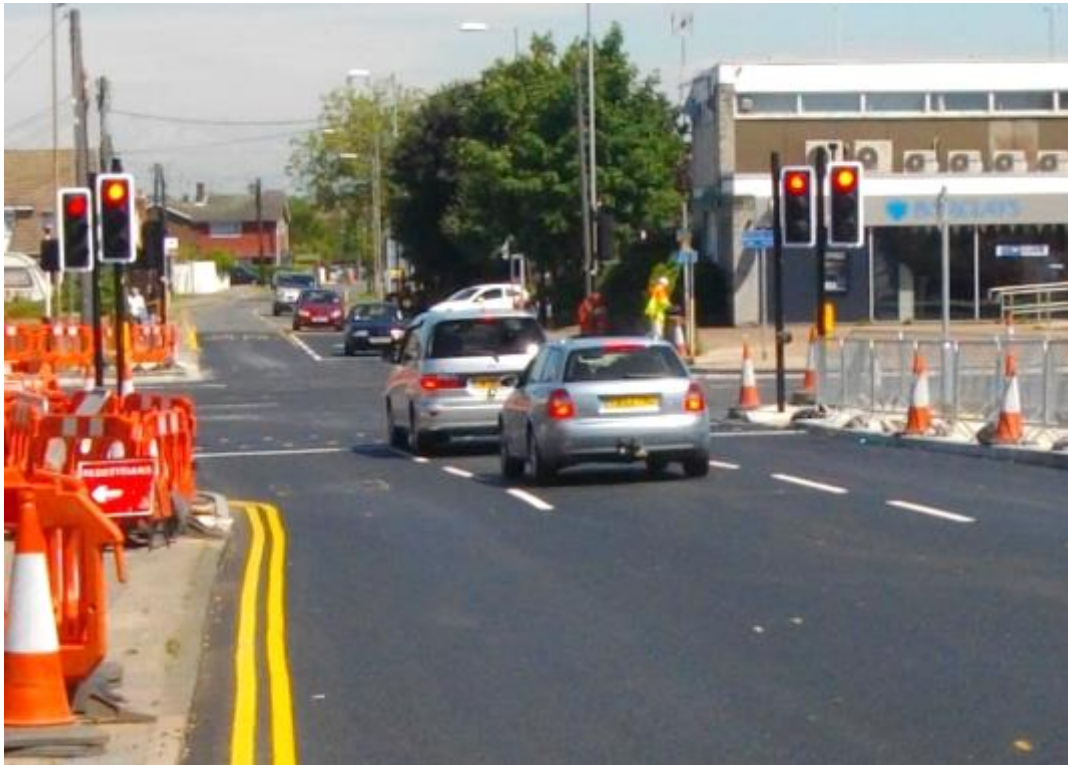
In this option it is proposed that the Meridian Way secondary signals, currently on the far side of the junction, are relocated to the Meridian Way side of the junction close to waiting drivers. This arrangement is referred to as closely-associated secondary signals. The secondary signal for each lane would be placed a few metres ahead of the existing primary signal as shown in the example in Figure 4.

Figure 4 : Example of closely-associated secondary signals on a junction approach

This would have the effect of physically separating the signals for each lane to minimise any misinterpretation by drivers reacting to the 'wrong' signal. In each lane drivers would have a clear view of the signals intended for the lane they are using with potential distraction by the signals for the other lane kept to a minimum.

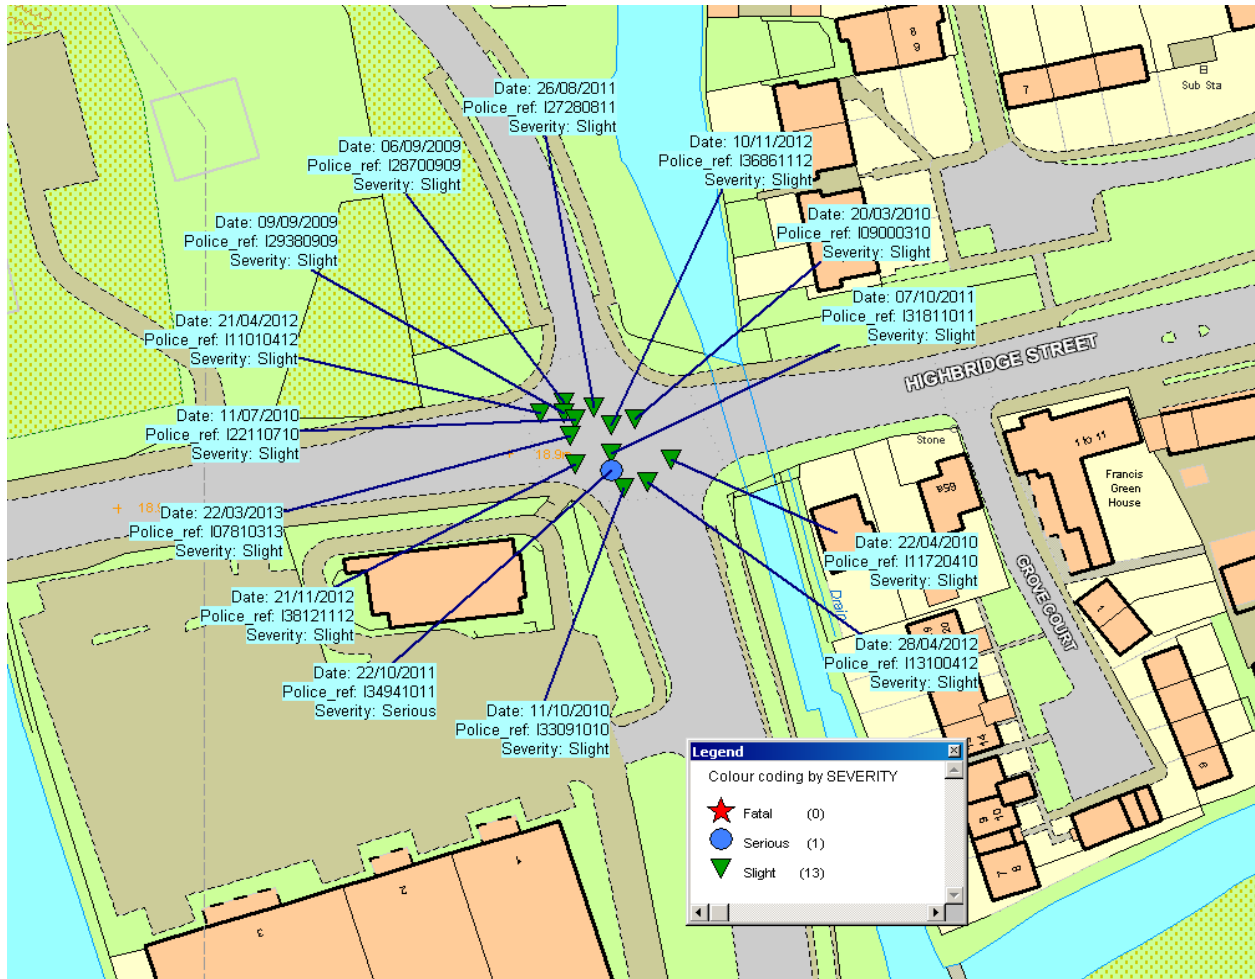
4.0 Personal Injury Collision Analysis (see AccsMap Data & attached stick diagrams)

A study of the Personal Injury Collision (PIC) data for the period from 01/04/2009 to 31/03/2013 at this location shows a pattern of collisions involving motorists travelling from A121 Meridian Way disobeying the traffic signals and colliding with other motorists, mainly motorists that were entering the junction from the A121 Station Road.

The data shows that overall there have been 14 PIC's at this location, 1 Serious and 13 Slight, resulting in 1 Serious and 17 Slight casualties.

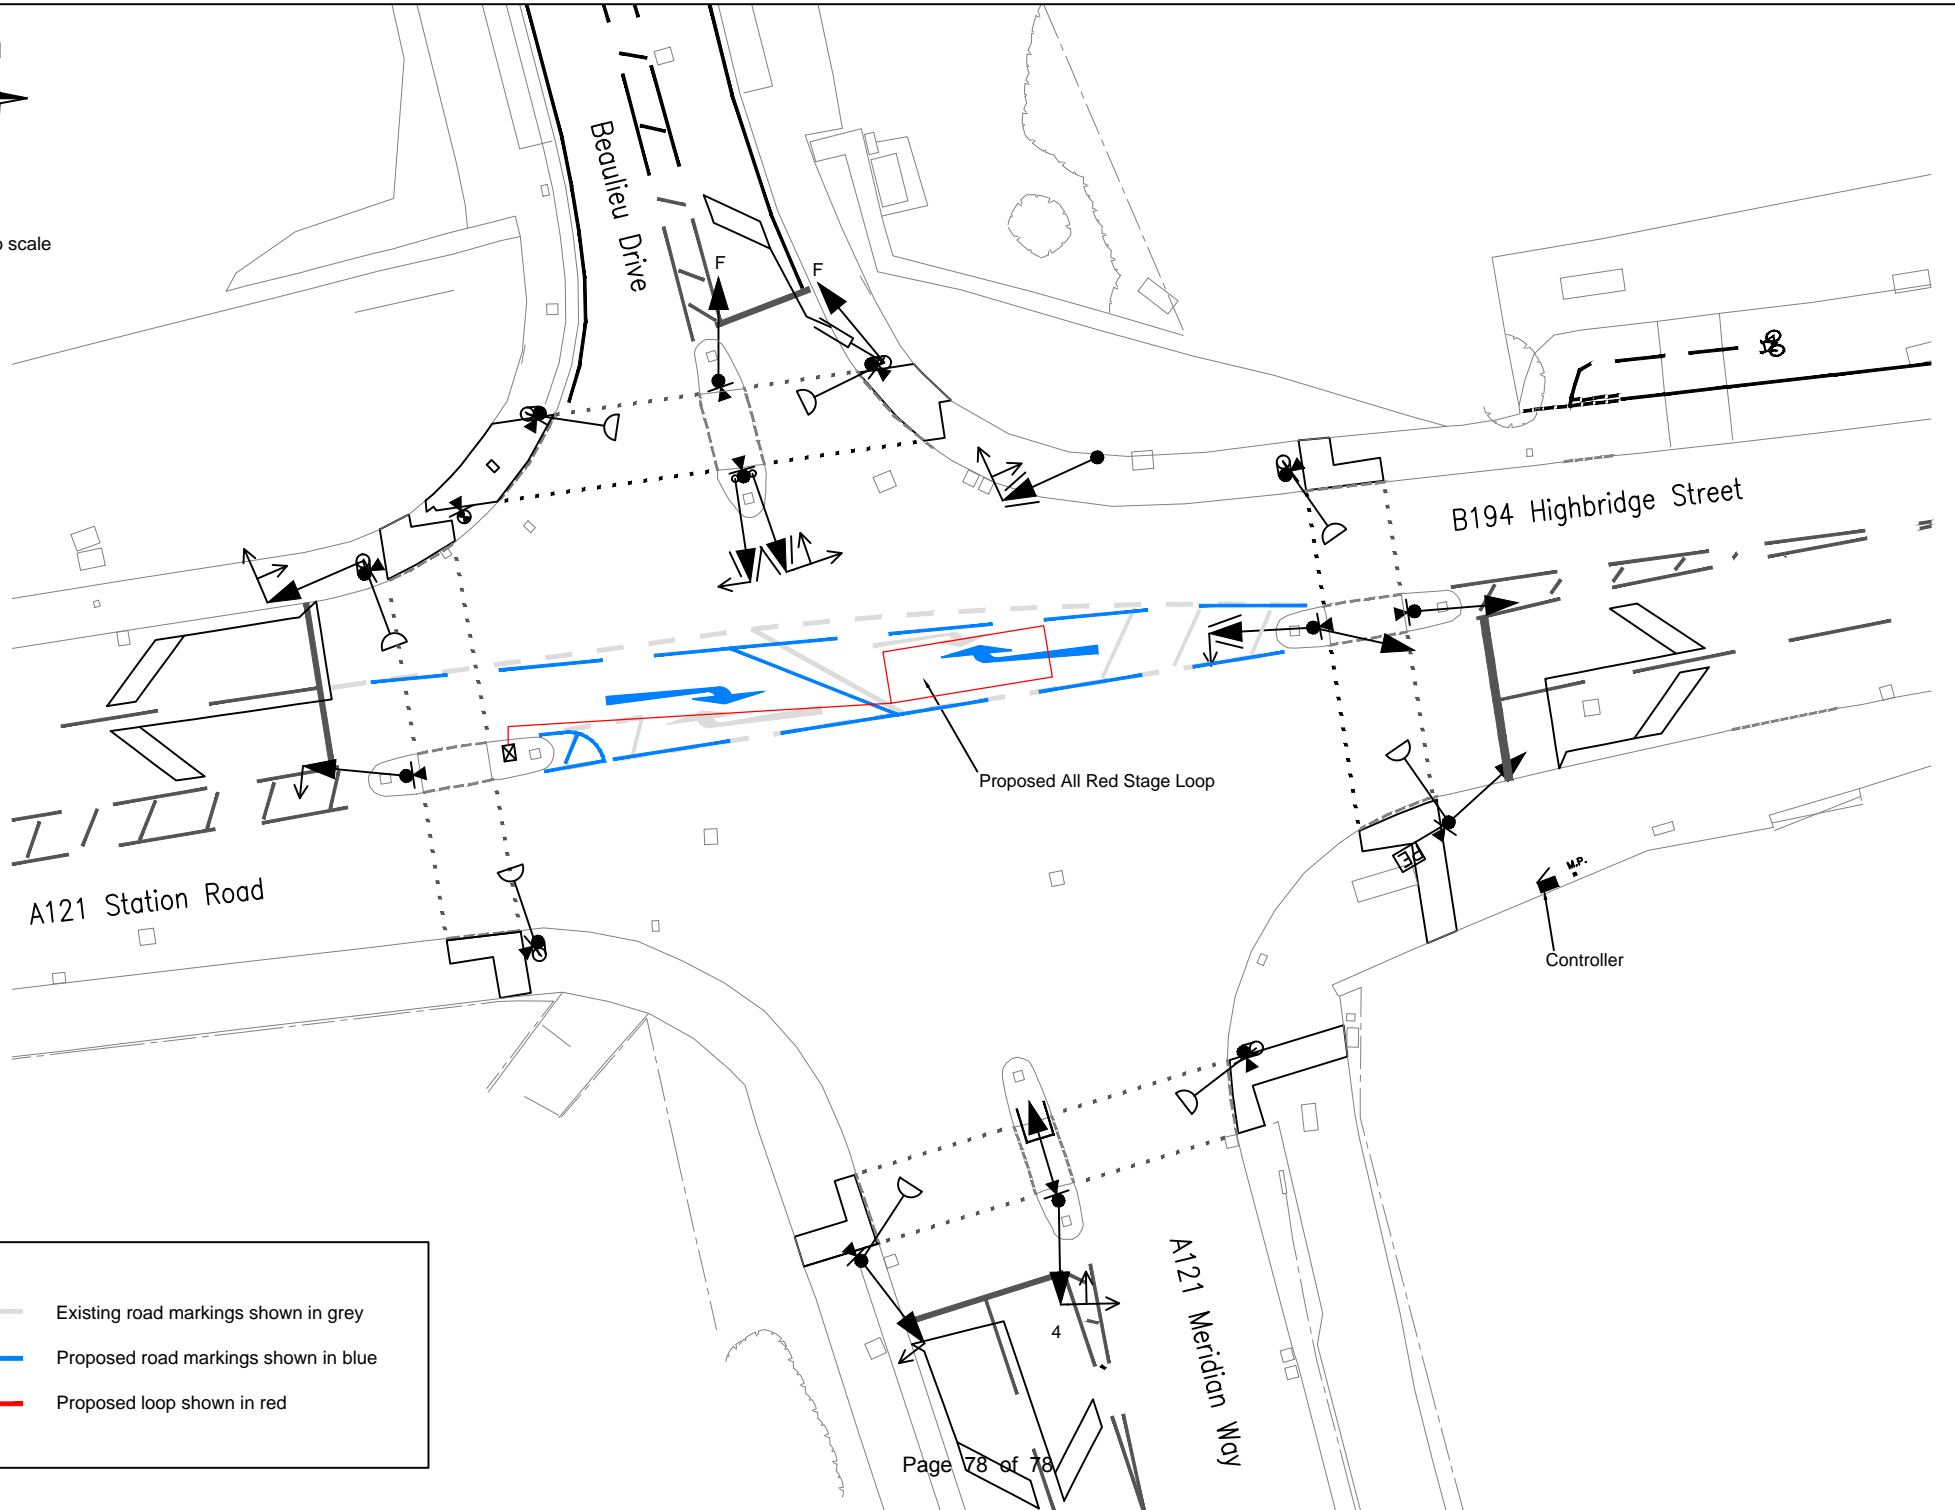
Proposed All Red Stage Loop

An 'all red' clearance stage was provided in the 2009 improvements to allow vehicles waiting to turn right into Beaulieu Drive to clear the junction with all other traffic movements stopped at red. The clearance stage is called by a loop in the centre of the junction, however it appears this loop may no longer be working as intended, particularly as the worn road markings make it difficult for drivers turning right to be positioned over the loop.
