ECC Casualty Reduction Site Investigation 2012-13

Safety Scheme: 20

Mount Road j/w Banks Lane

District: Epping Forest

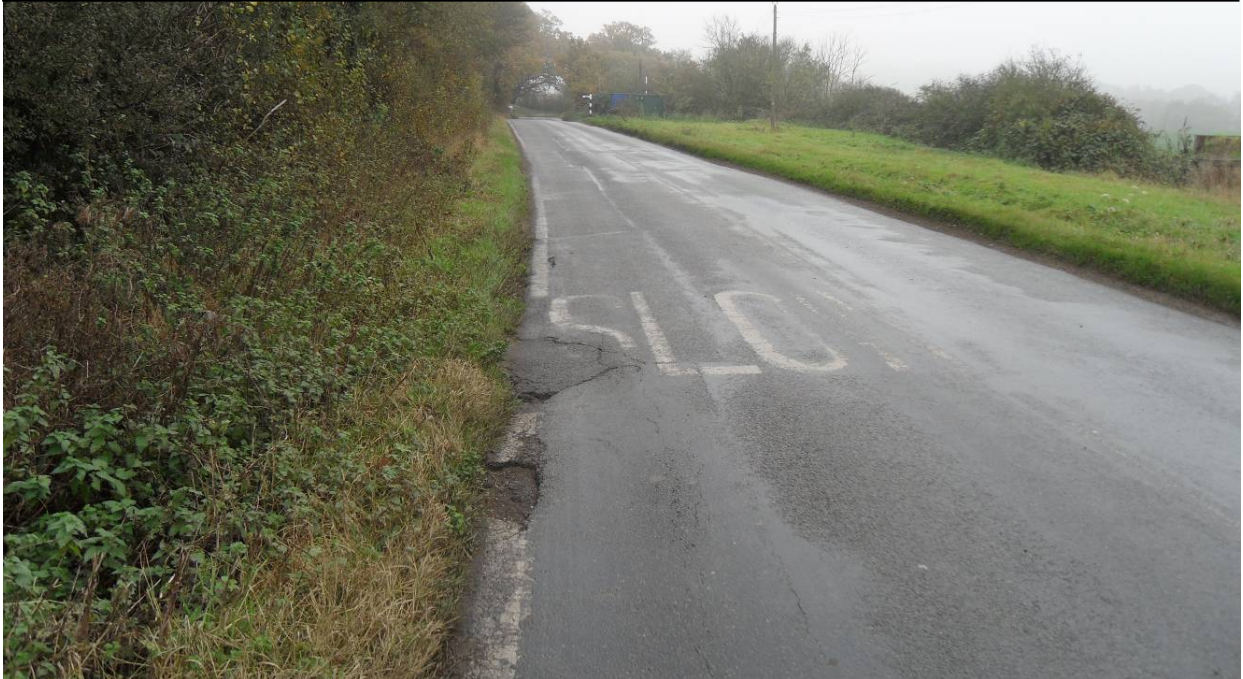
Photograph 5. Eastbound on Mount Road approaching the junction

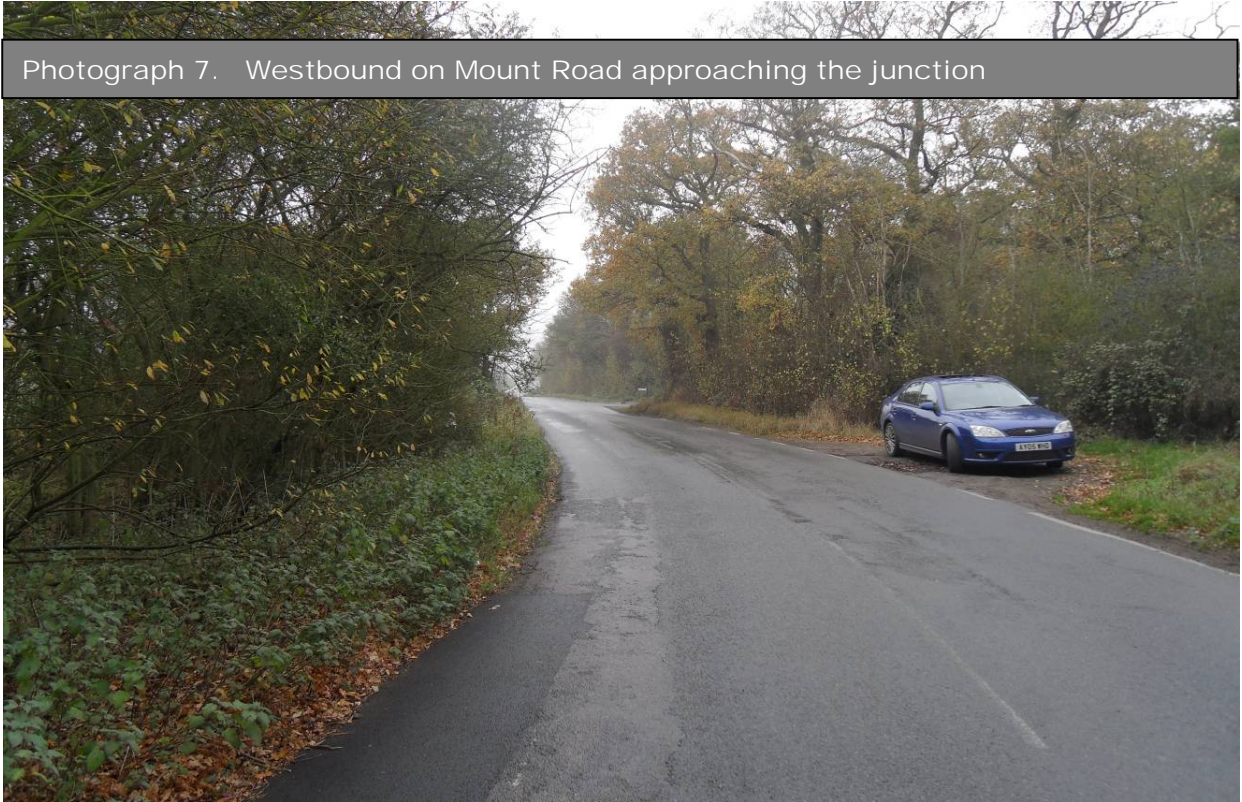
Photograph 7. Westbound on Mount Road approaching the junction

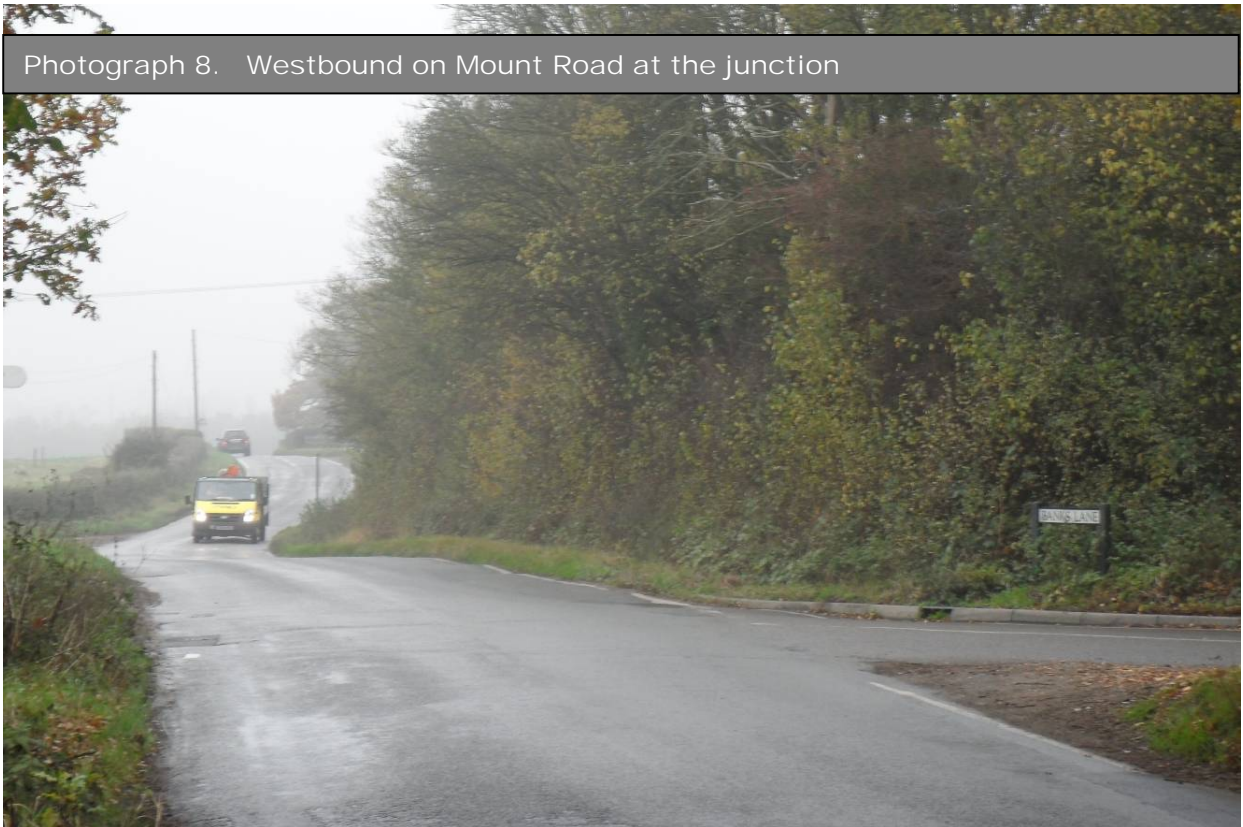
Photograph 8. Westbound on Mount Road at the junction

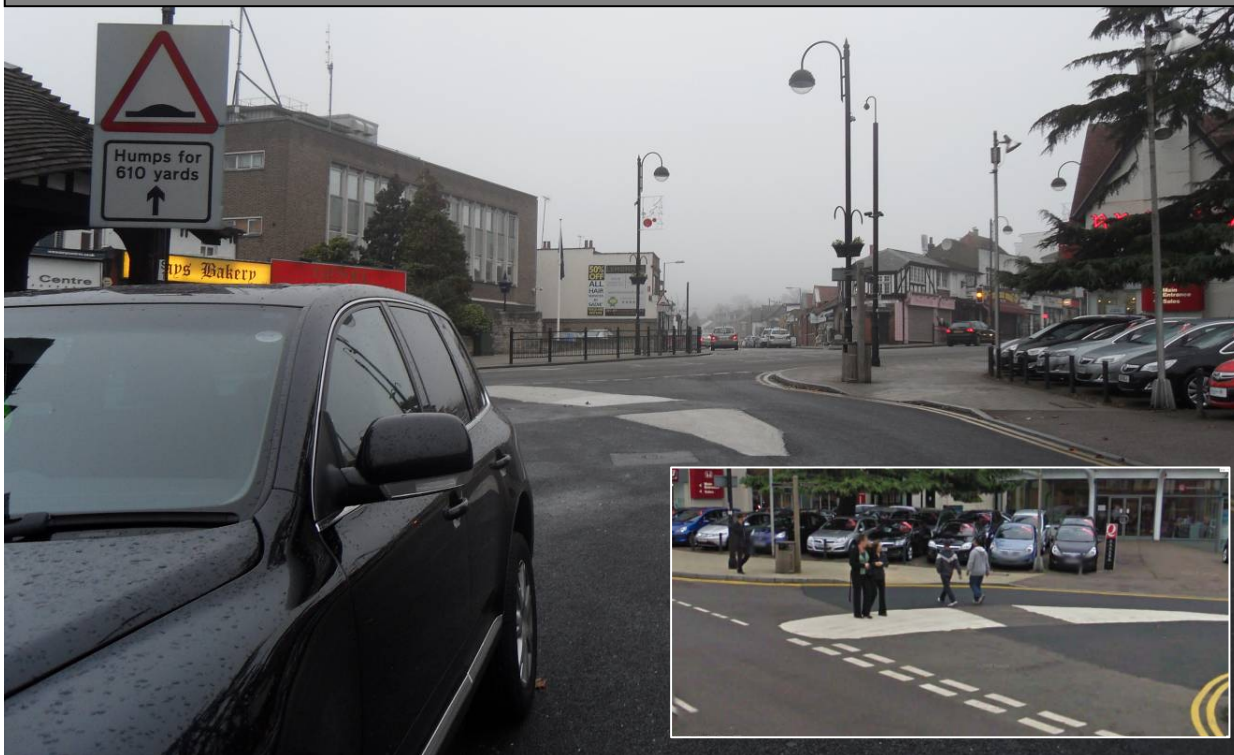
Photograph 1. Crossing point on Station Road (also see Google Earth inset)

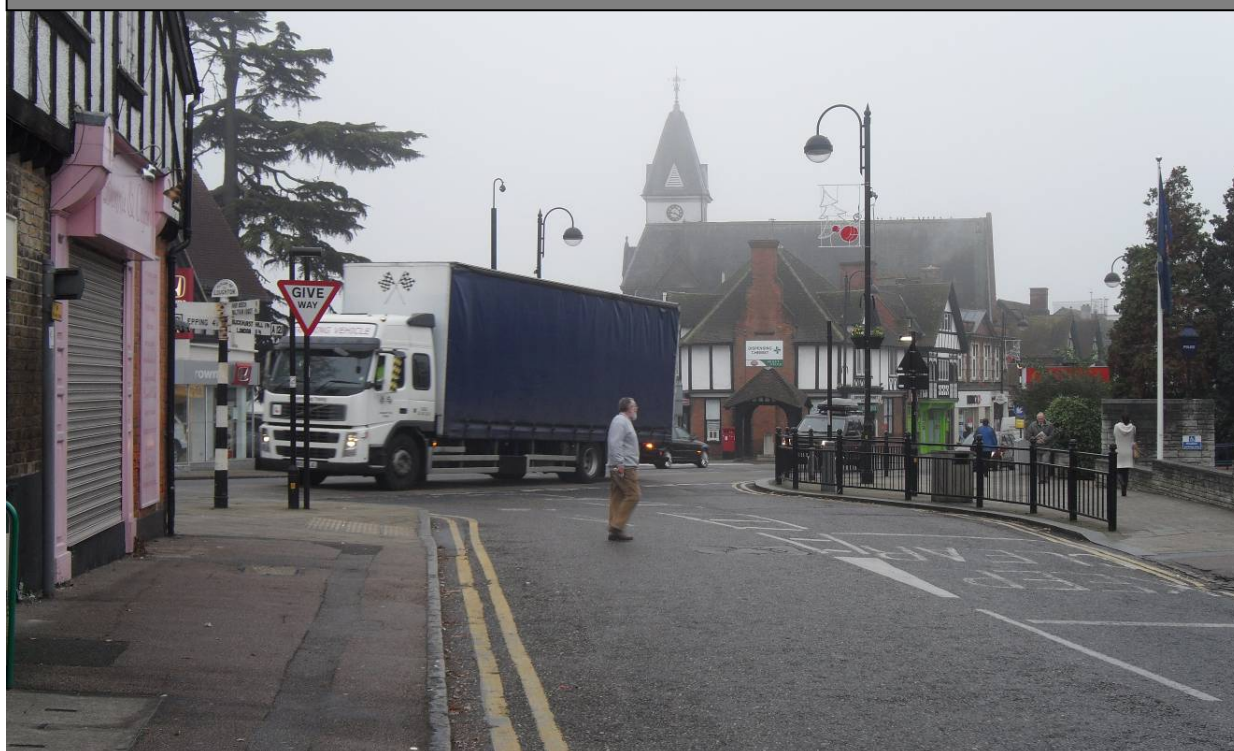
Photograph 2. Crossing point on Forest Road

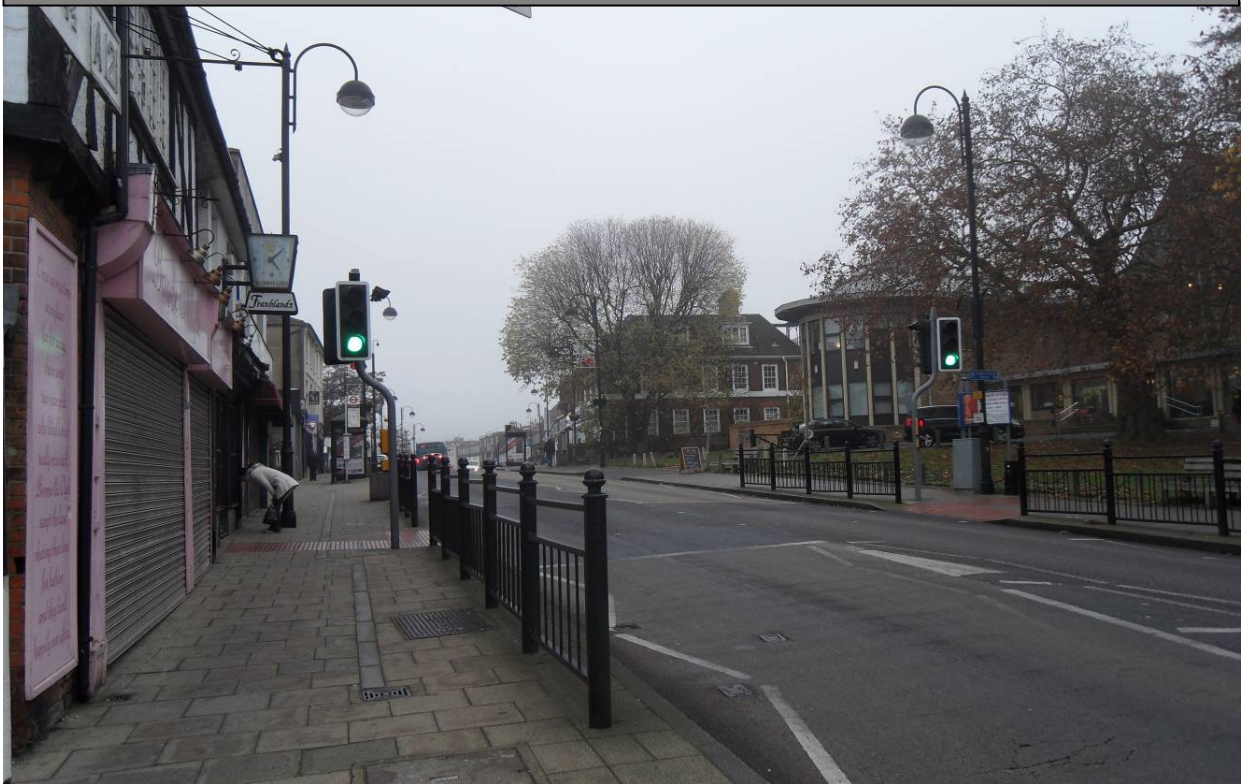
Photograph 3. Pedestrian controlled crossing on High Road north of junction

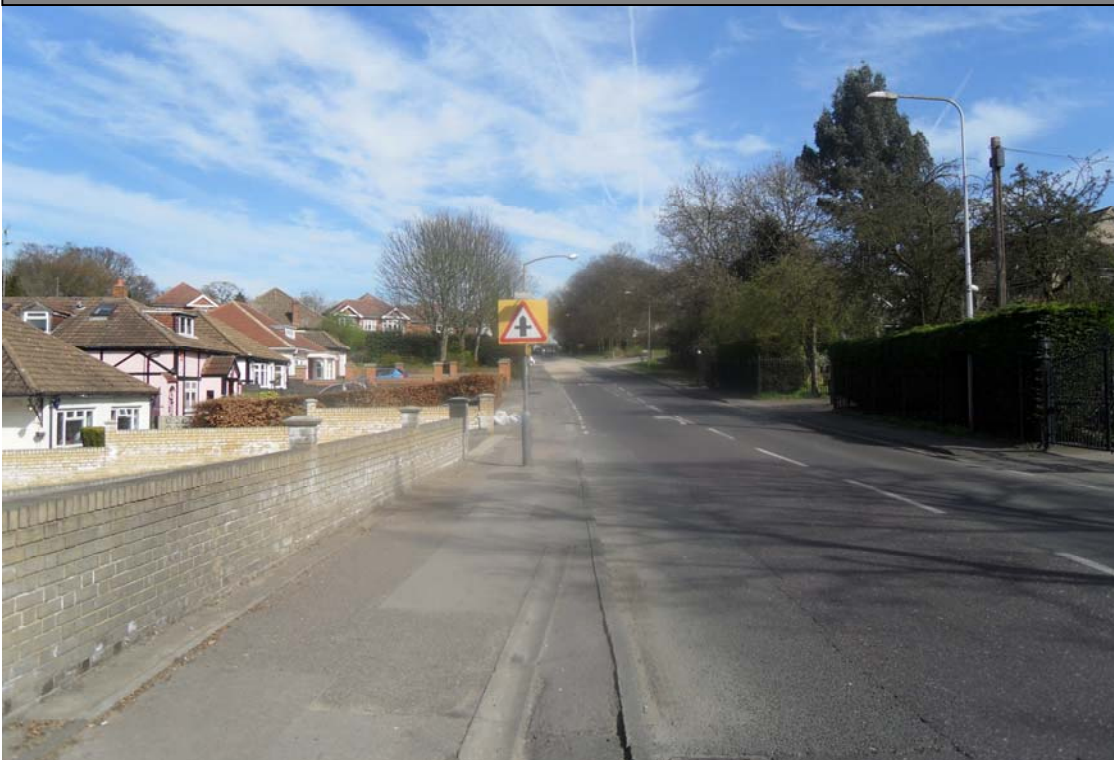
Photograph 1. Northeast bound on Manor Road, approaching the junction

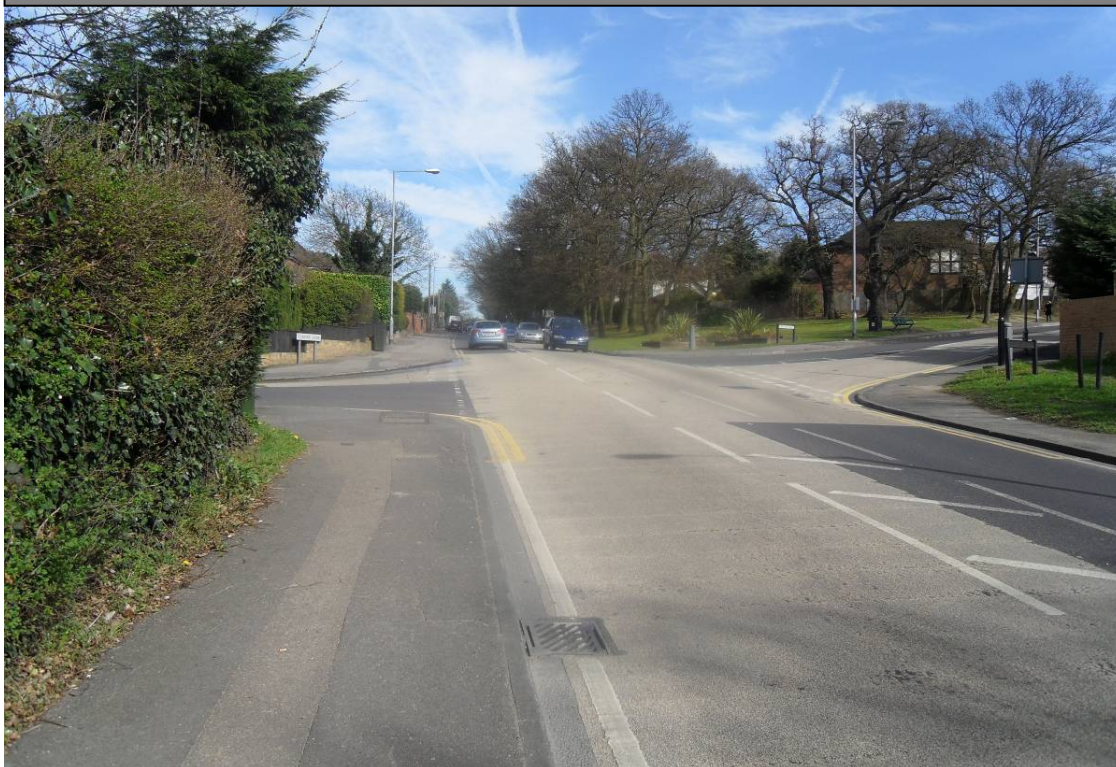
Photograph 2. Northeast bound on Manor Road, at the junction

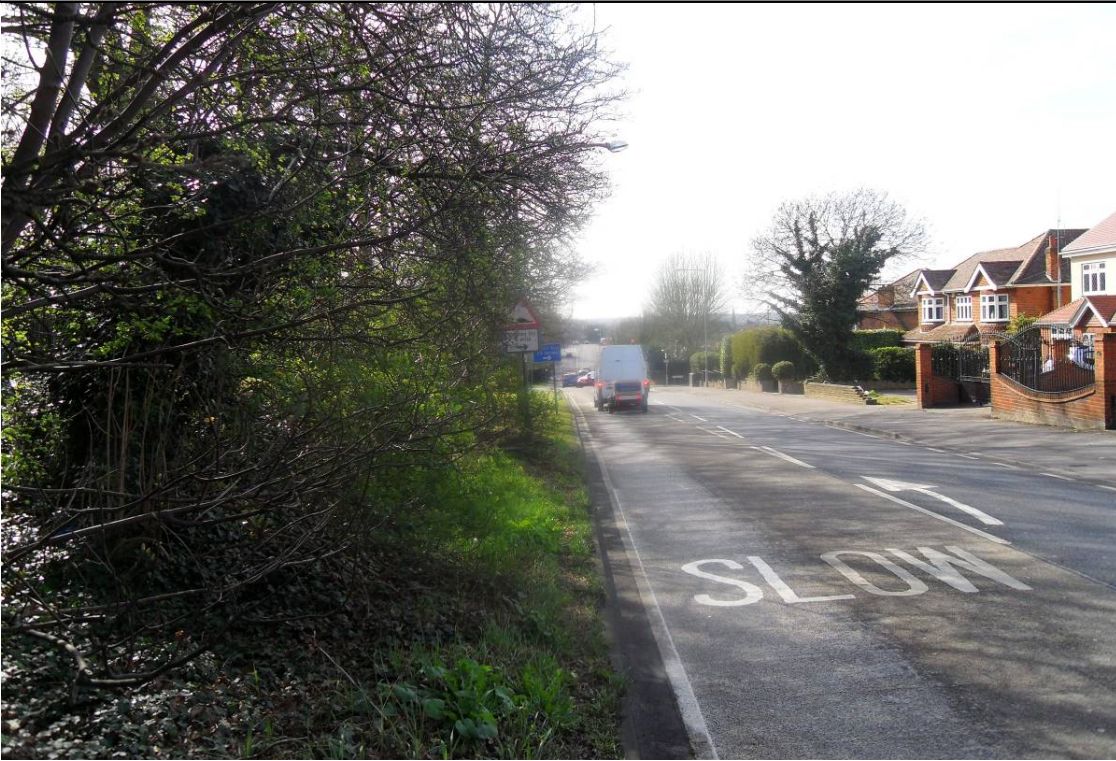
Photograph 4. Southwest bound on Manor Road, approaching the junction

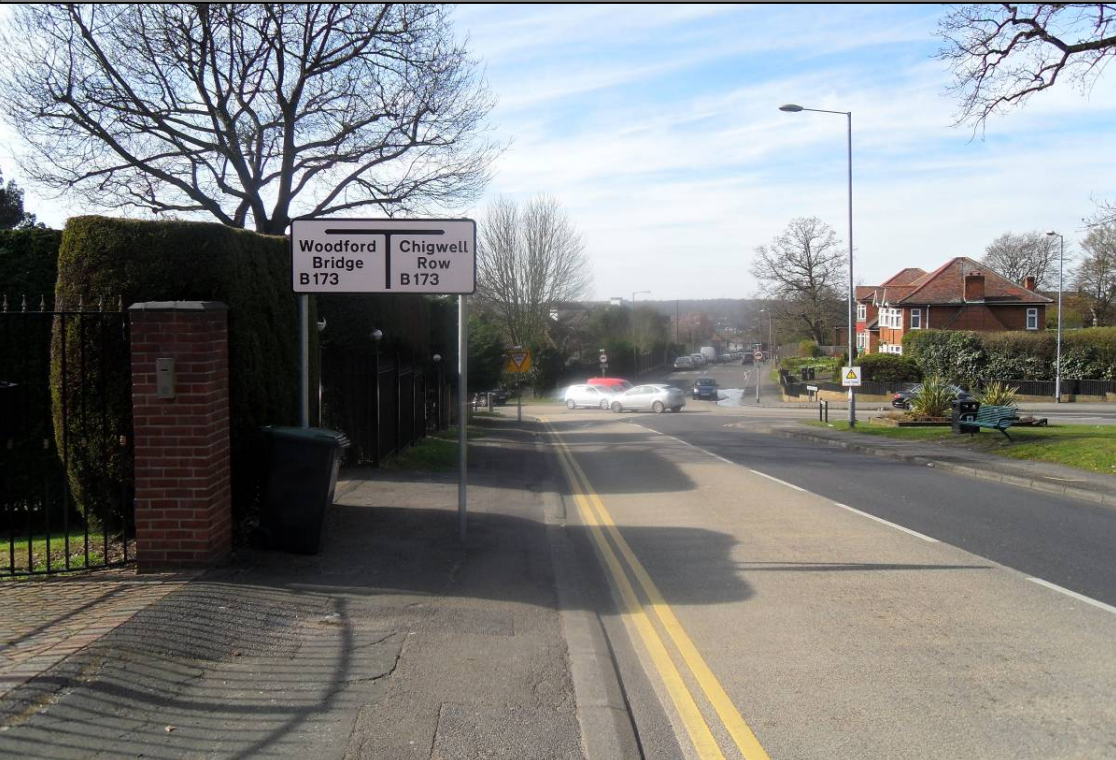
Photograph 5. On Tomswood Road, approaching the junction

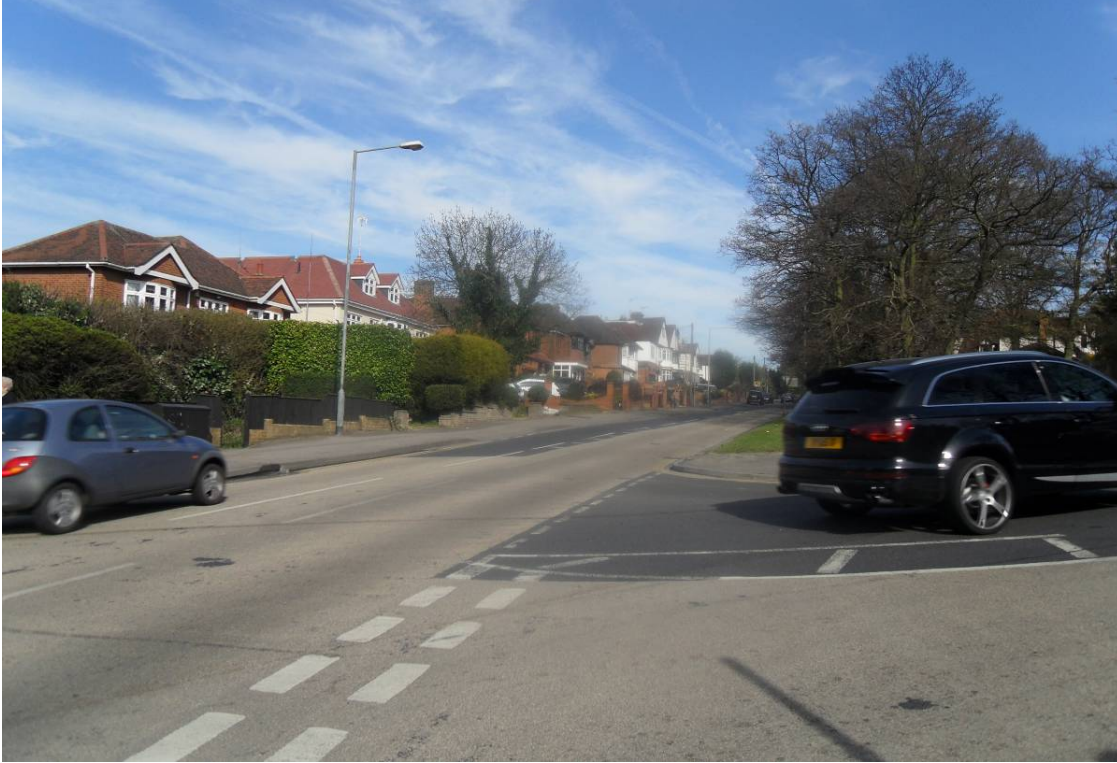
Photograph 6. On Tomswood Road, at the junction, looking to the right

Improve visibility to the right for road users entering Manor Road from Tomswood Road by:

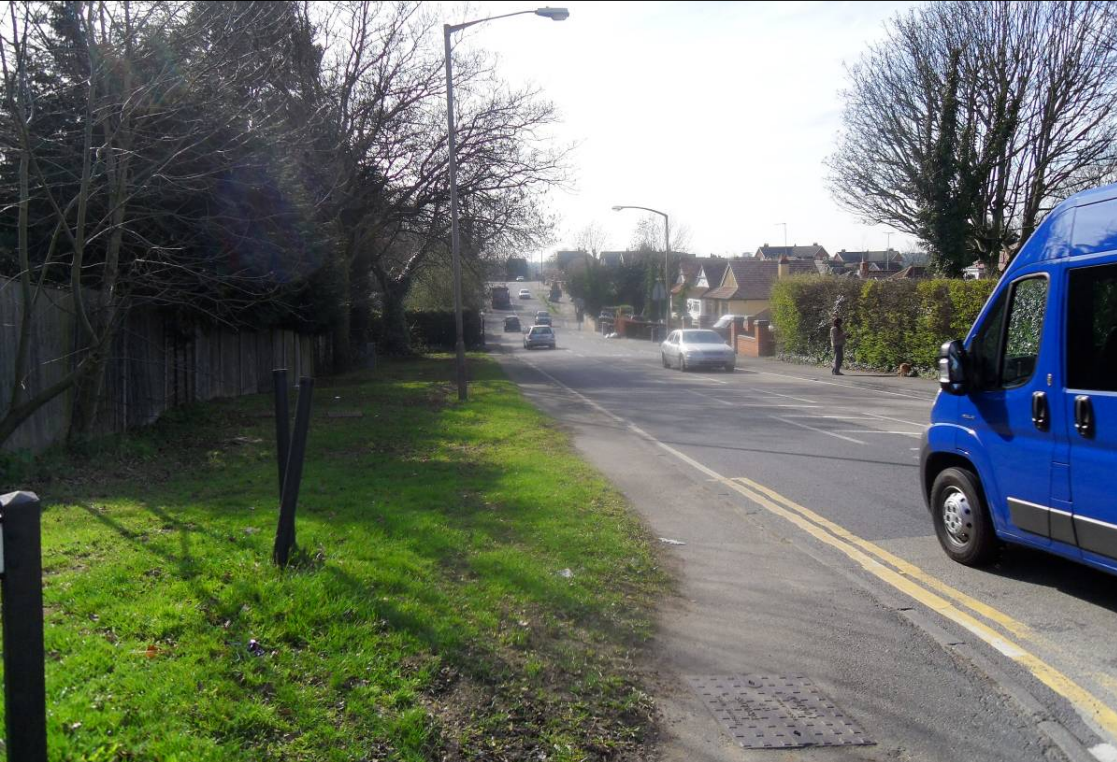
Photograph 7. On Tomswood Road, at the junction, looking to the left

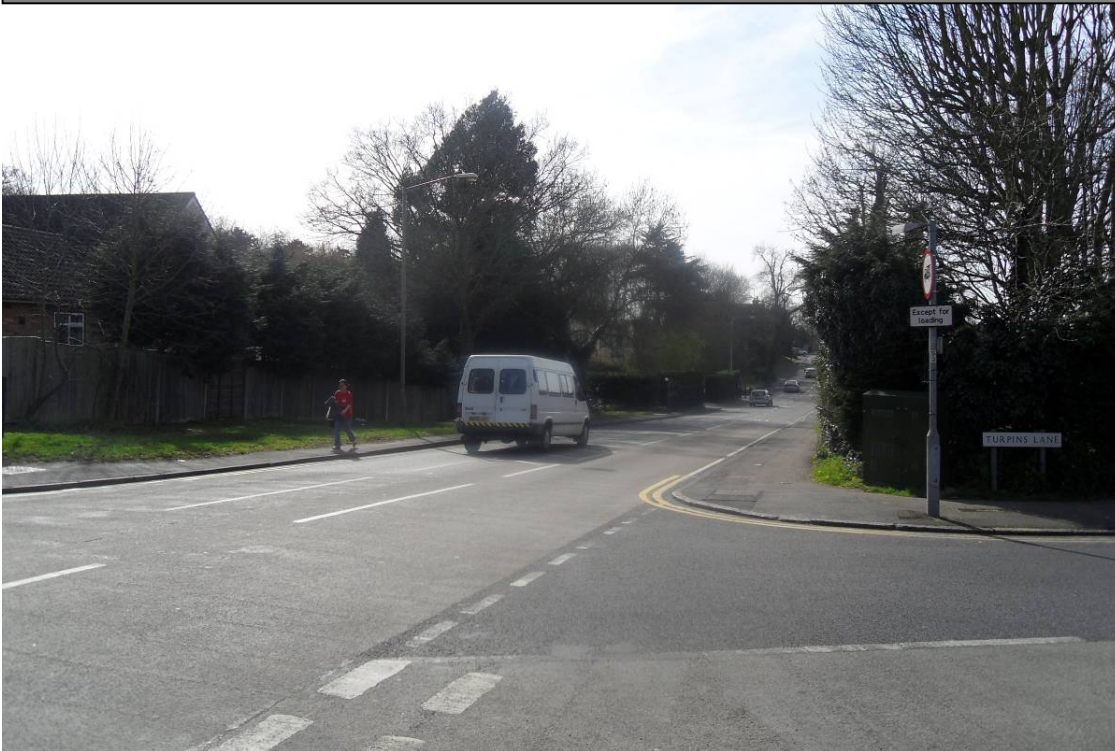
Photograph 9. On Turpins Lane, at the junction, looking to the right

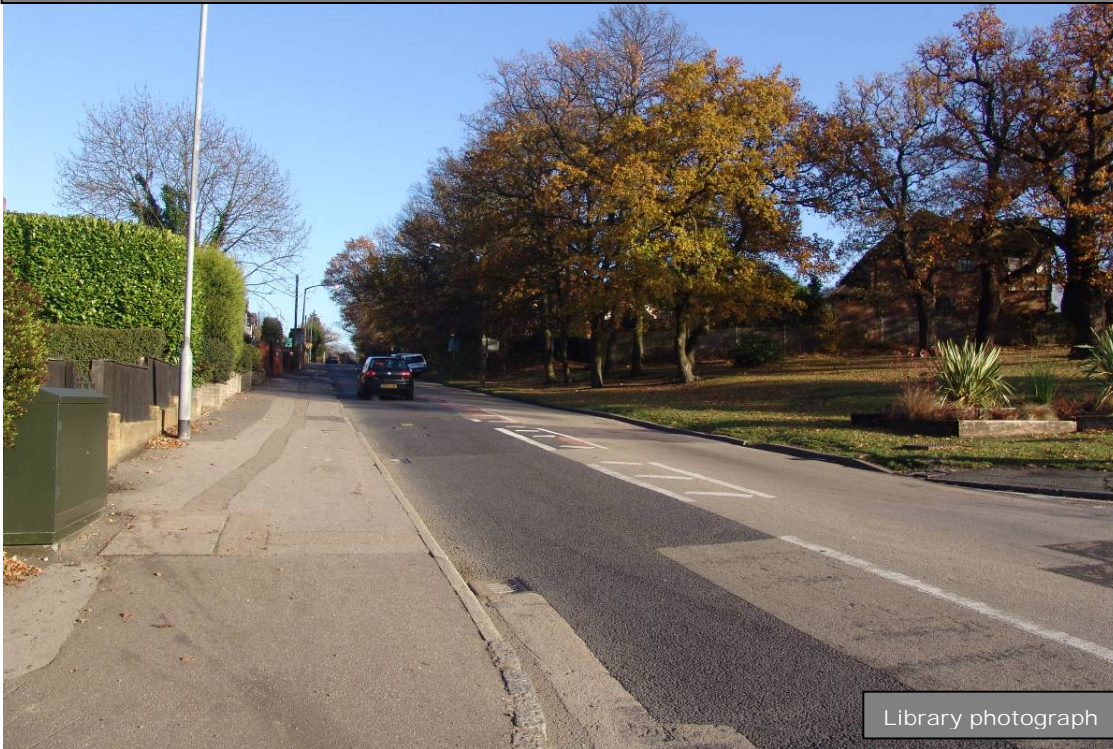
Photograph 10. On Turpins Lane, at the junction, looking to the left

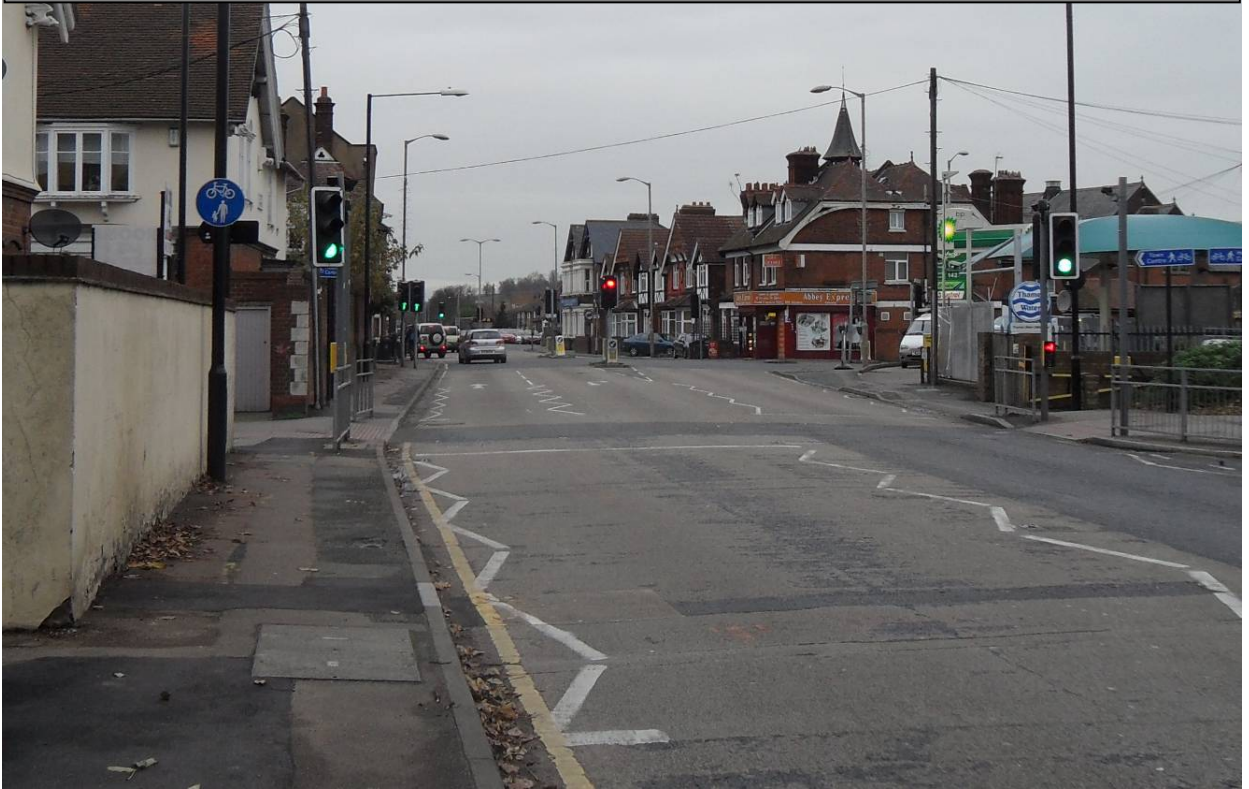
Photograph 1. Pedestrian controlled crossing on Sewardstone Rd south of junction

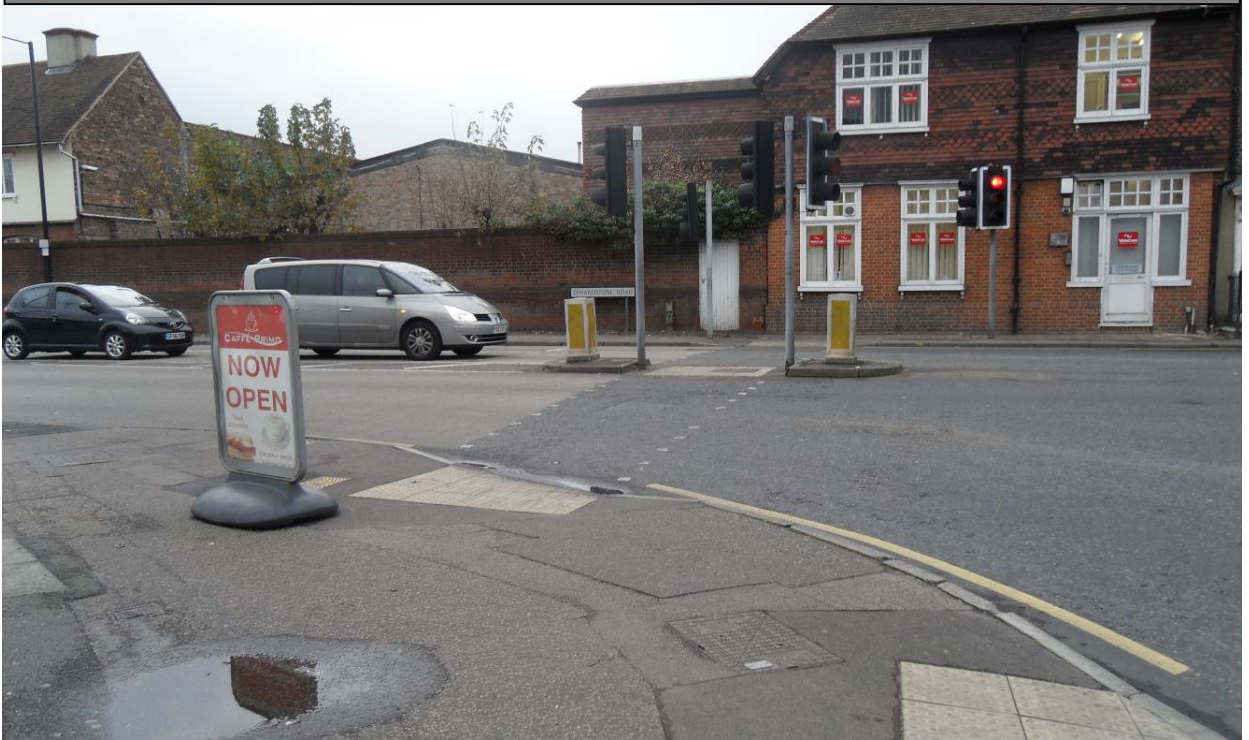
Photograph 2. Pedestrian crossing at Sewardstone Rd signals south of junction

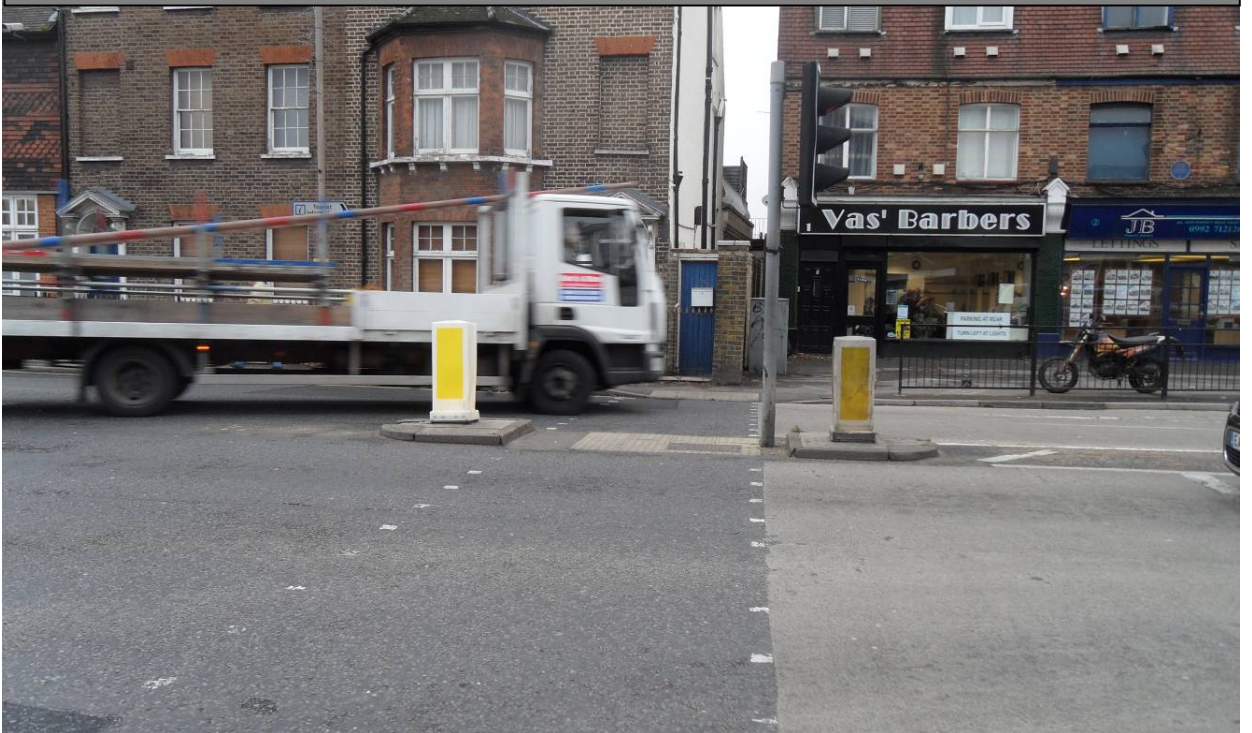
Photograph 4. Pedestrian crossing at Sewardstone Rd signals south of junction

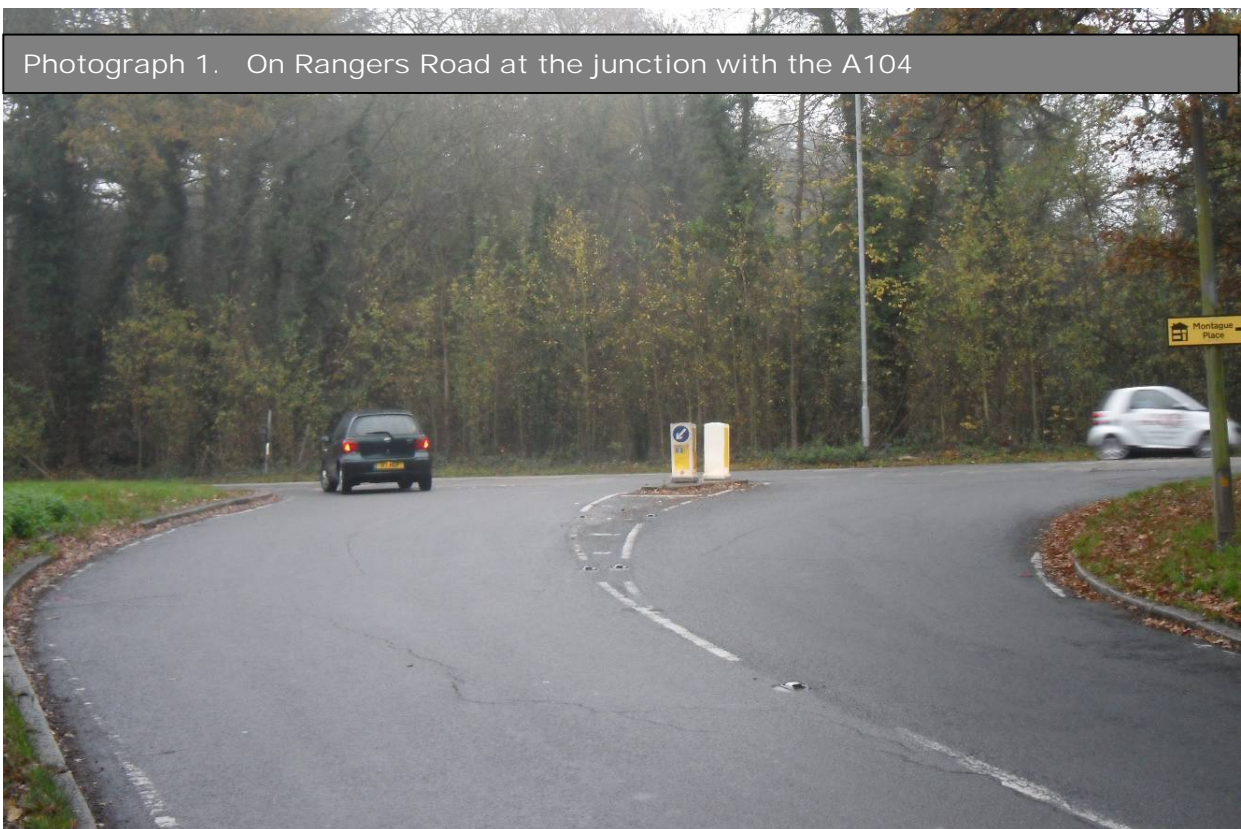
Photograph 2. On Rangers Road at the junction with the A104, looking to the right

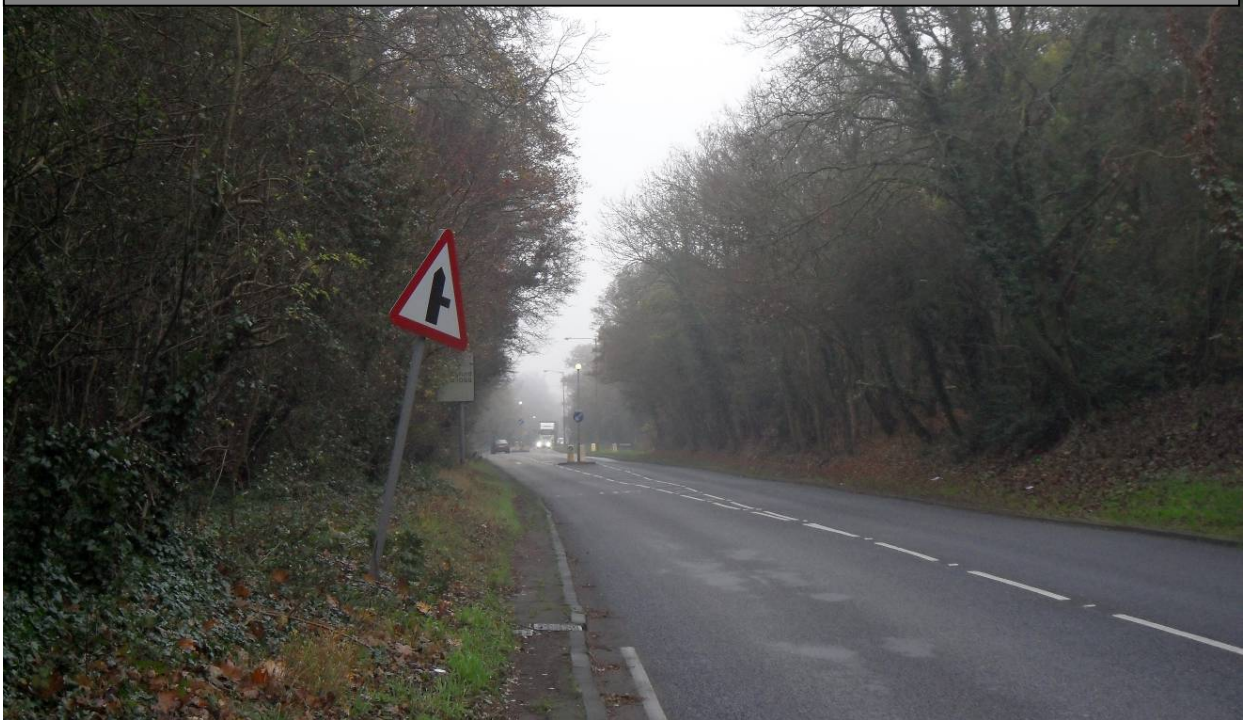
Photograph 9. Southbound on the A104, approaching junction with Rangers Road

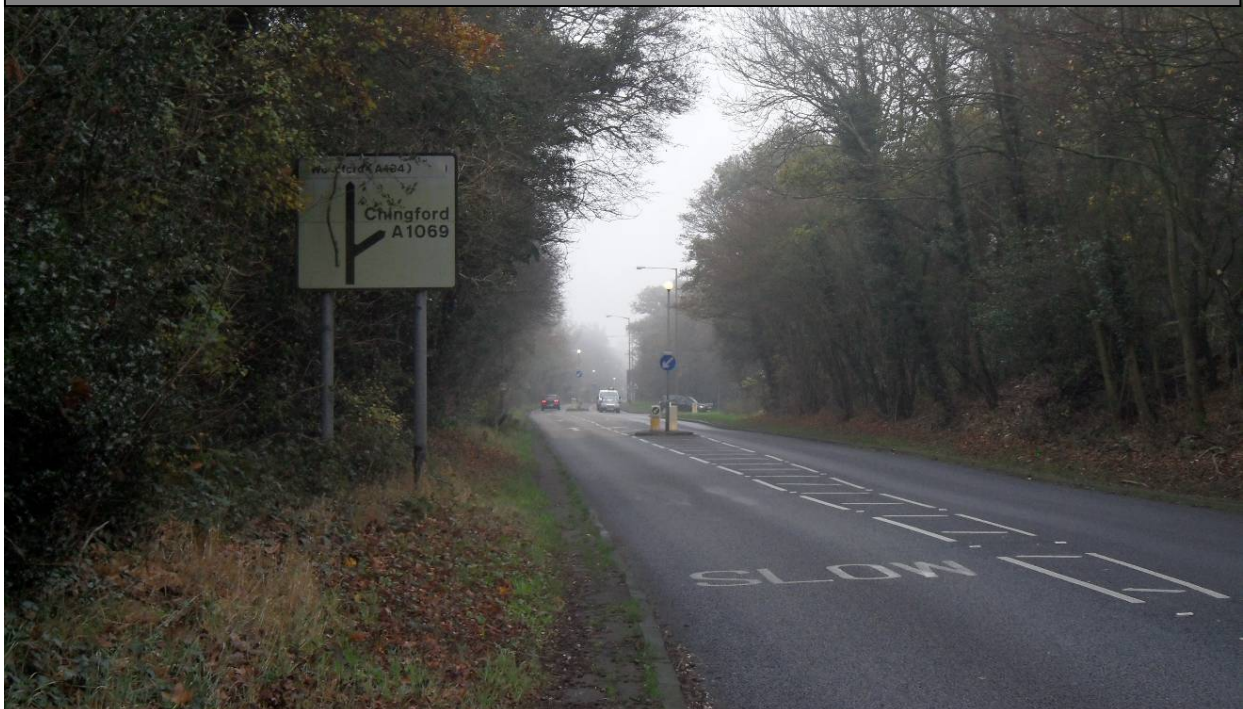
Photograph 10. Southbound on the A104, at the junction with Rangers Road

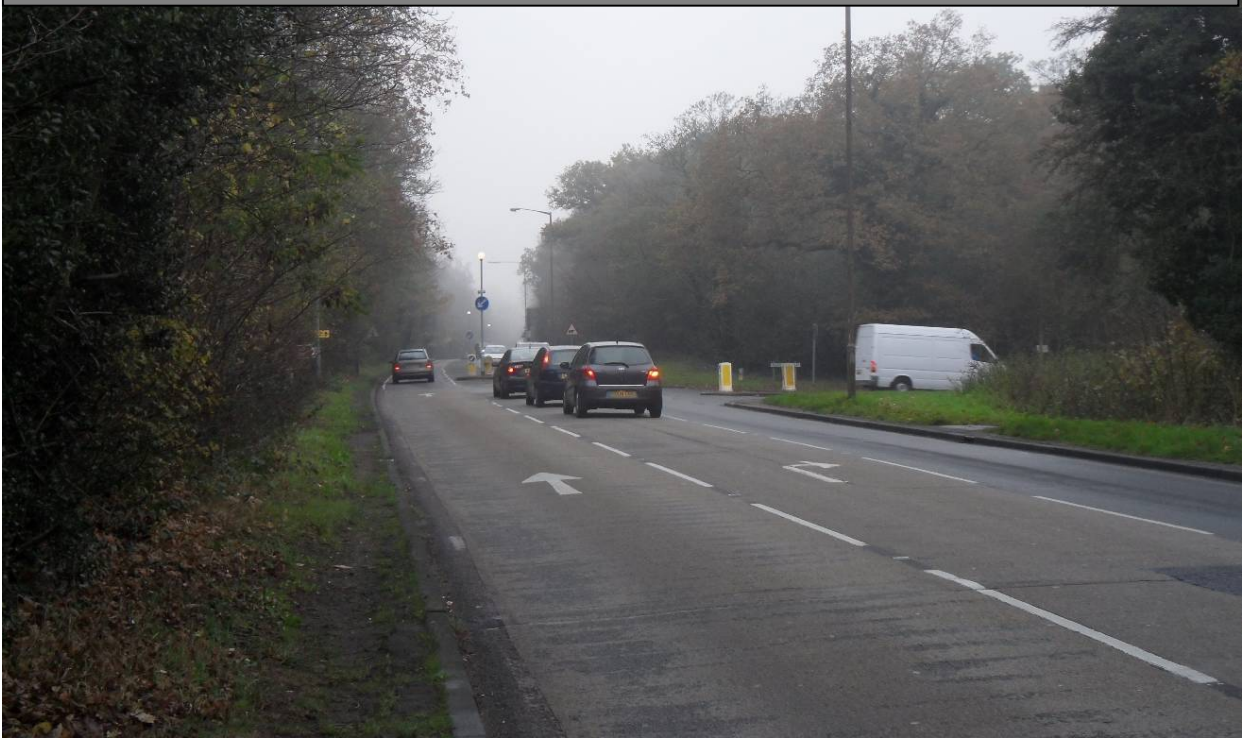
The brown direction sign opposite Rangers Road is leaning and misaligned and other sign/s may be missing from this location.

Photograph 11. Sign opposite Rangers Road
